*The Berrien House Restoration*

322-324 EAST BROUGHTON STREET  
SAVANNAH, GEORGIA 31401

Savannah HDRB Supplement  
Continued Application  
September 19, 2013

## UPDATED NOTES FOR BERRIEN RESTORATION

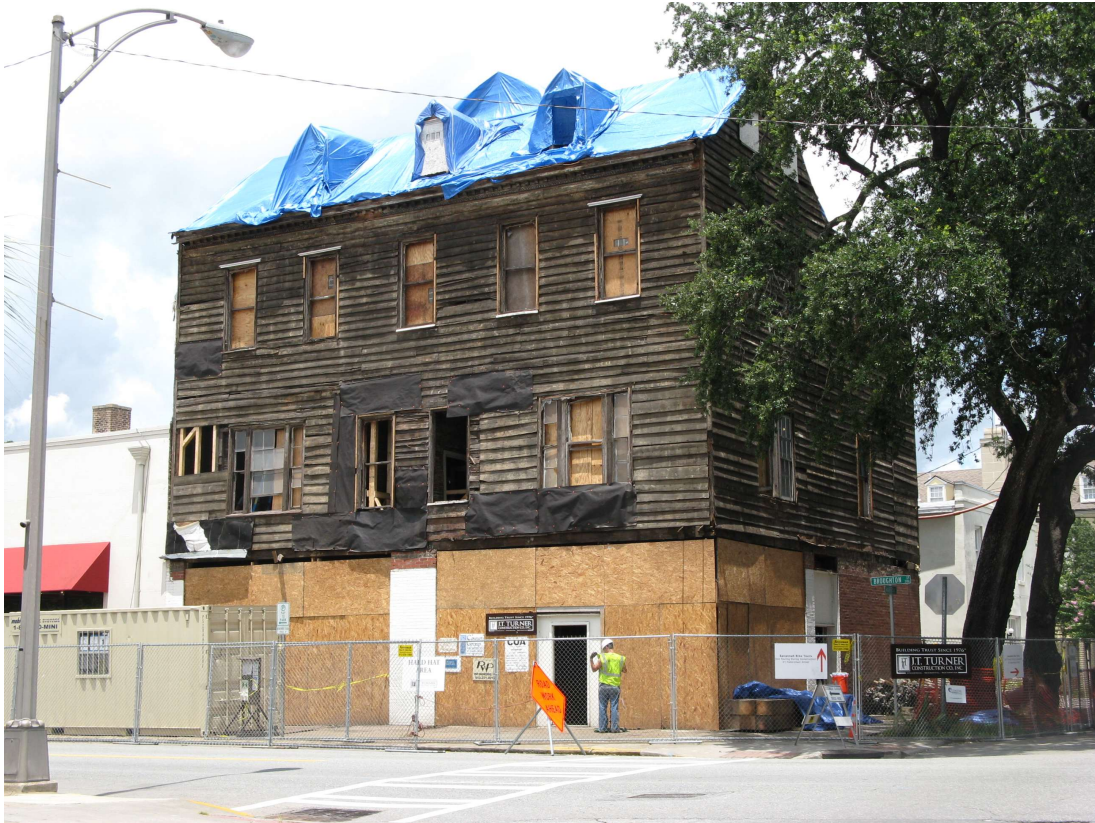
Broughton Street elevation before after stucco removal and before lowering in July 2013

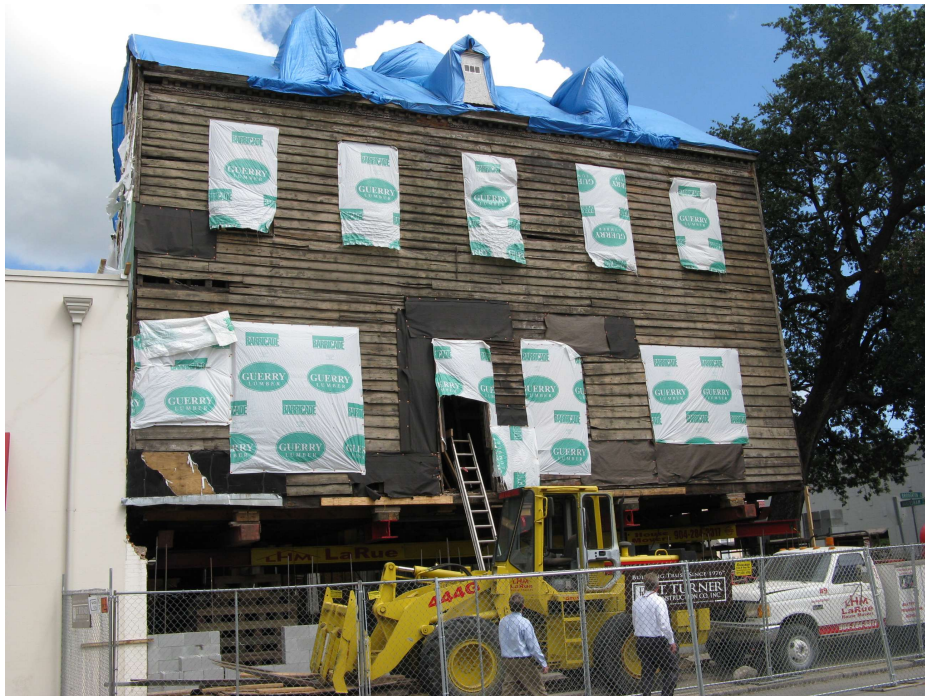
Berrien House as of 9-18-2013 . Perimeter wall 75% complete, repairs between Blick building complete and building lowered 2' of the 3'8''.

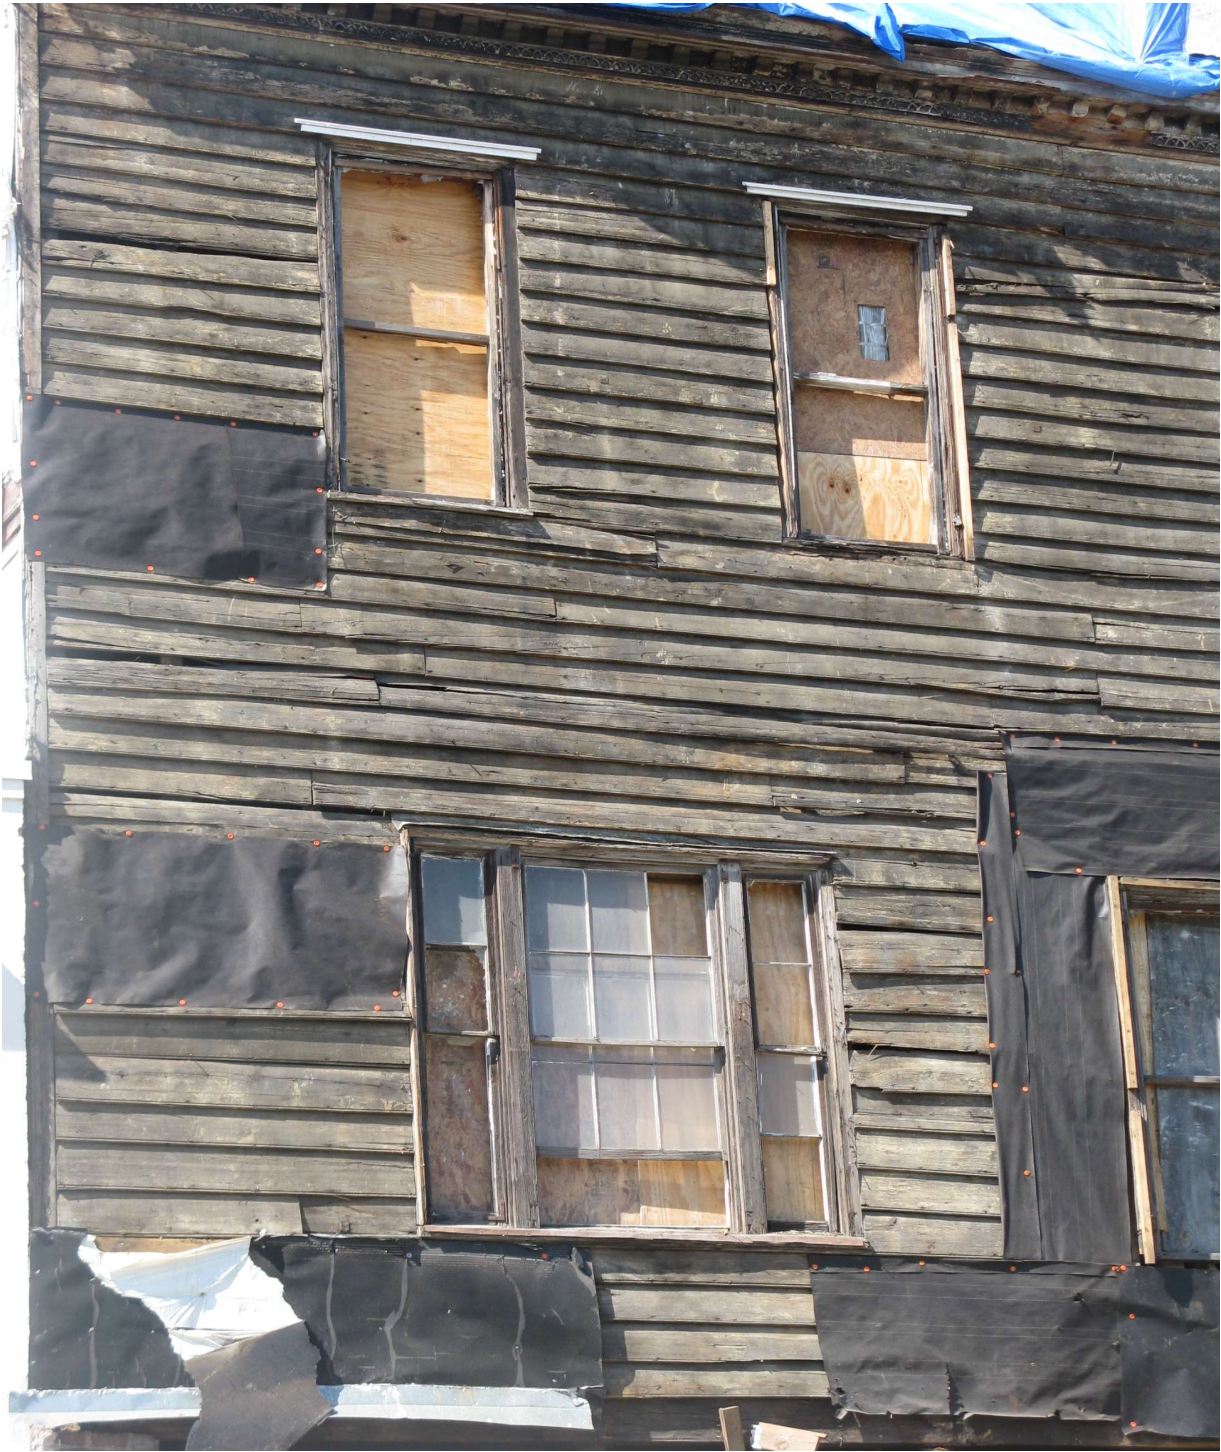
Closer view of front facade after stucco removal show the poor condition of siding and windows.

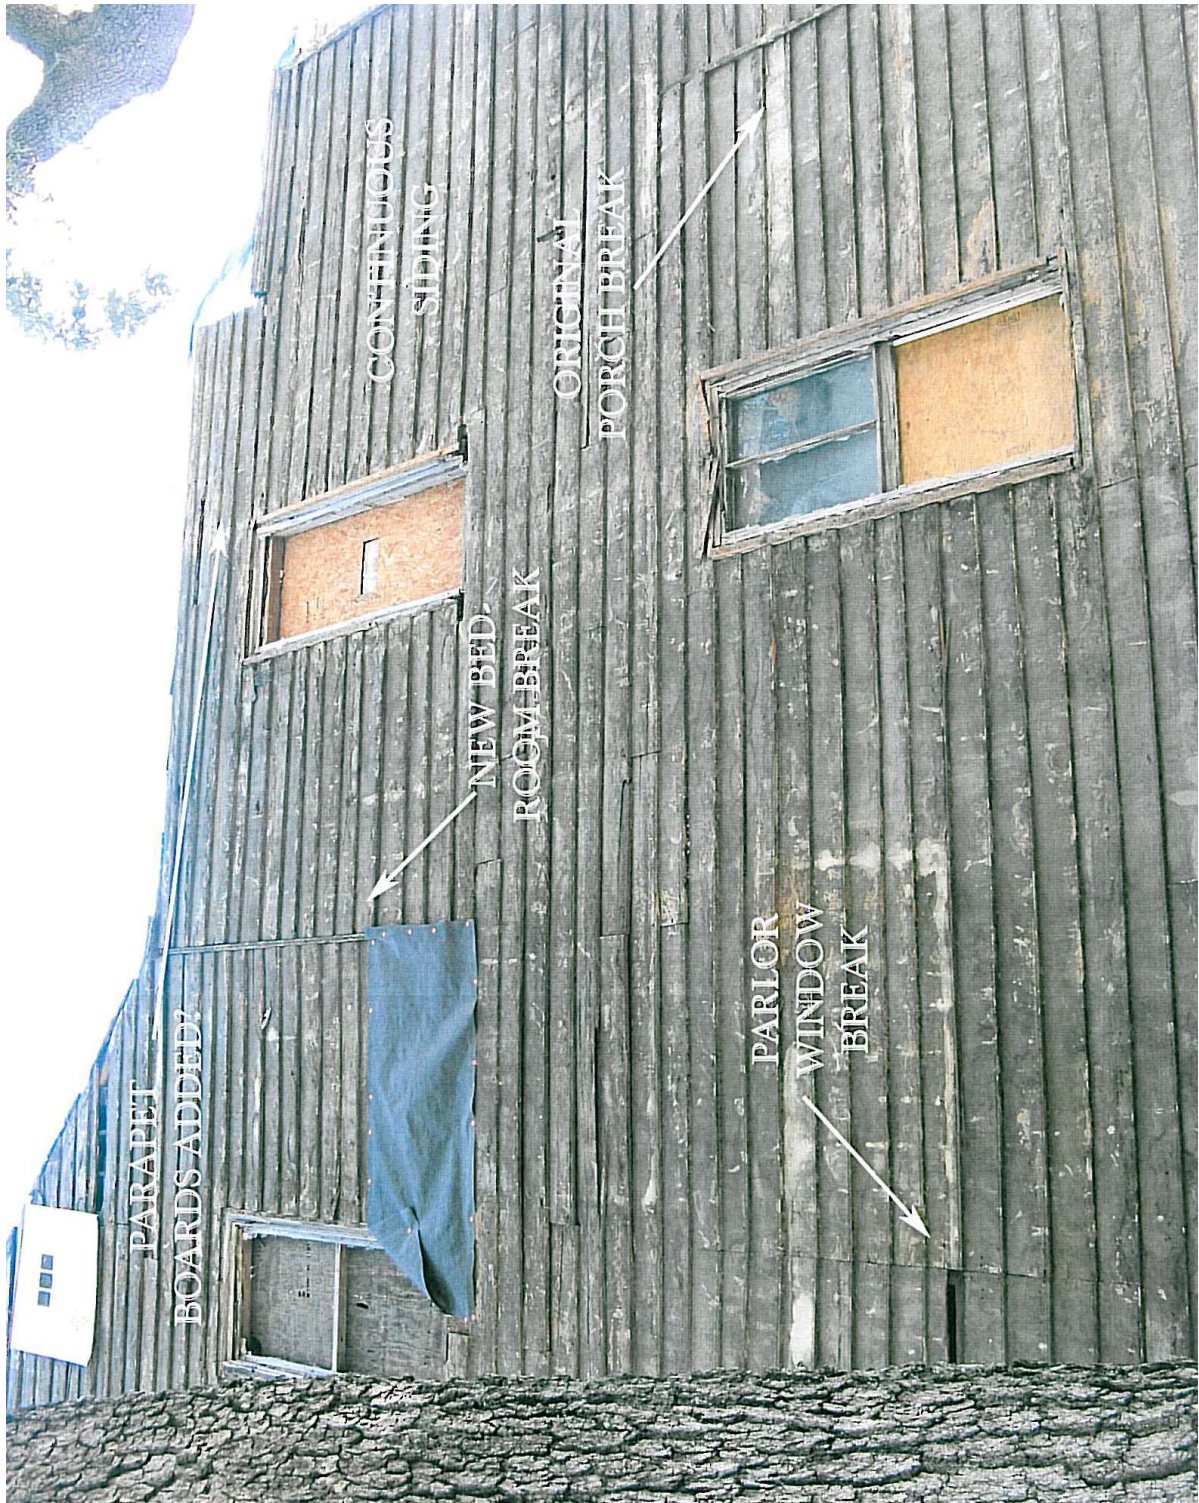
Habersham elevation shows the evolution of the building in the breaks of the siding . The third floor rear shed rooms and sleeping porches were added c.1830-1840 by John Macpherson Berrien.

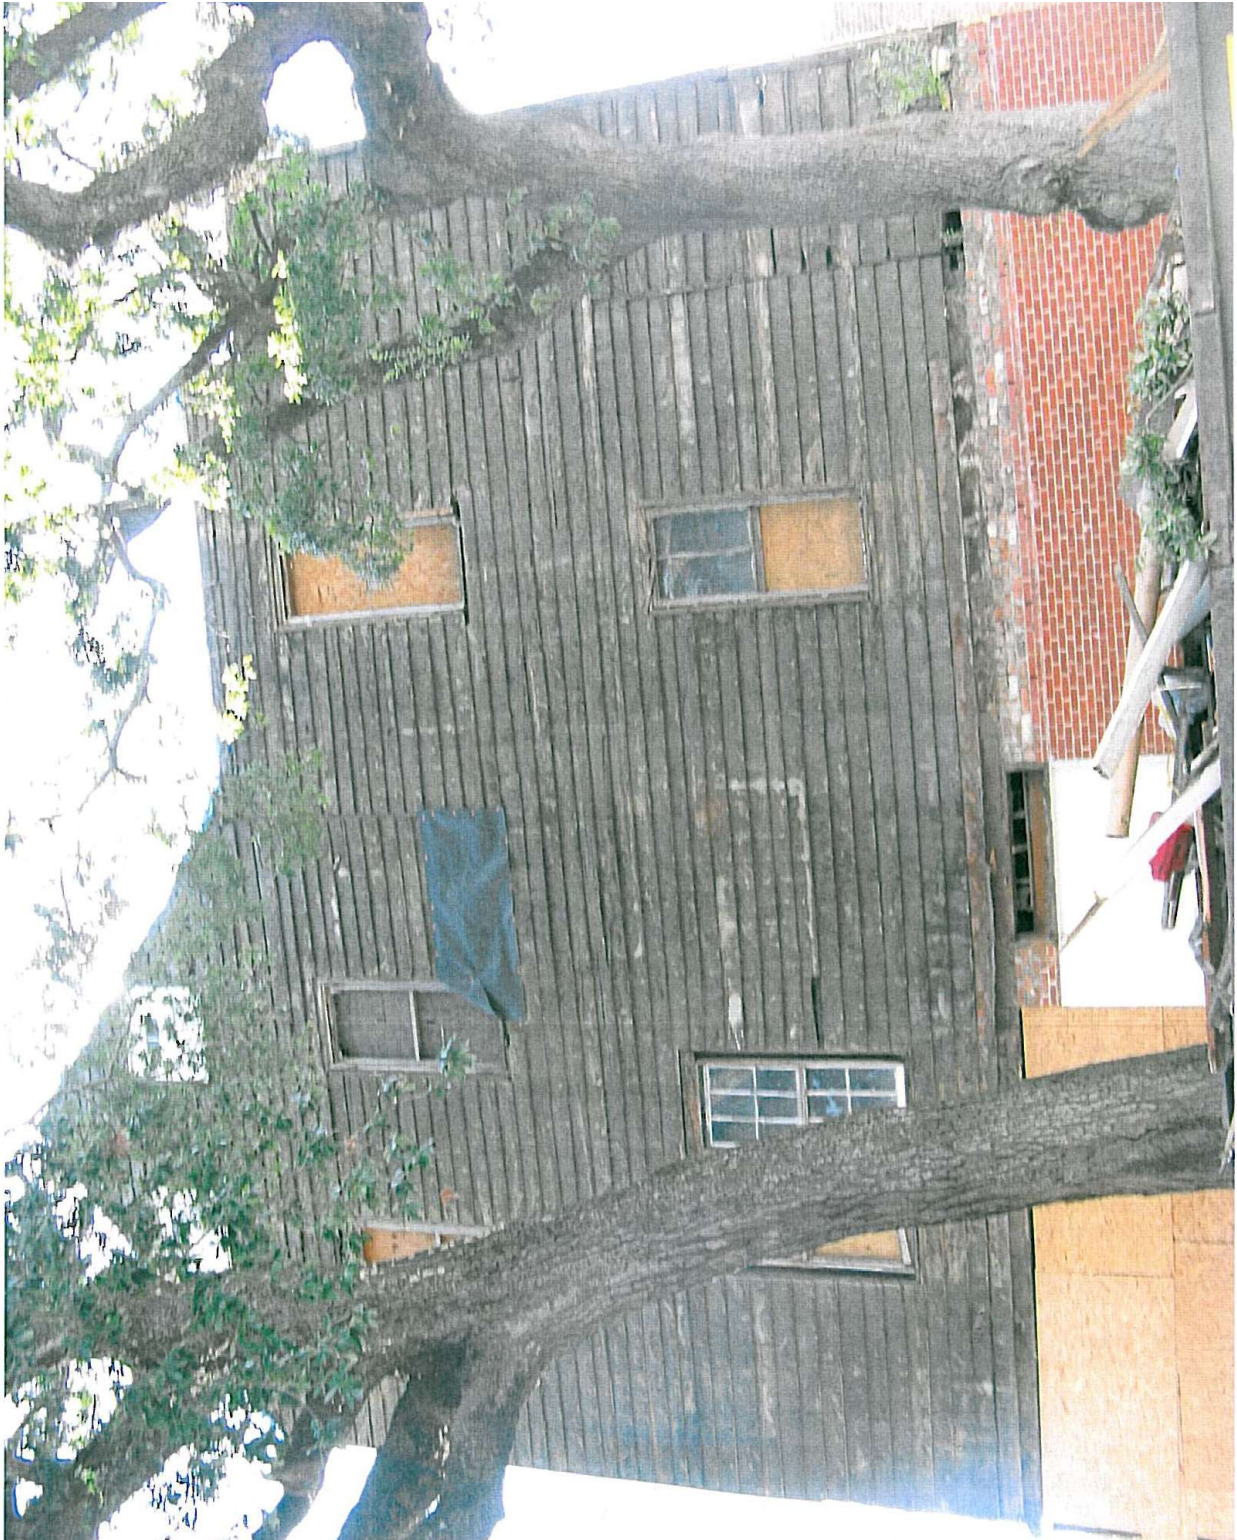
Full view of the Habersham elevation before demolition of ground floor.

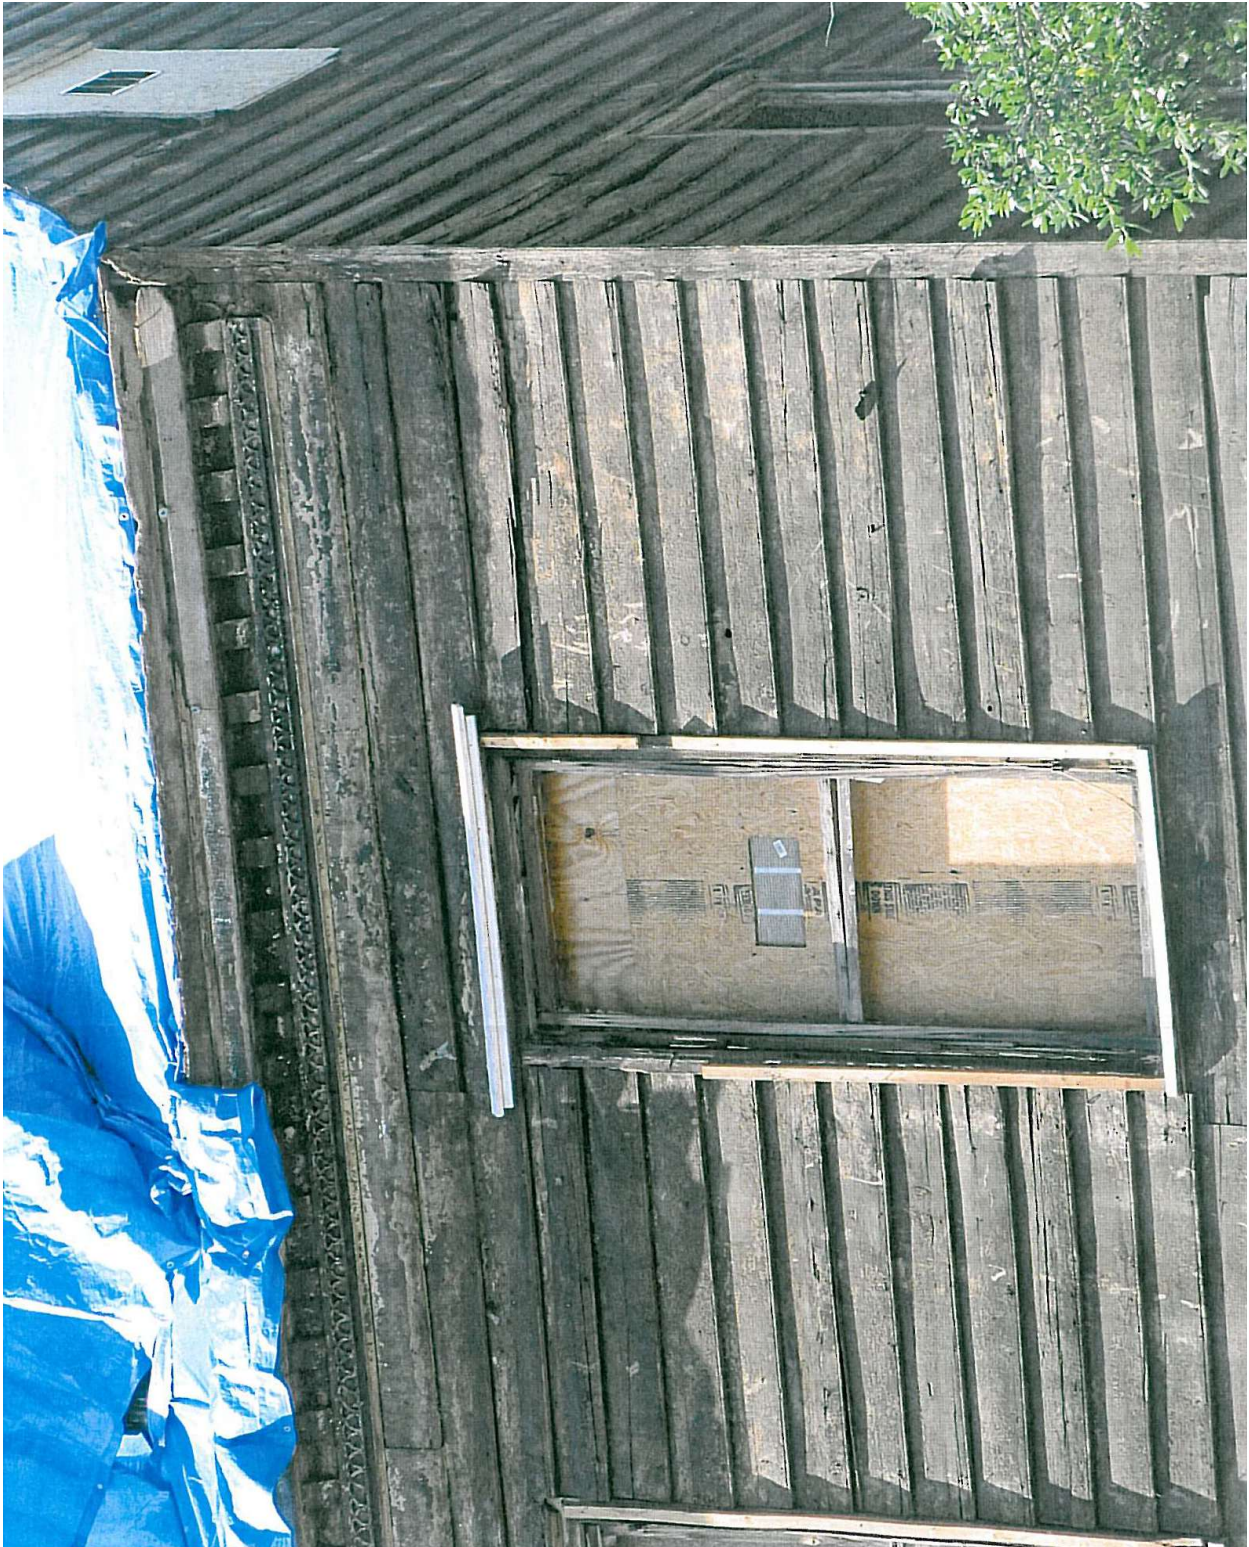
Removal of the stucco revealed the original cornice is good condition. Water damage will require replication of some of the details.

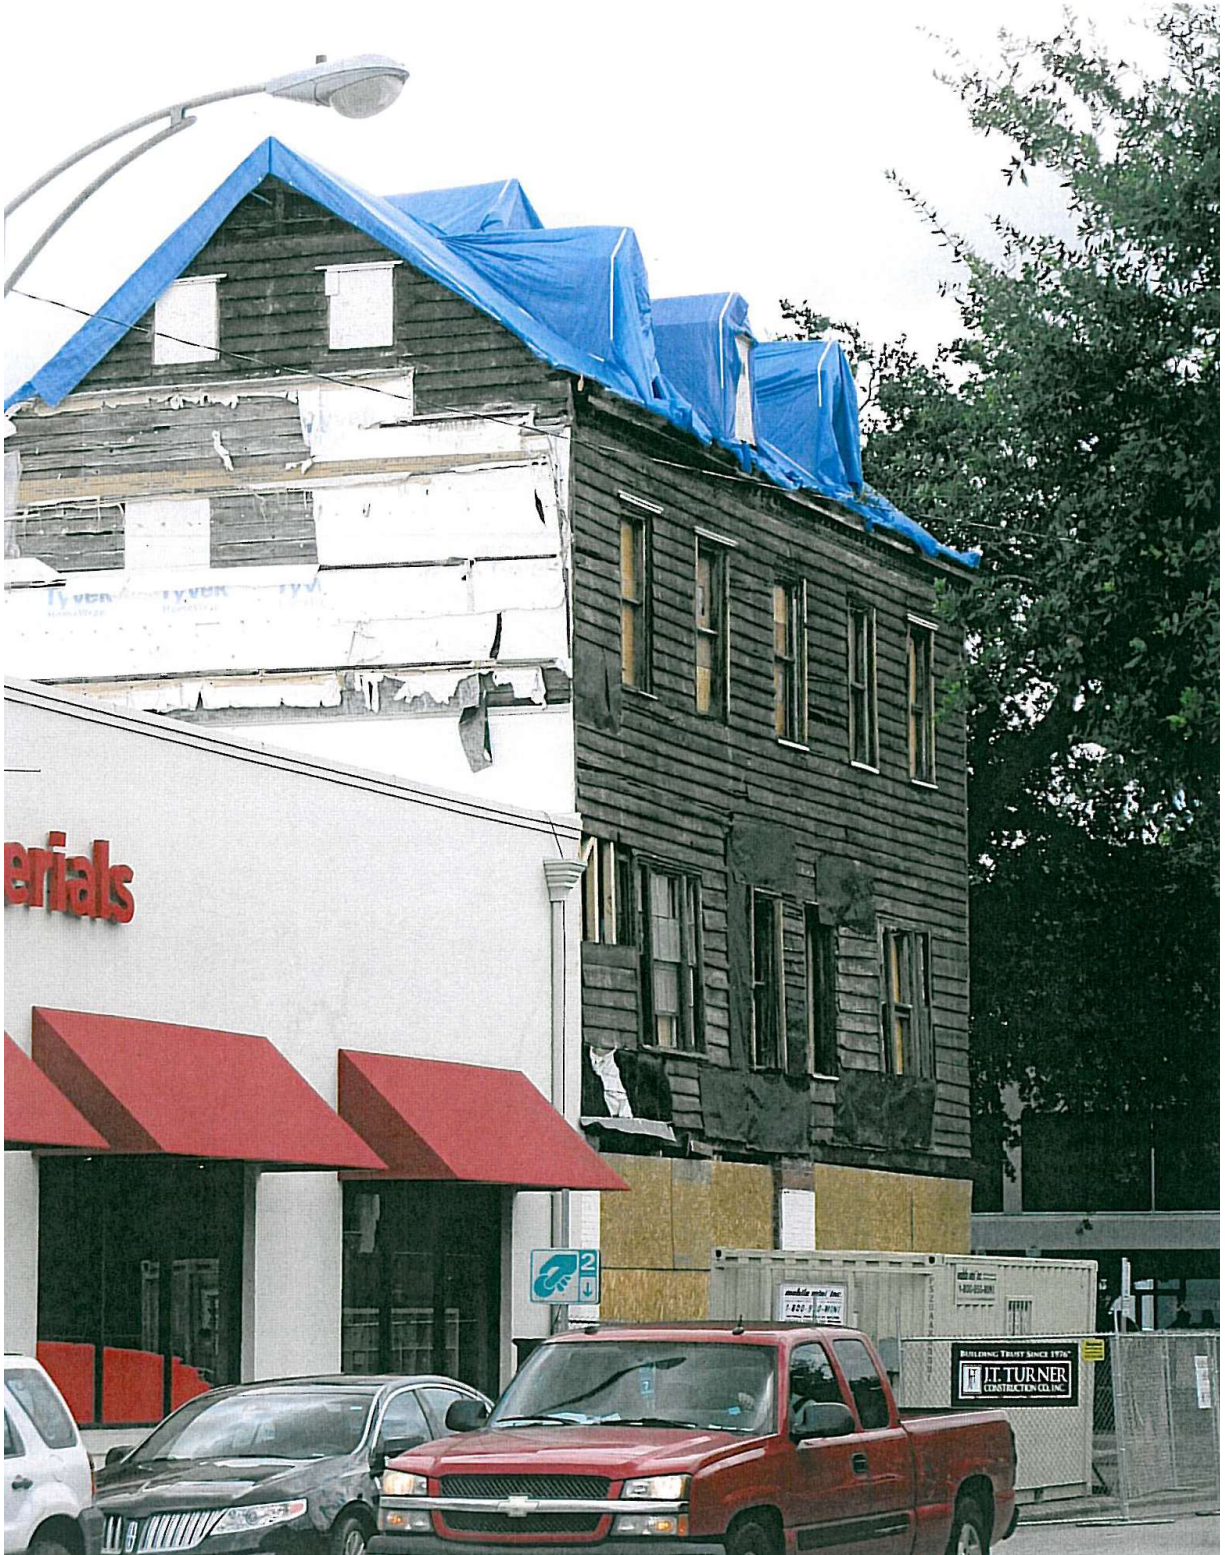
View of the west elevation before lowering of the building.

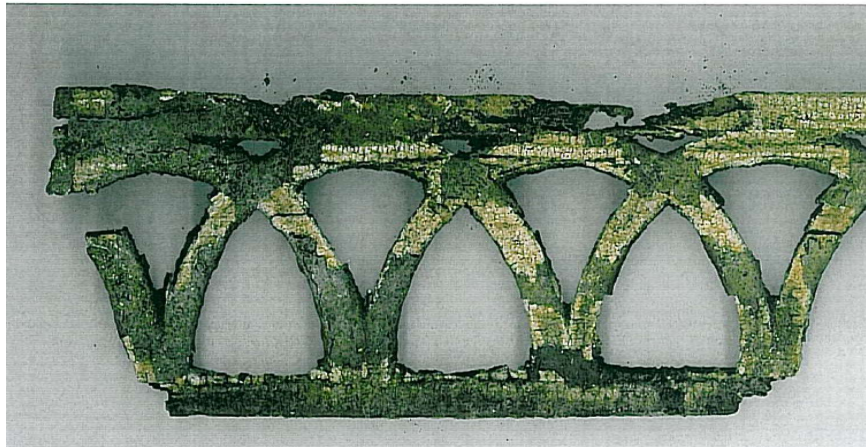
We have collected and cataloged damaged parts of the cornice and trim work for reproduction .  
This is a small section of the cornice fret work.

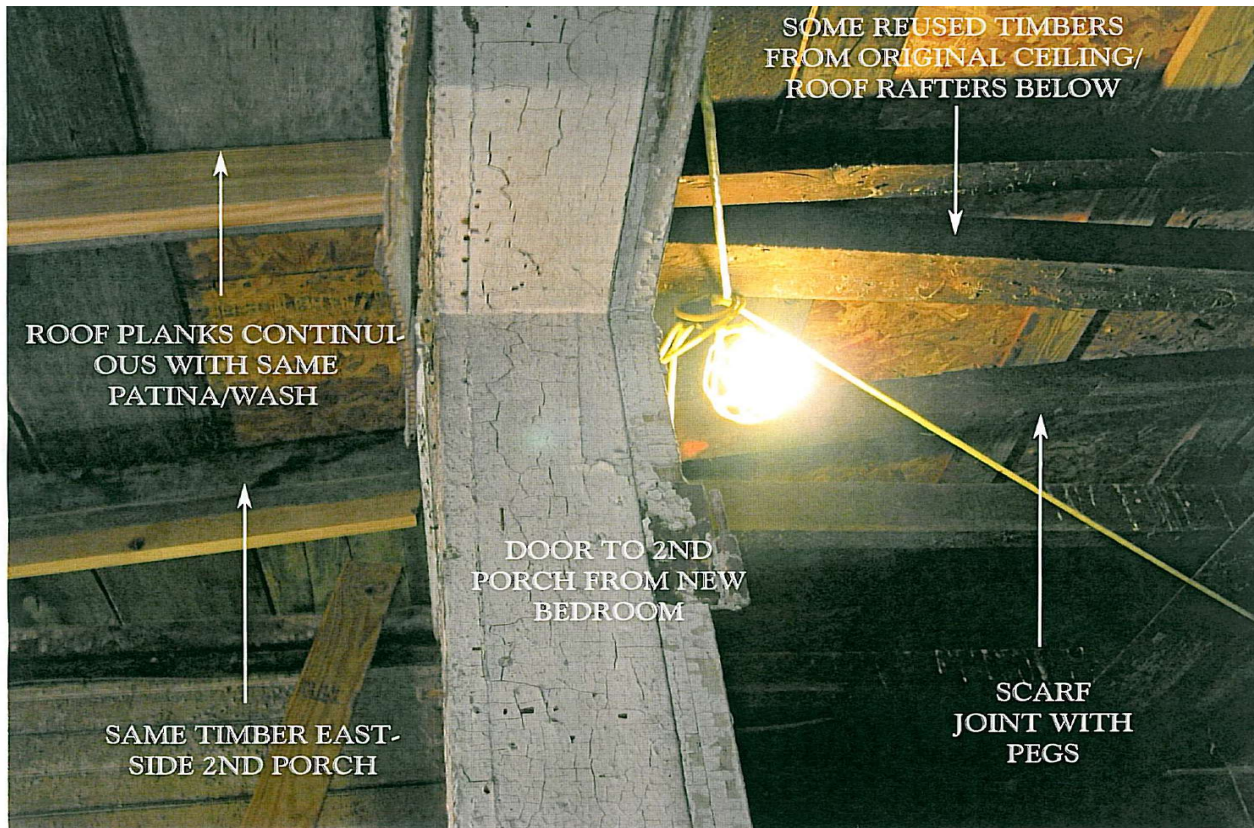
We study the construction of the third floor additions extensively. This view shows the continuity of the construction from the back room to the sleeping porch.

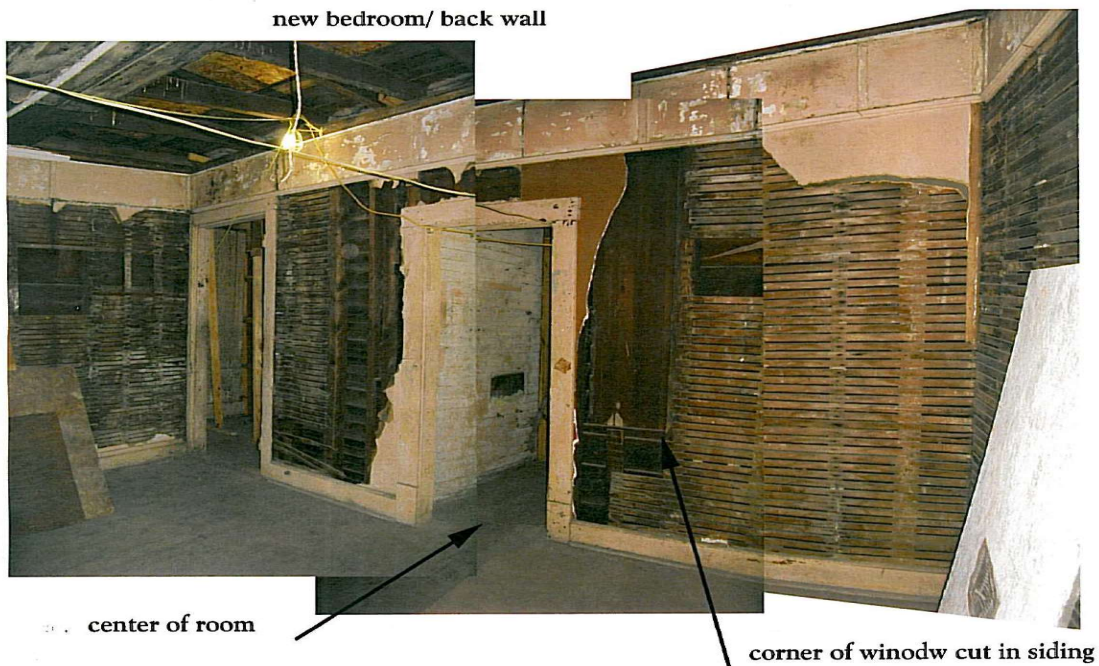
The scars in the siding on the back wall of the building are identical on both east and west sleeping porches. The corner of the window cut corresponds to the corner of the door sidelights in the rear elevation. This is the east side addition looking north.

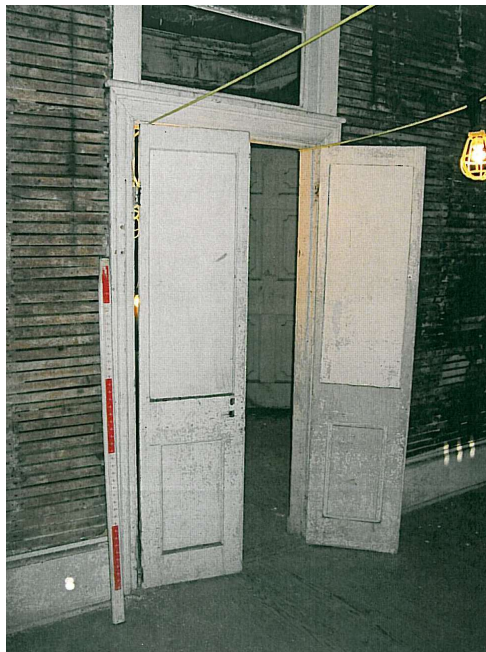
These doors (from a later wall on the inside of the building) will be used for the sleeping porch.

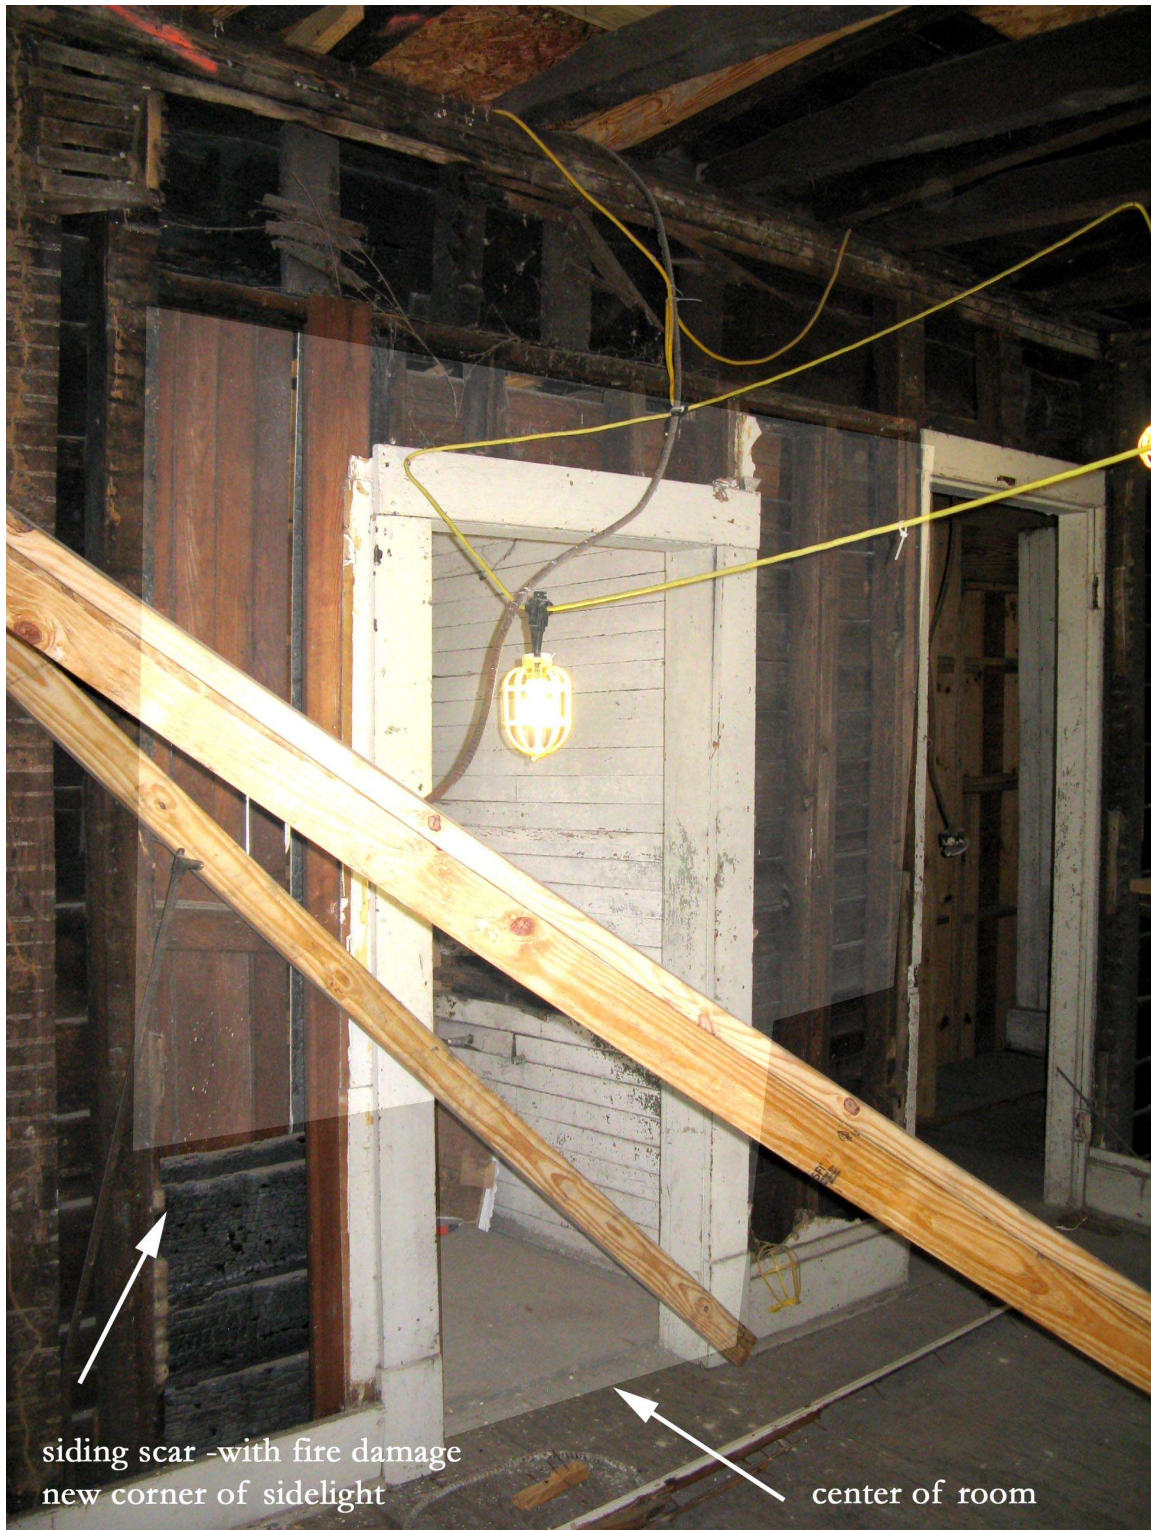
West side shed addition looking north. Show the same cut in the siding as the east side room. Here you can see the fire damage on the back of the siding. The highlighted area shows restored french

door with sidelights.

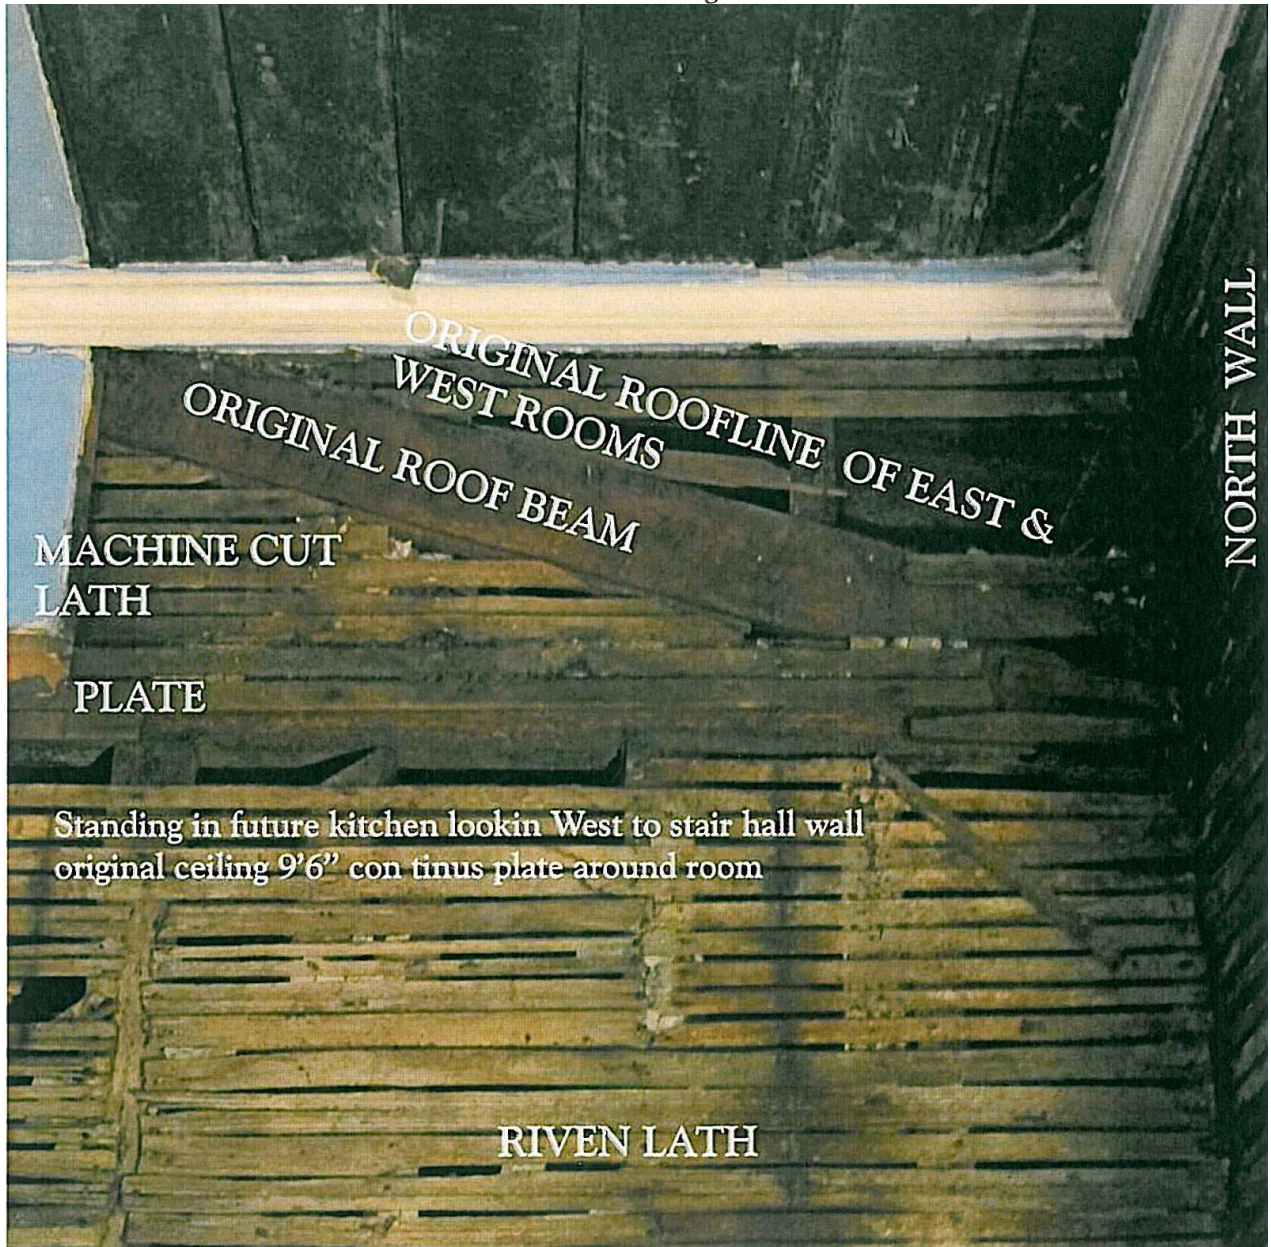
This view shows the evolution of the original 2<sup>nd</sup> floor shed rooms . The central stair tower is believed to have been original to the house with access to the garret.

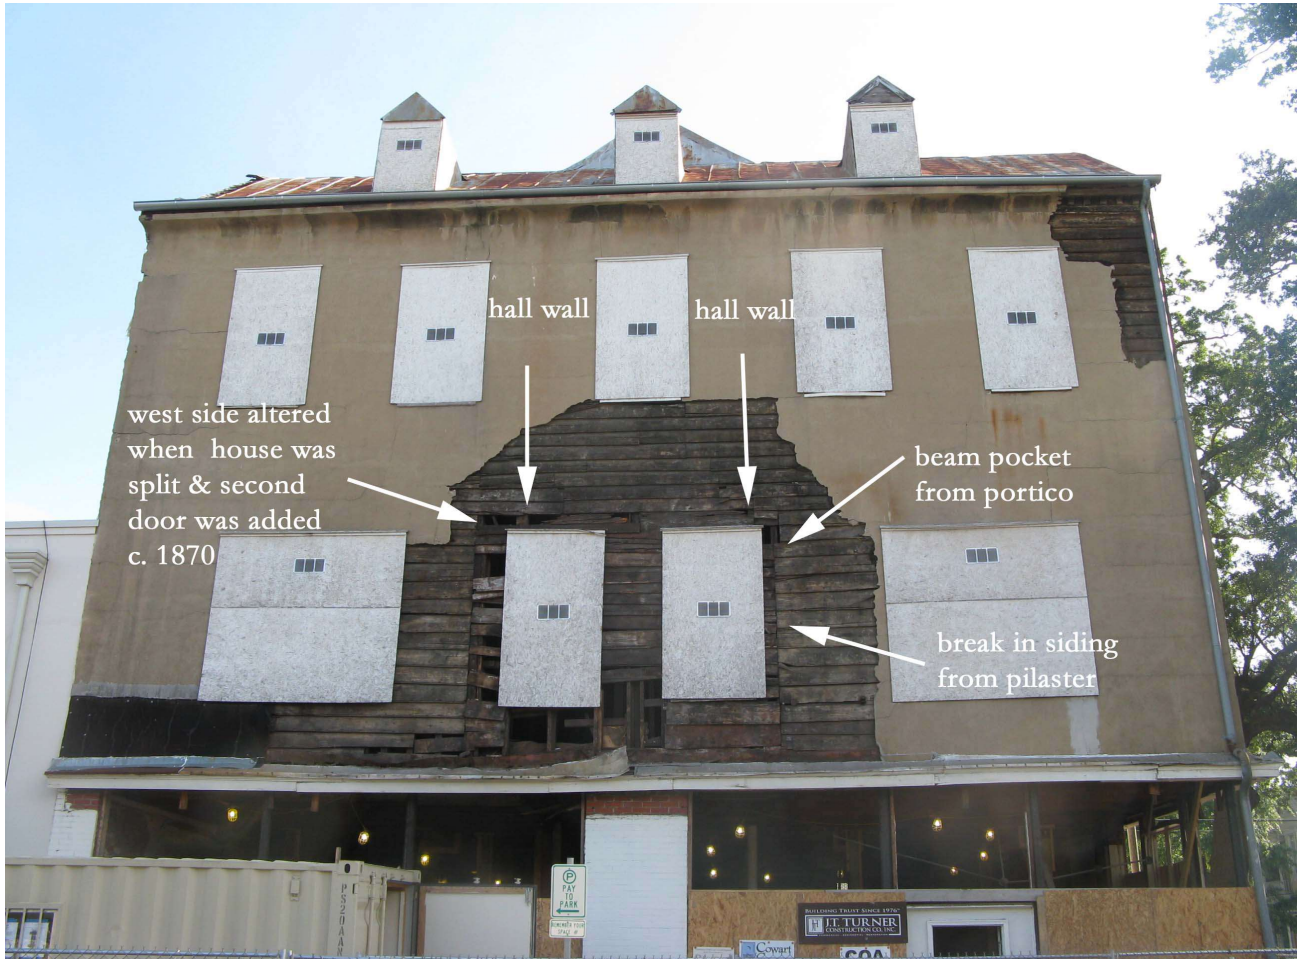
View of front elevation with portico scars. The evidence clearly gives a height & width based on the east side of the scars that are believed to be original to our period of significance.

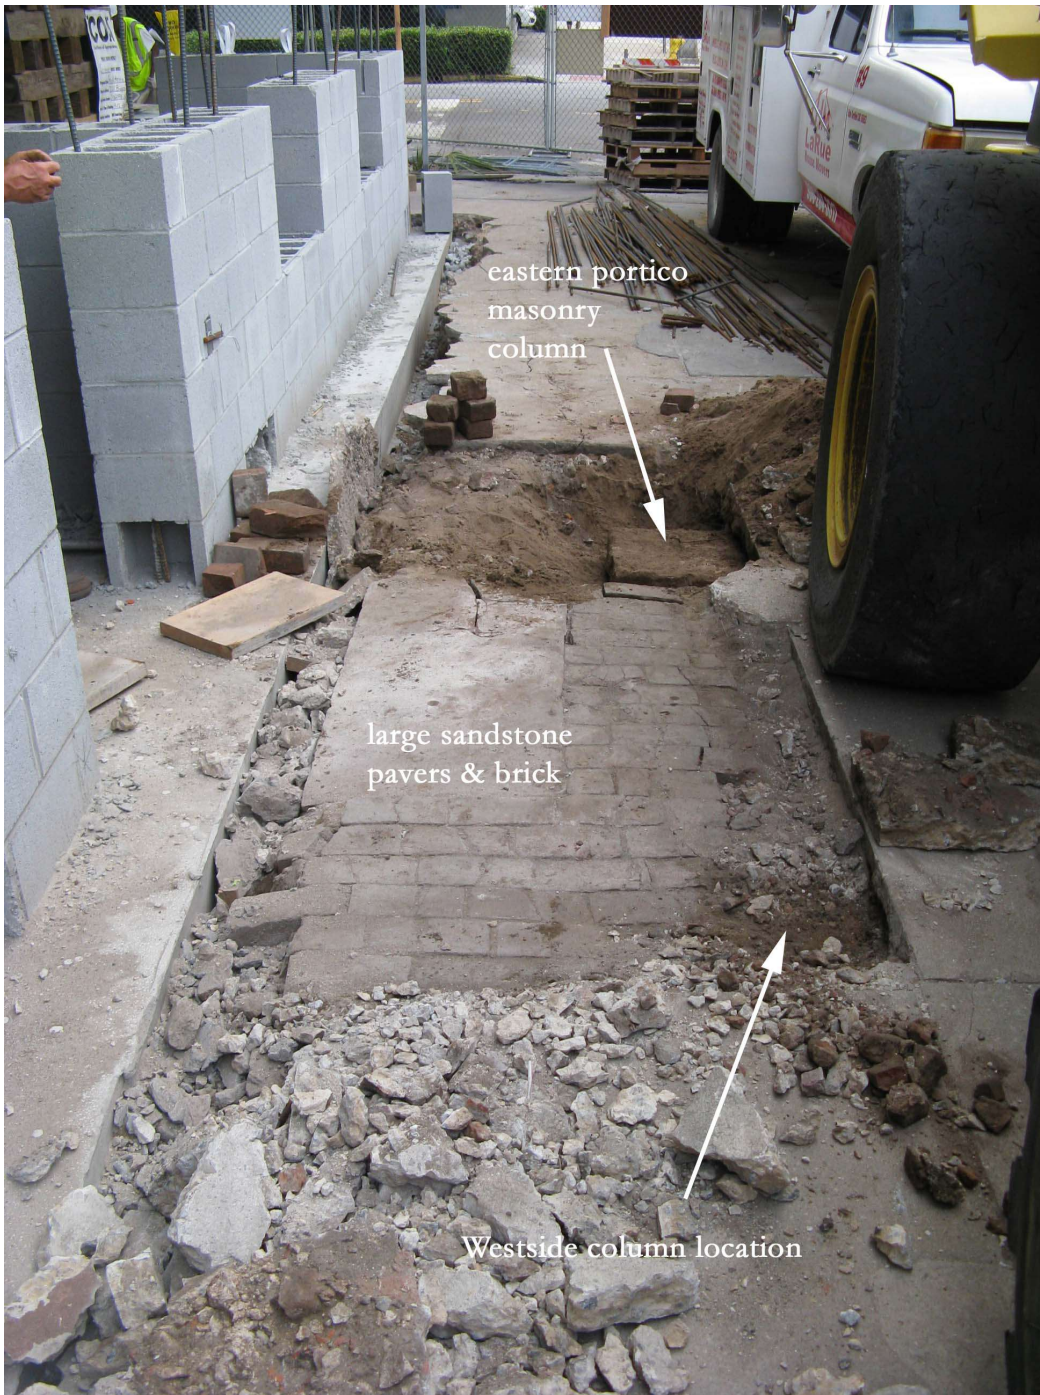
View of the sidewalk excavation for the front portico. The square pad matches exactly the size and location of eastern masonry column of our proposed design.

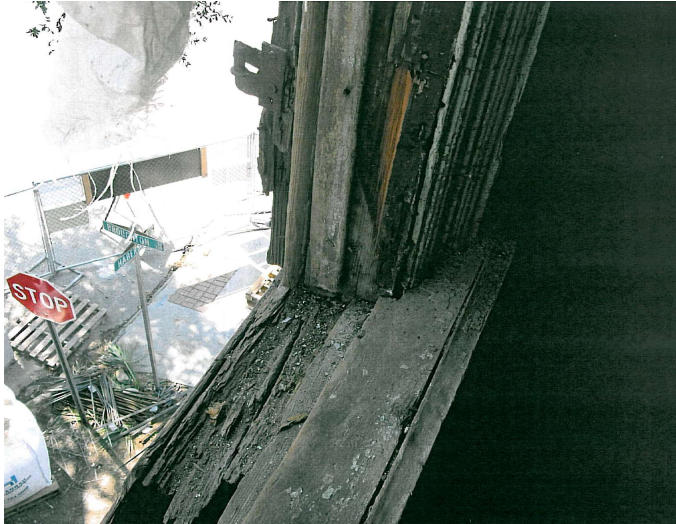
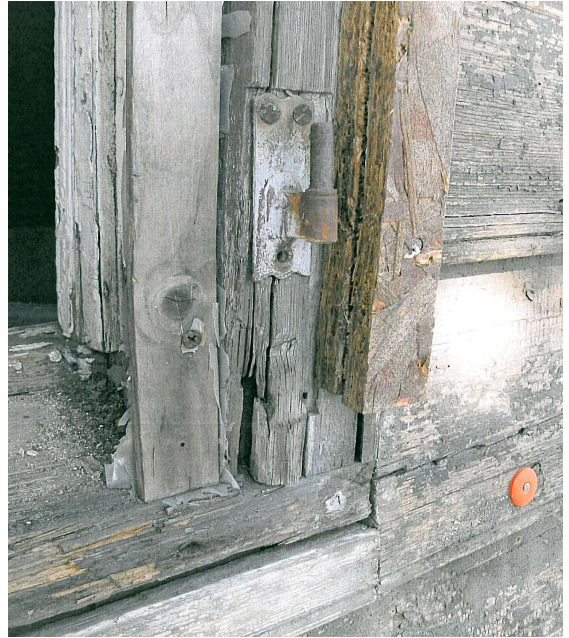
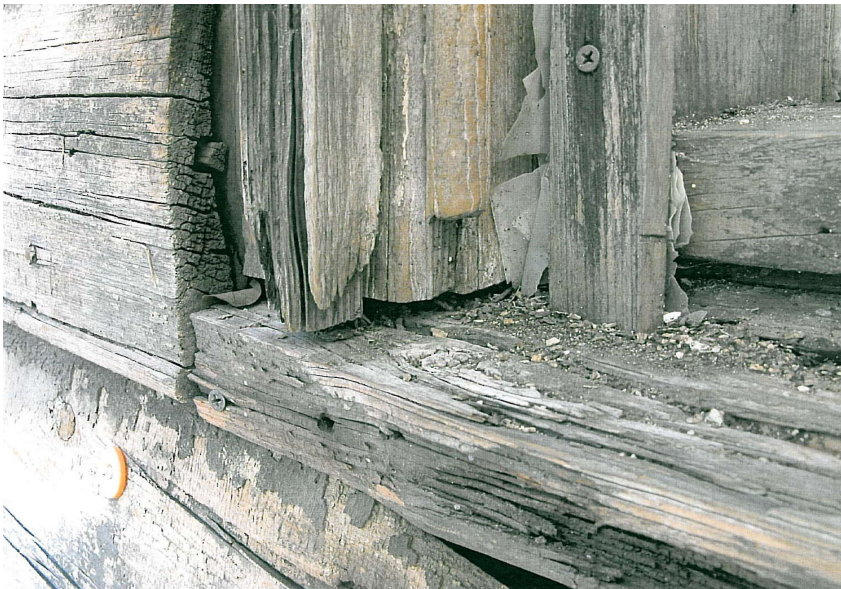
Typical window condition for the building .  
Window are to be replaced with approved TDL DH by Kolbe.
