#### 12.30.25 SCOPE OF WORK

# DRONE-ASSISTED UNDERWRITING REPORT

**808 Barnard St  
Savannah, GA 31401**

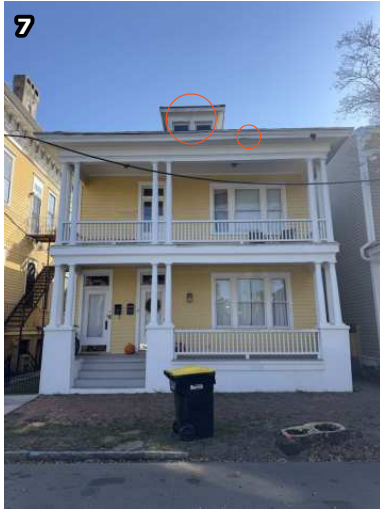
- Front Elevation: Peeling paint was noted on the fascia, window frame.

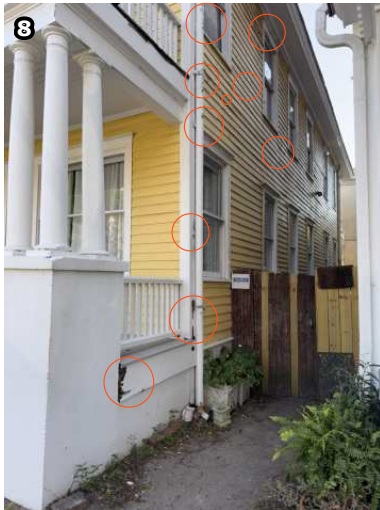
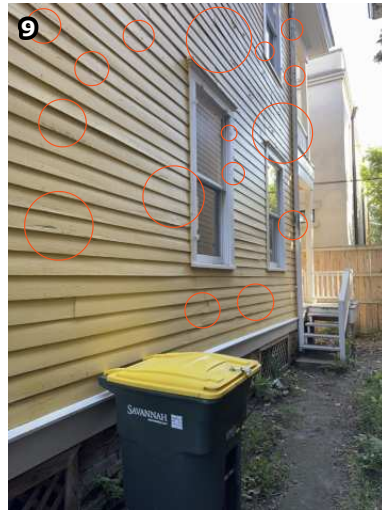
- Right Elevation: Damage was noted to the siding, deck. Peeling paint was noted on the siding, downspouts, window frame. Crack(s) on the siding was noted.

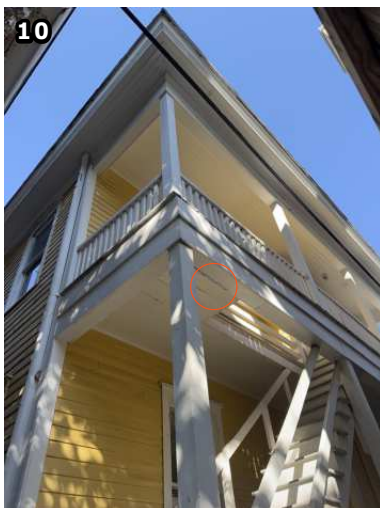
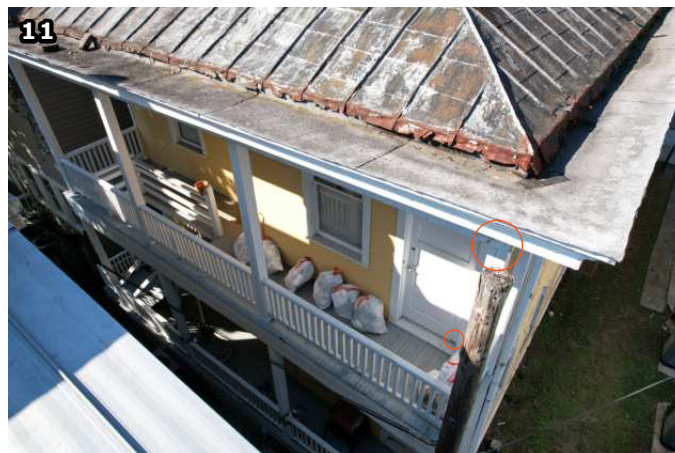
- Rear Elevation: Damage was noted to the deck, door.

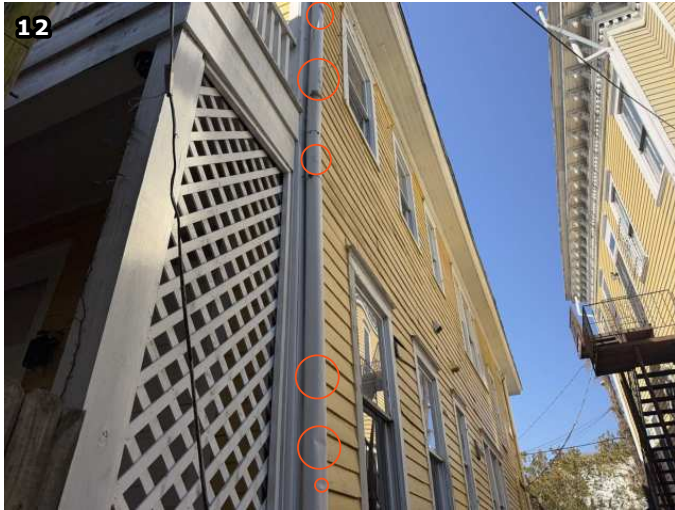
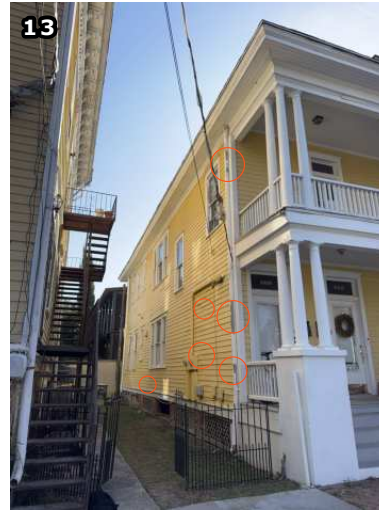
- Left Elevation: Damage was noted to the siding. Peeling paint was noted on the siding, downspouts, window frame. Loose, missing, or damaged gutters and/or downspouts was noted. Crack(s) on the siding was noted.

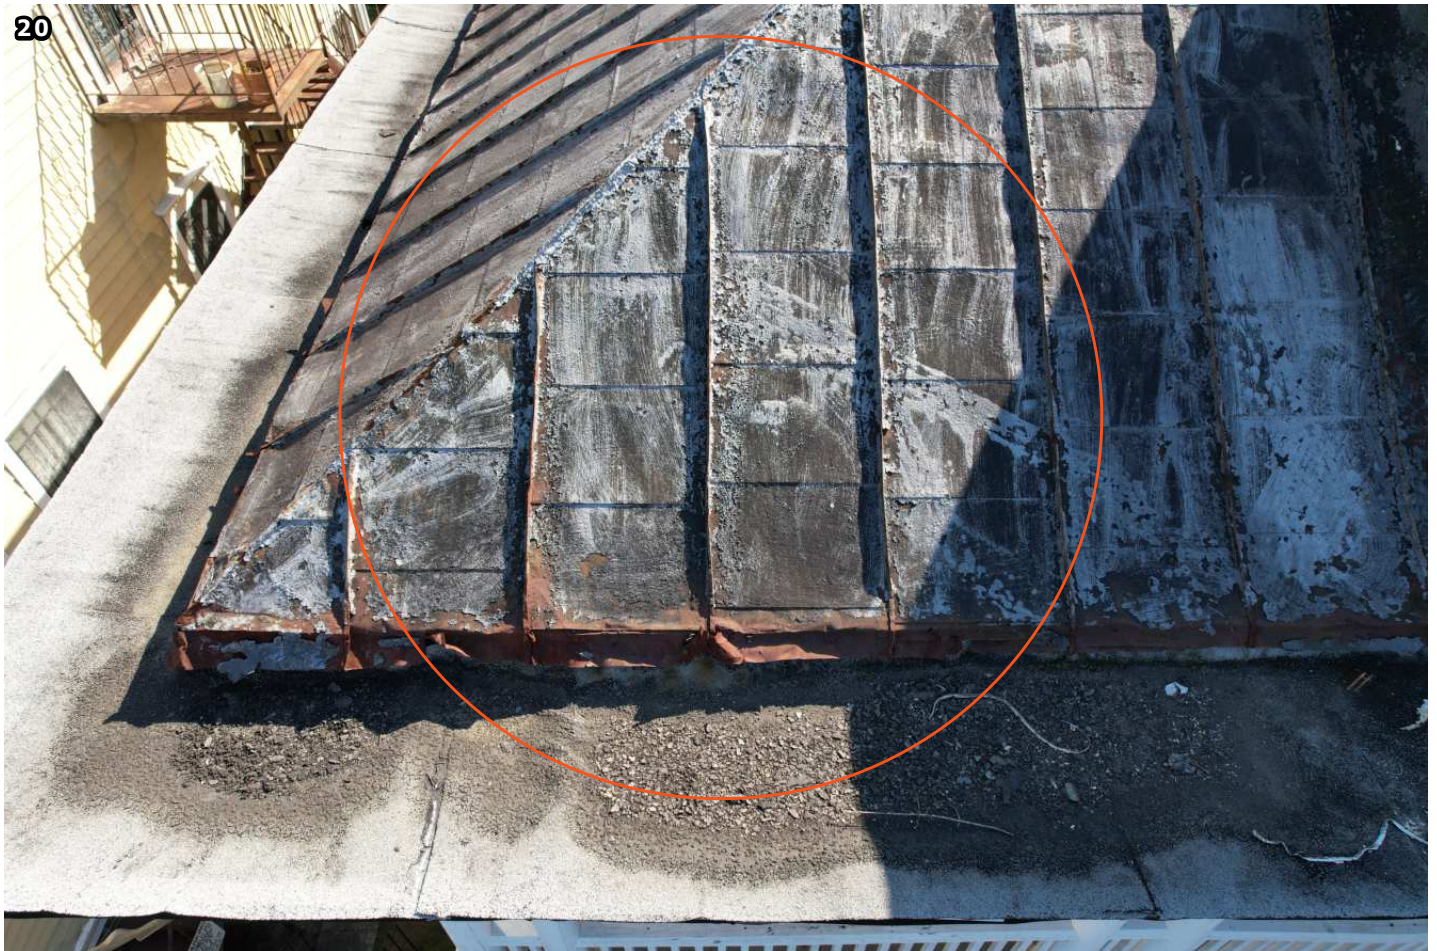
**Front Slope. Peeling paint was noted on the roof. Algae/Moss was noted on roof. Loose, damaged, or missing metal roof were noted. Rust on the roof was noted.**

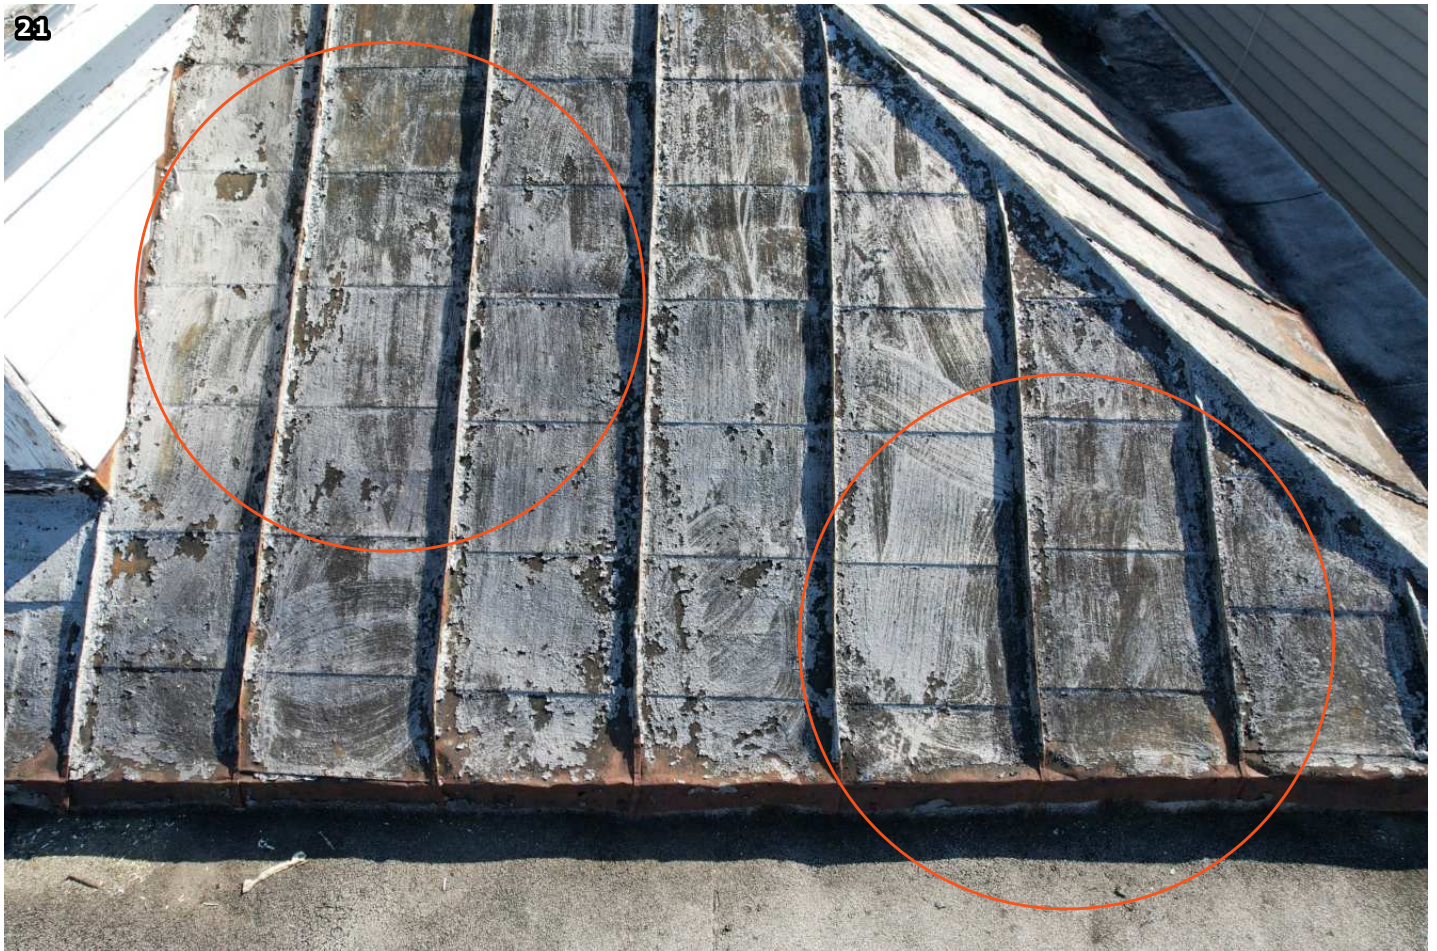
**Front Slope. Algae/Moss was noted on roof. Peeling paint was noted on the roof. Loose, damaged, or missing metal roof were noted. Rust on the roof was noted.**

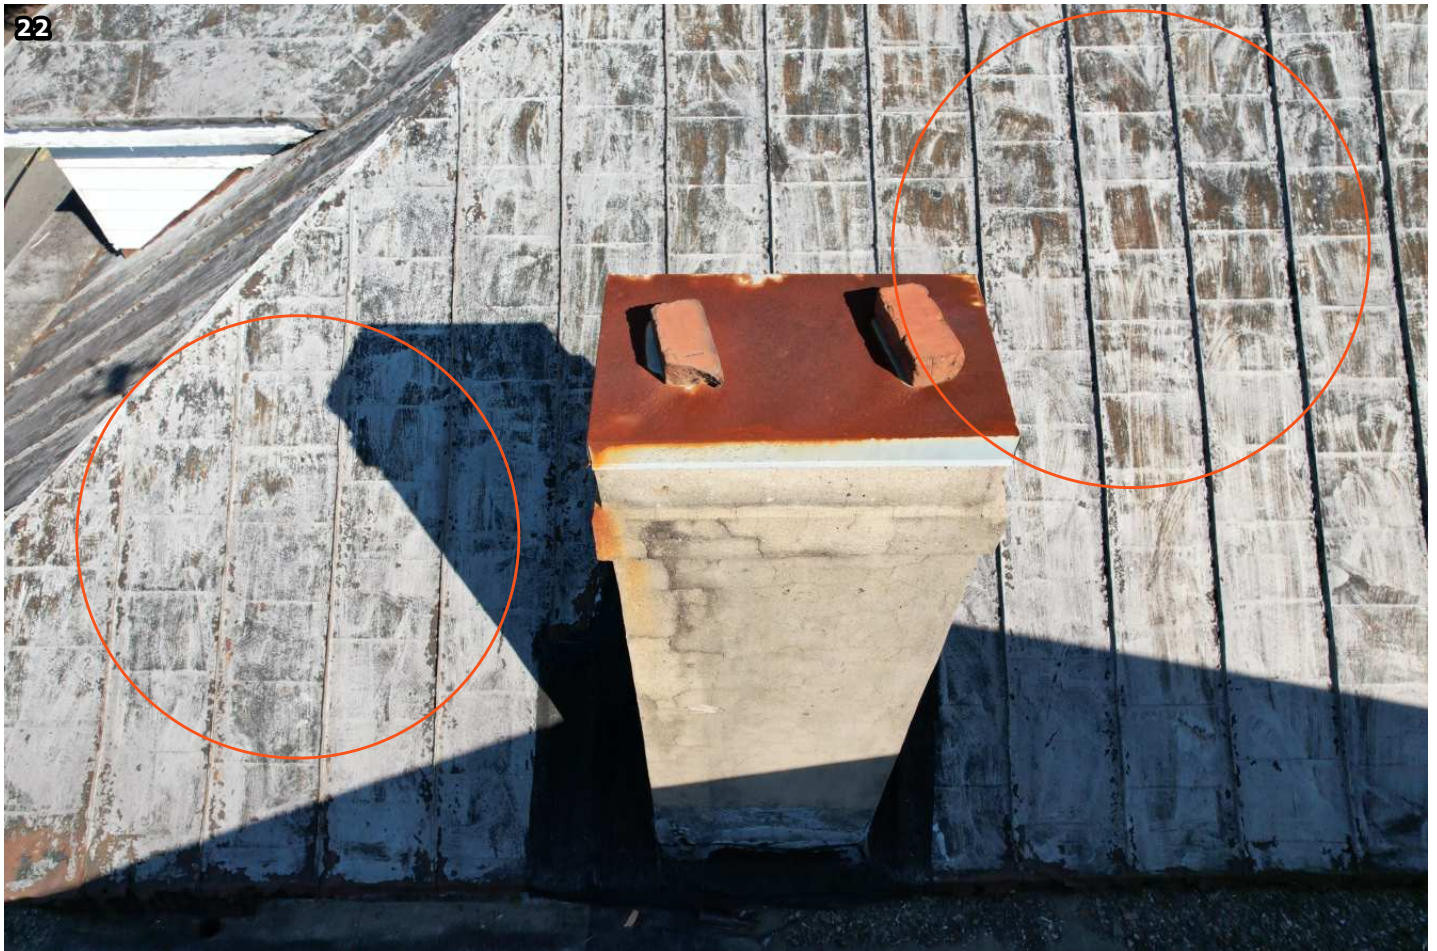
**Right Slope. Peeling paint was noted on the roof. Algae/Moss was noted on roof. Rust on the roof was noted.**

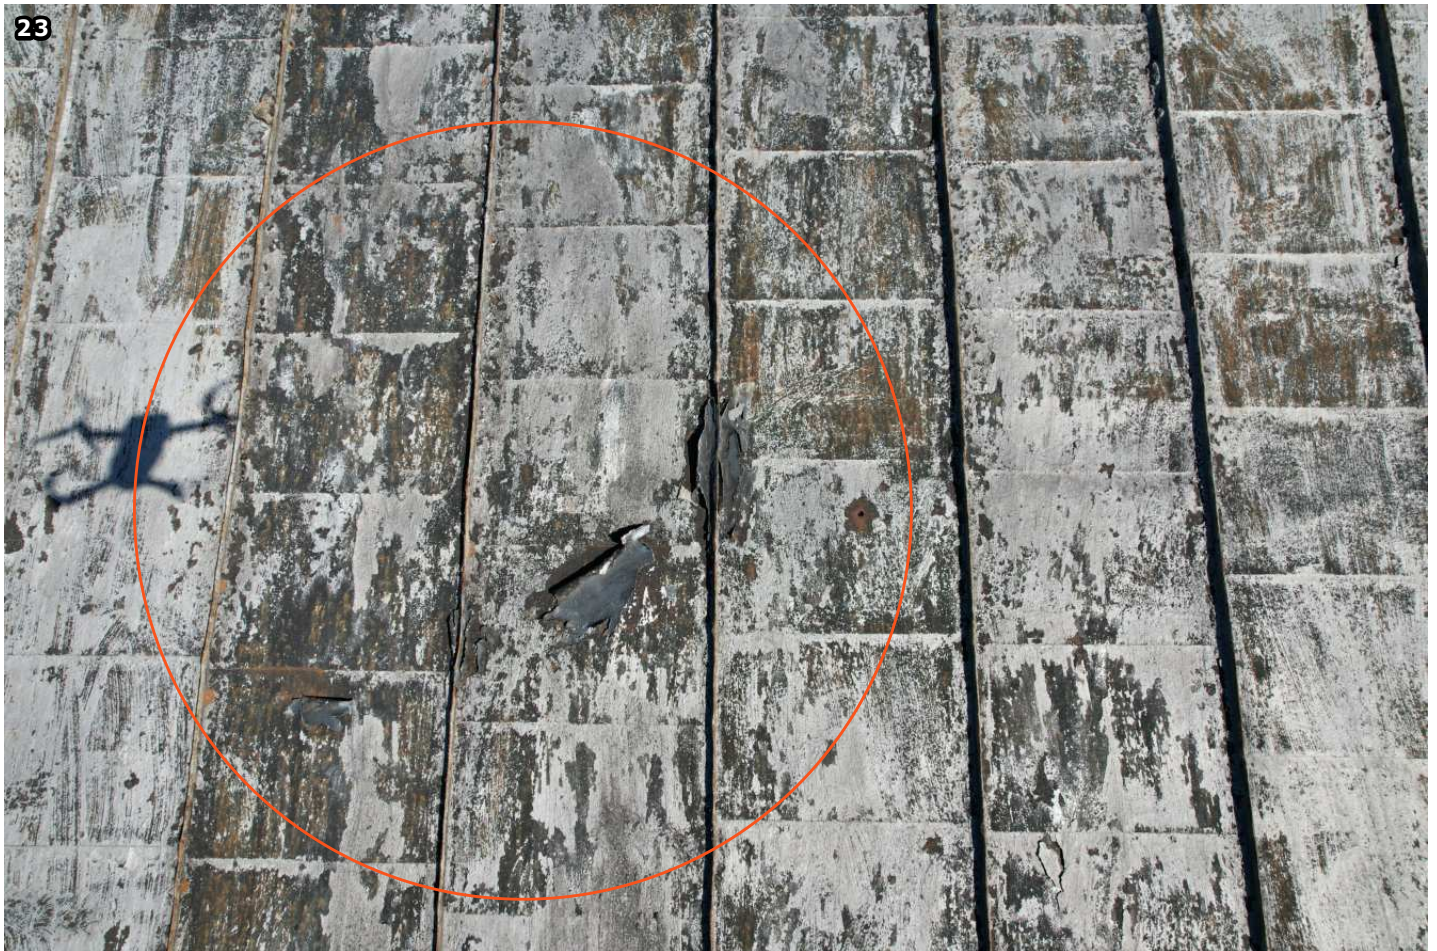
**Right Slope. Algae/Moss was noted on roof. Peeling paint was noted on the roof. Rust on the roof was noted.**

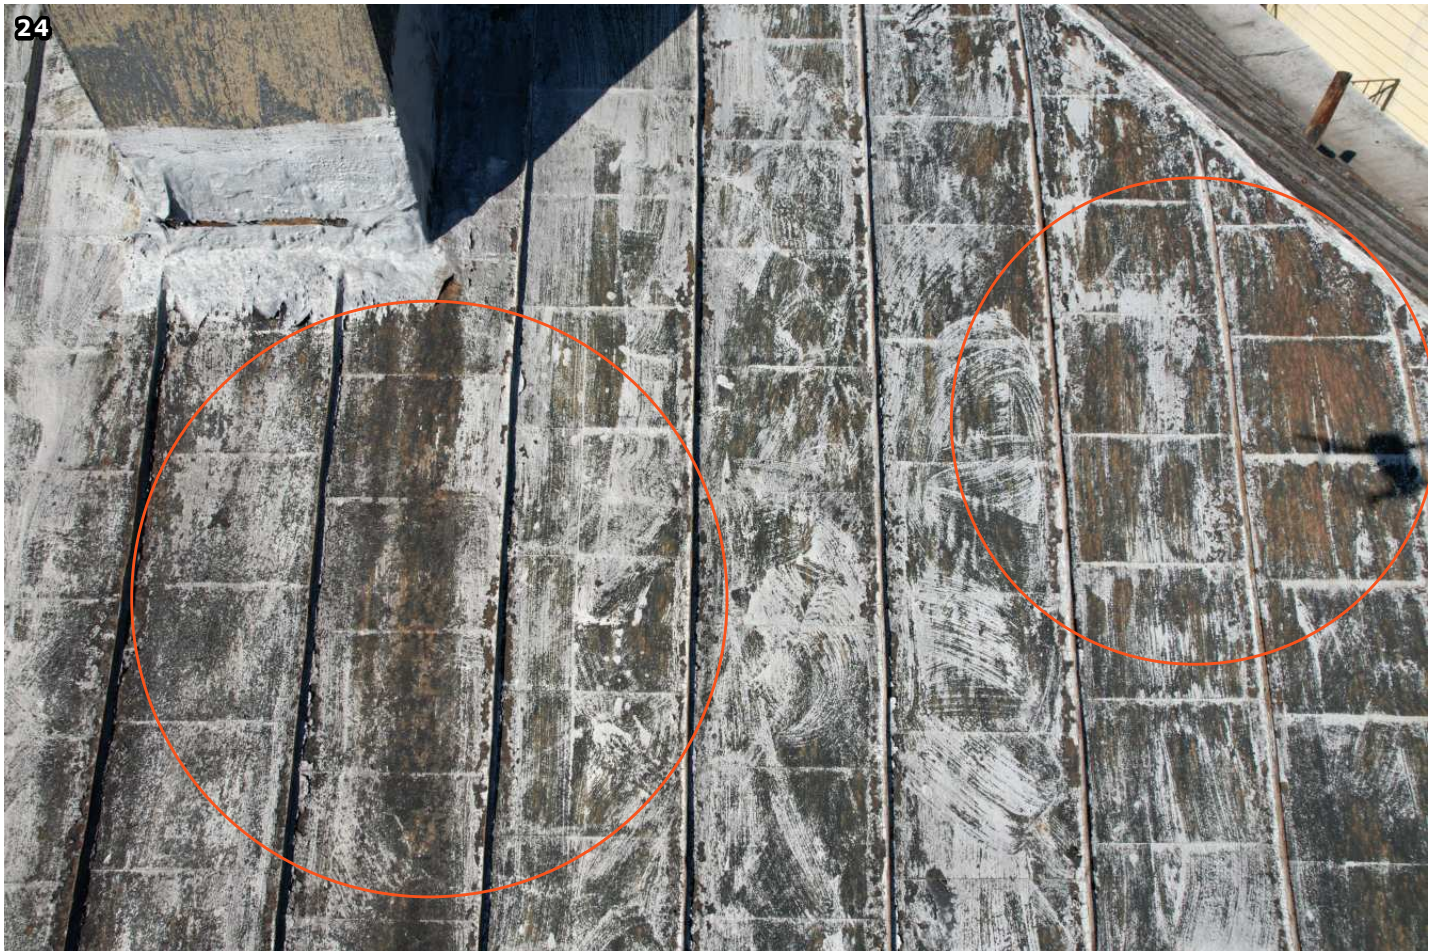
**Rear Slope. Algae/Moss was noted on roof. Peeling paint was noted on the roof. Rust on the roof was noted.**

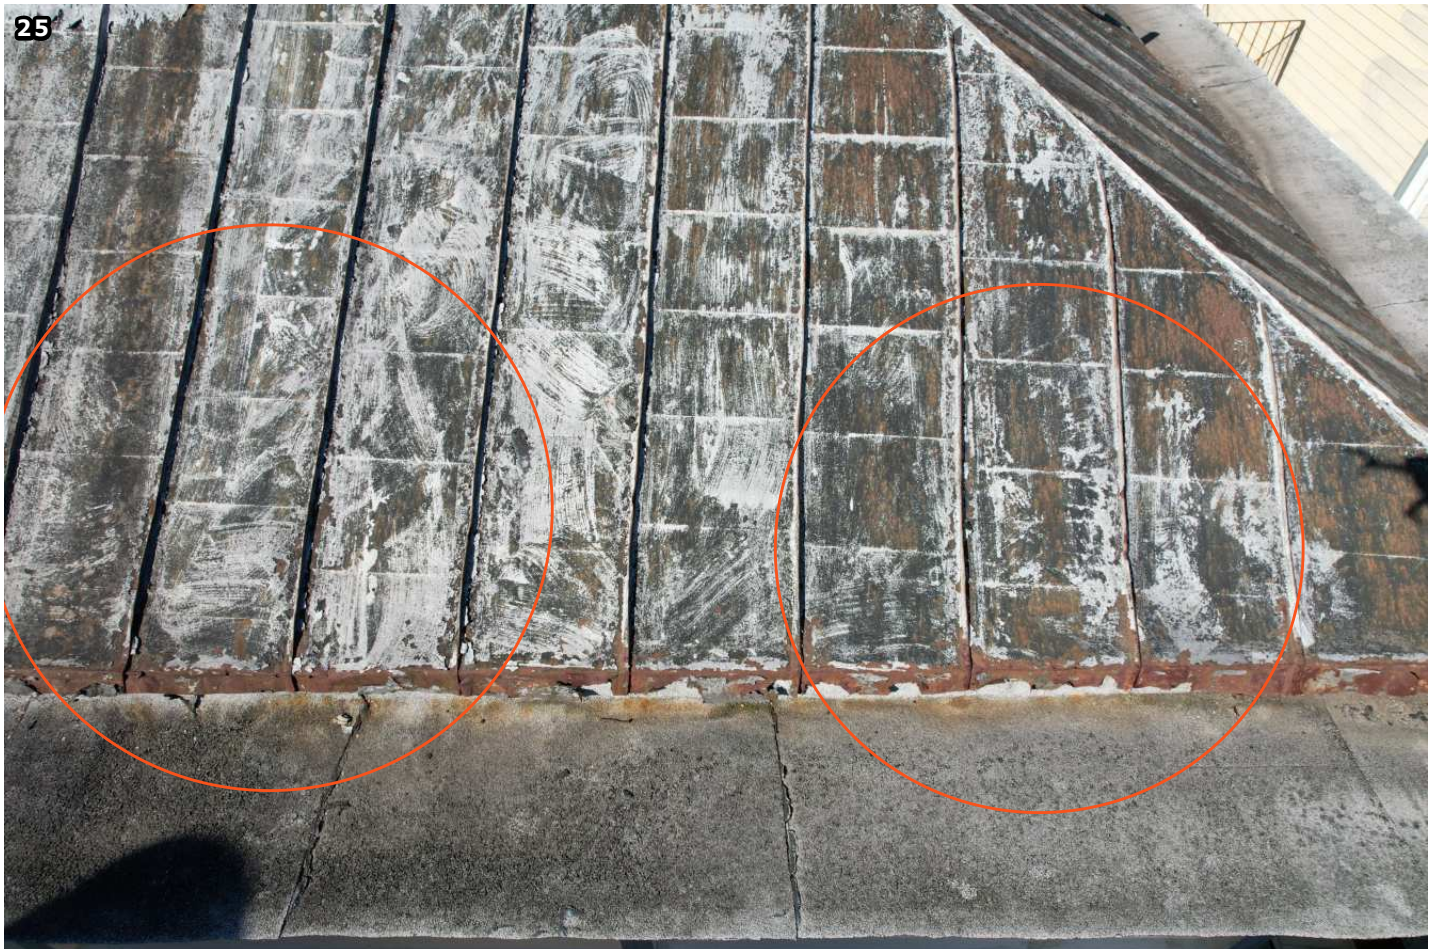
**Rear Slope. Algae/Moss was noted on roof. Peeling paint was noted on the roof. Loose, damaged, or missing metal roof were noted. Rust on the roof was noted.**

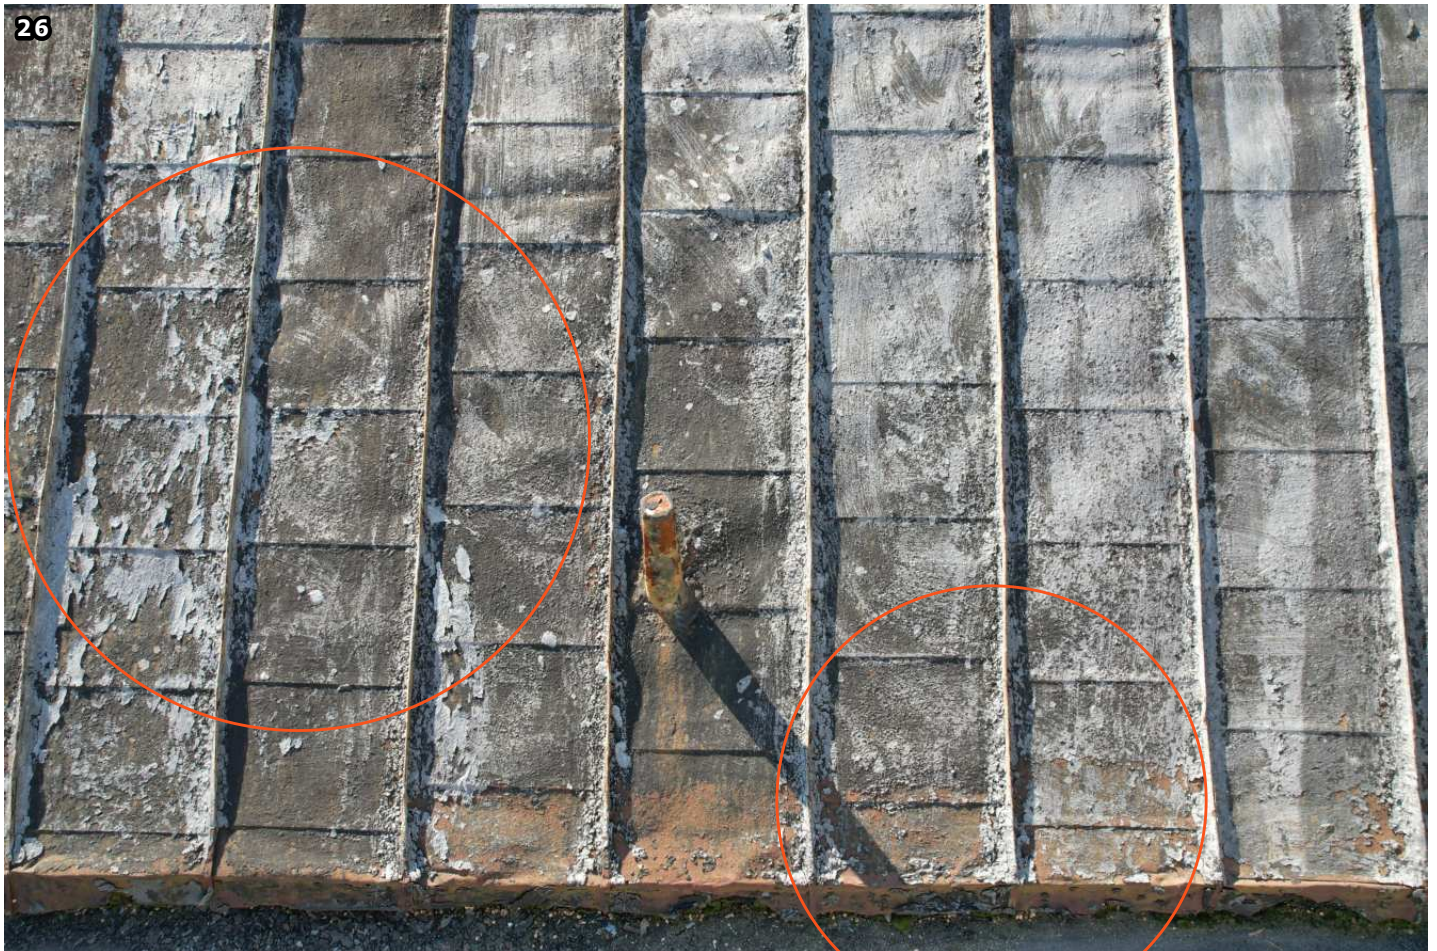
**Left Slope. Peeling paint was noted on the roof. Algae/Moss was noted on roof. Rust on the roof was noted.**

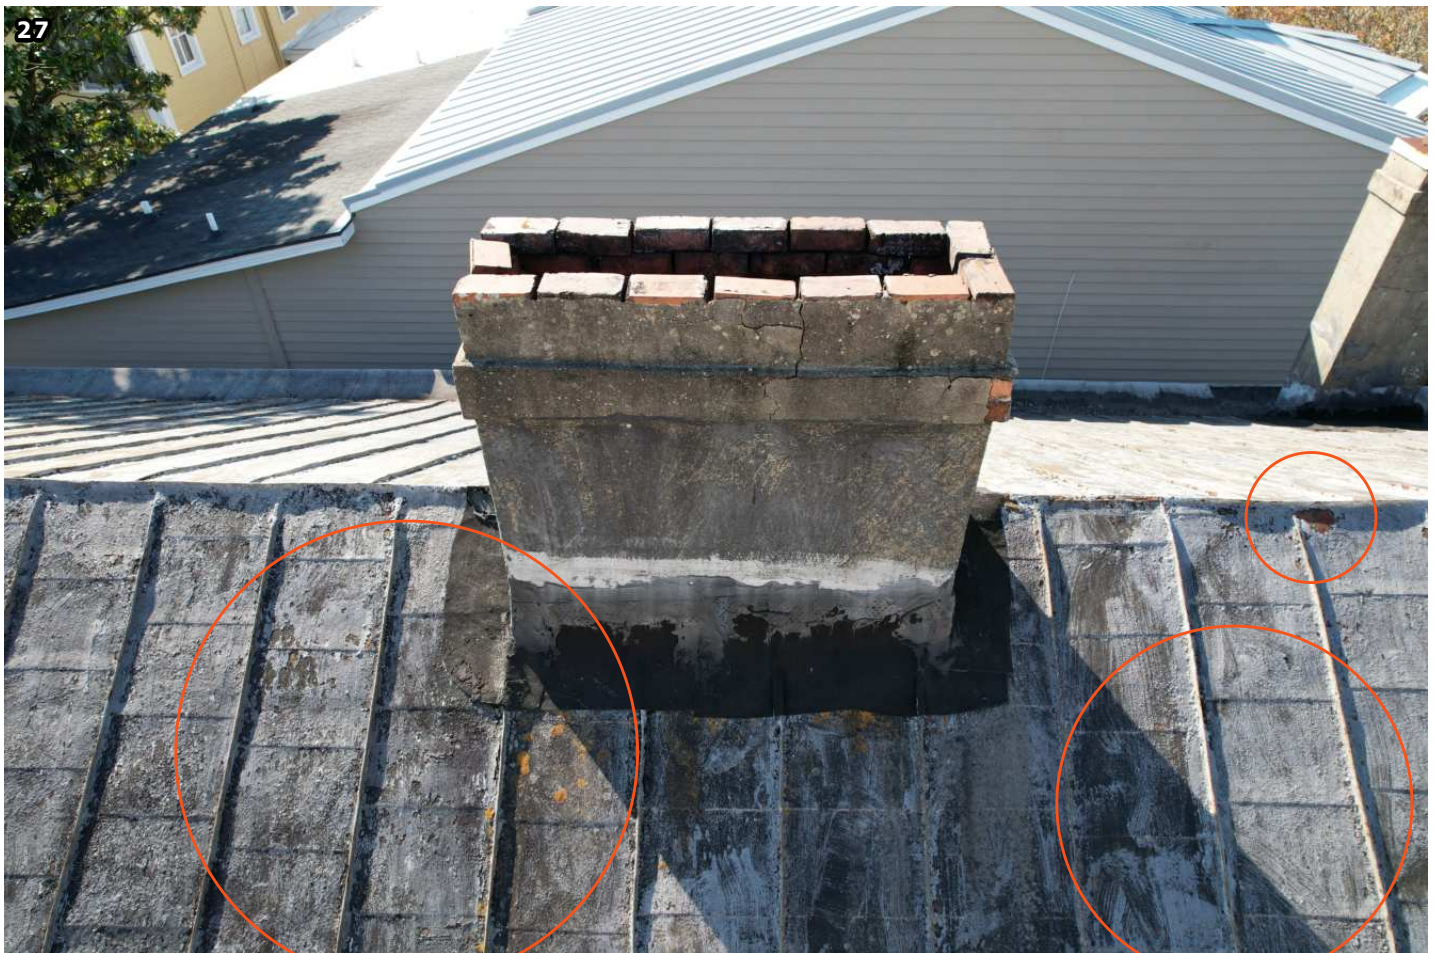
**Left Slope. Algae/Moss was noted on roof. Peeling paint was noted on the roof. Rust on the roof was noted.**

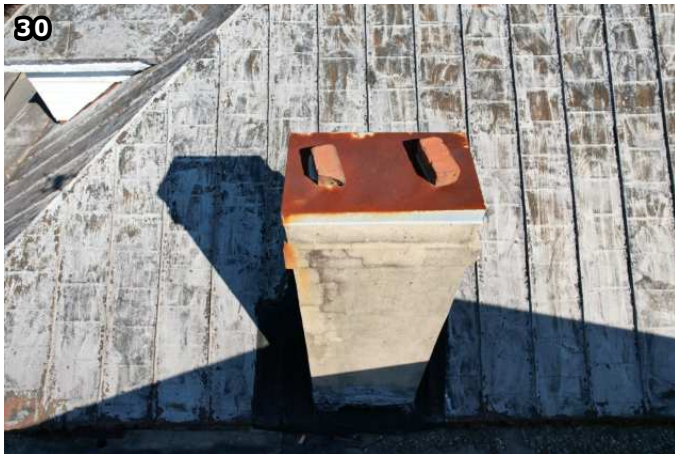
- Chimney through roof on the Right slope was noted. It is recommended to conduct interior chimney sweep.

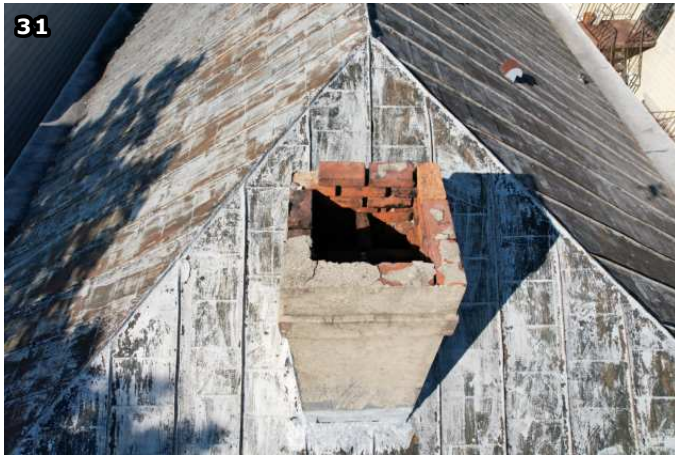
- Chimney through roof on the Rear slope was noted. It is recommended to conduct interior chimney sweep.

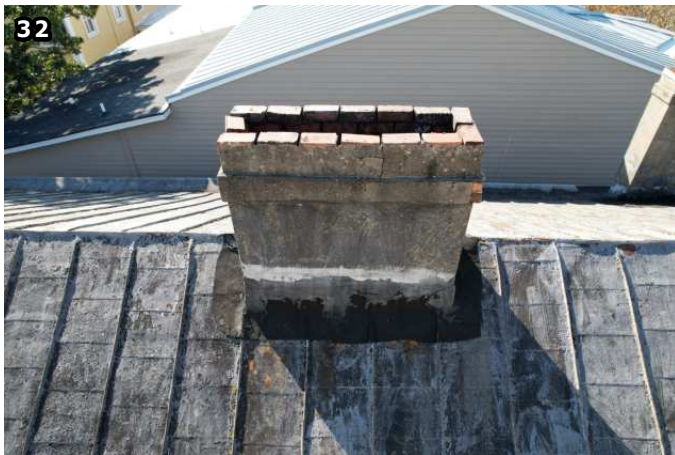
- Chimney through roof on the Left slope was noted. It is recommended to conduct interior chimney sweep.
