## The Roche-Walker House

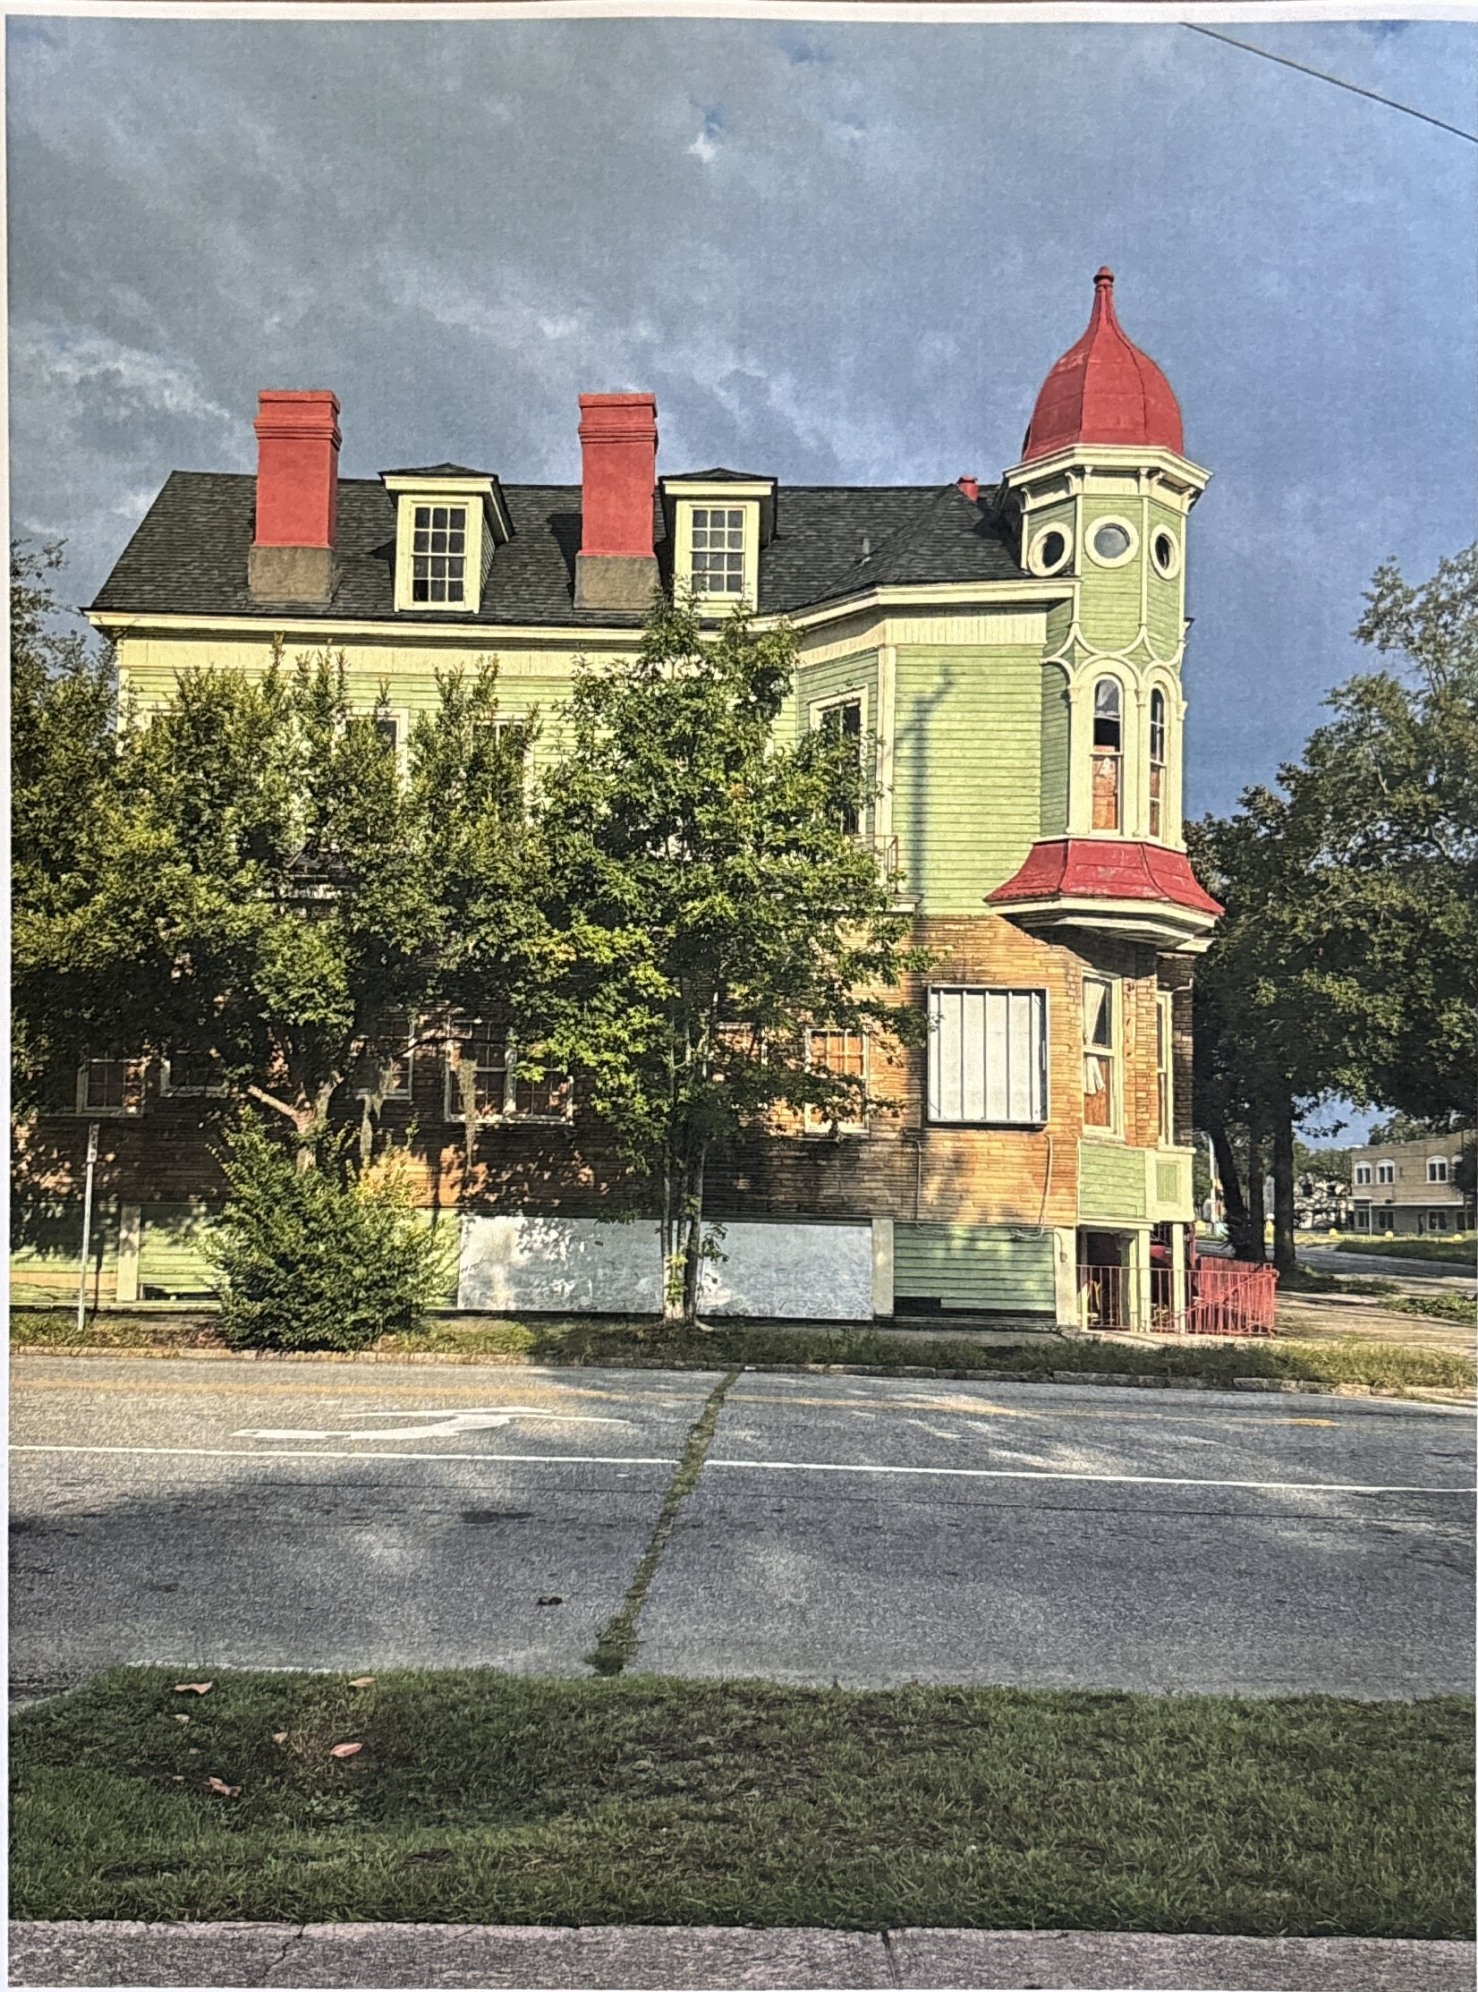
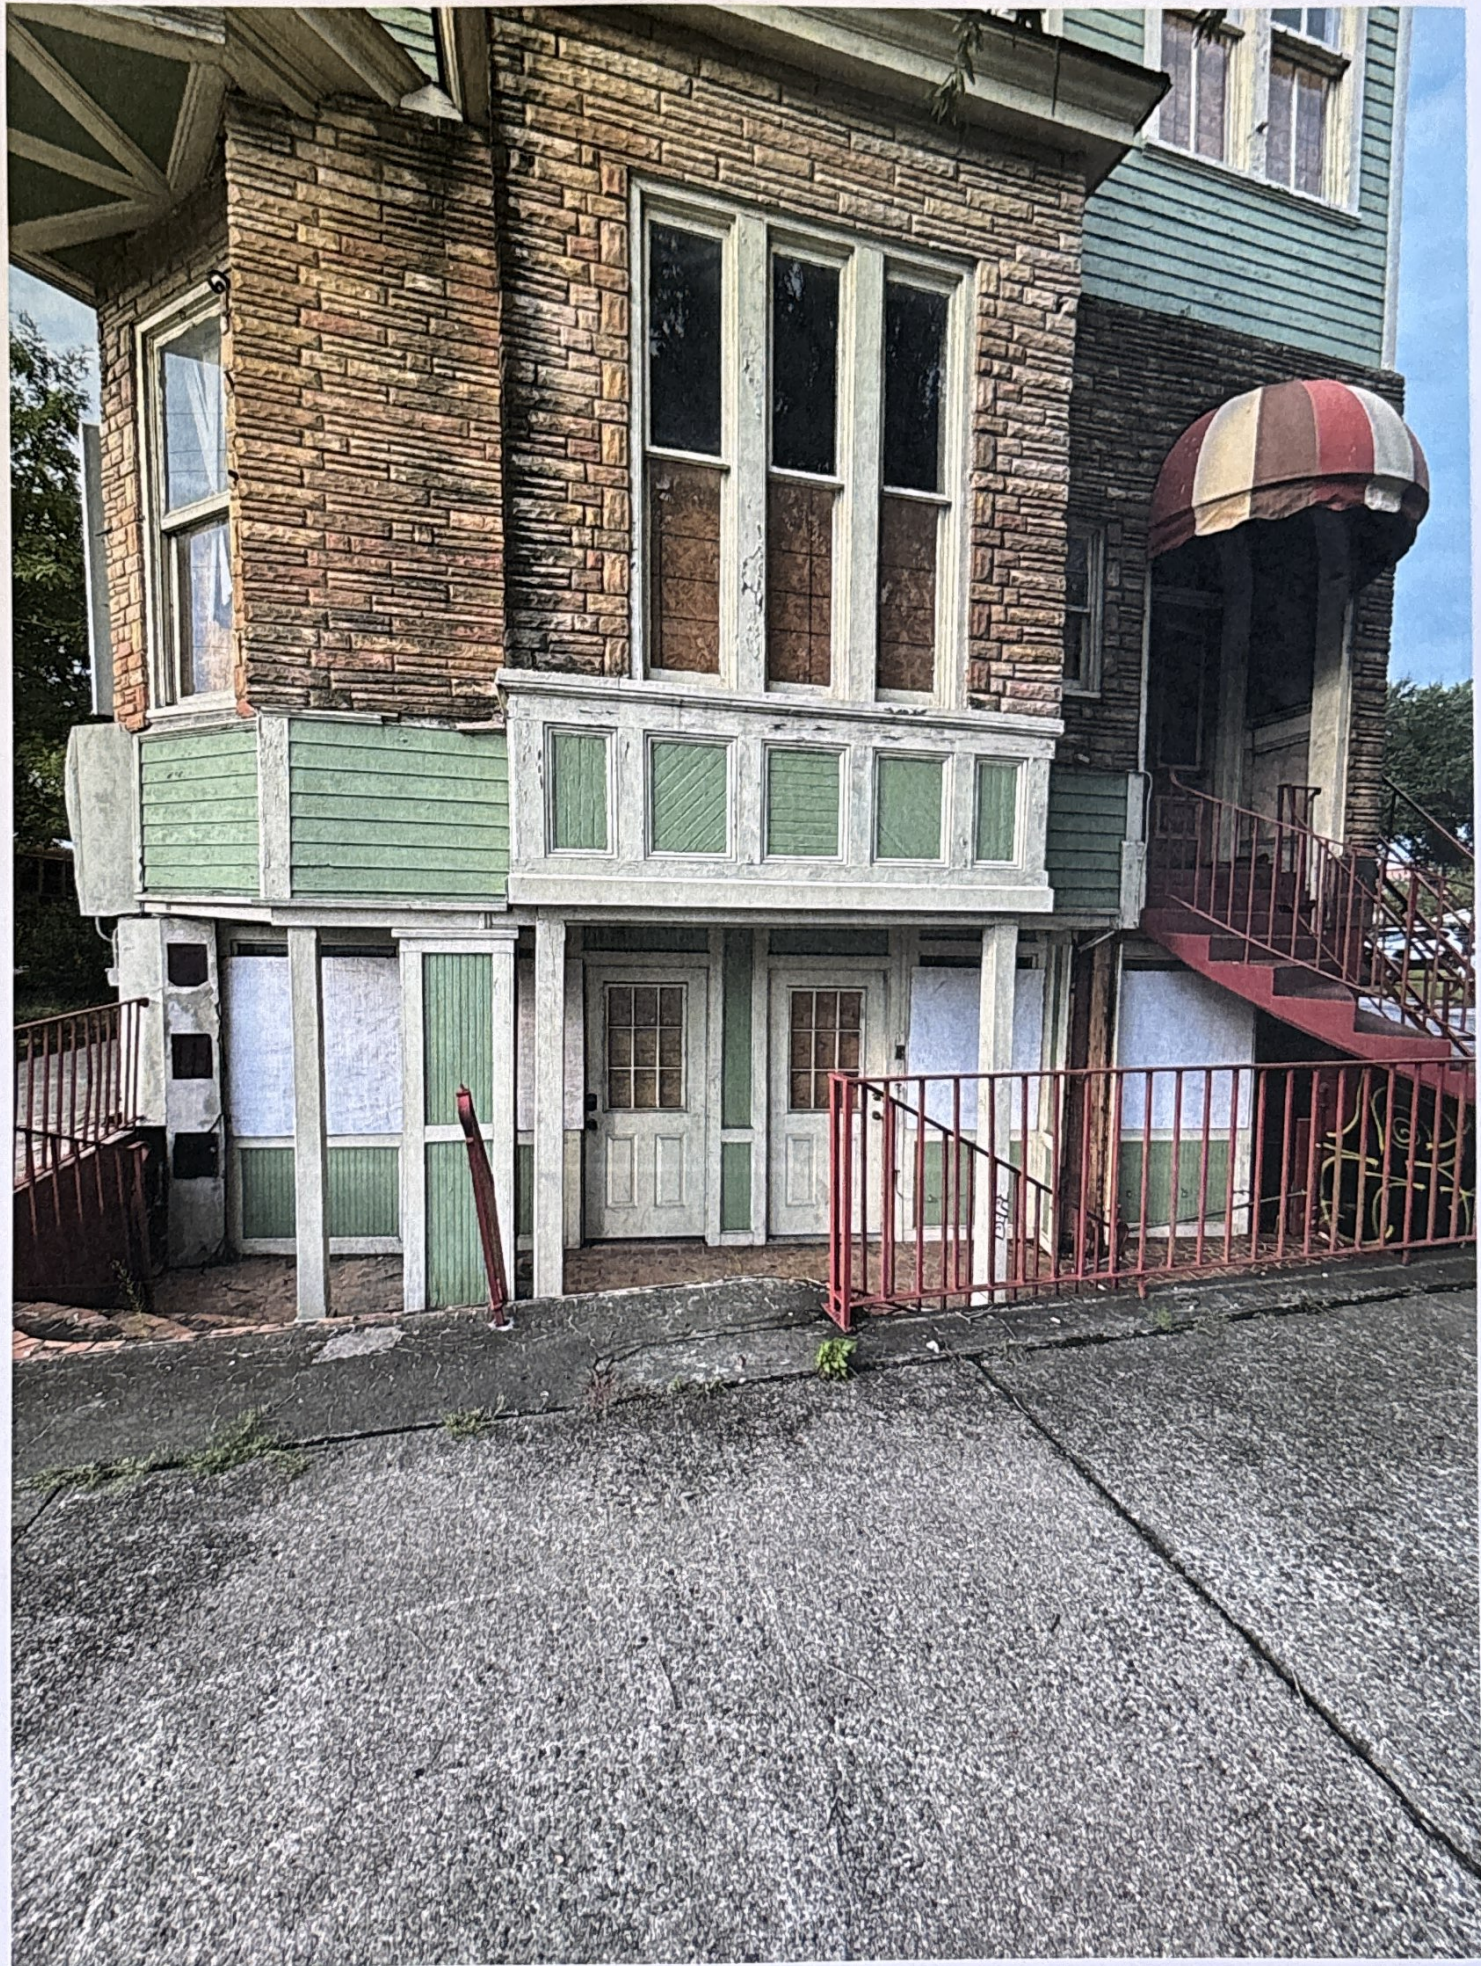
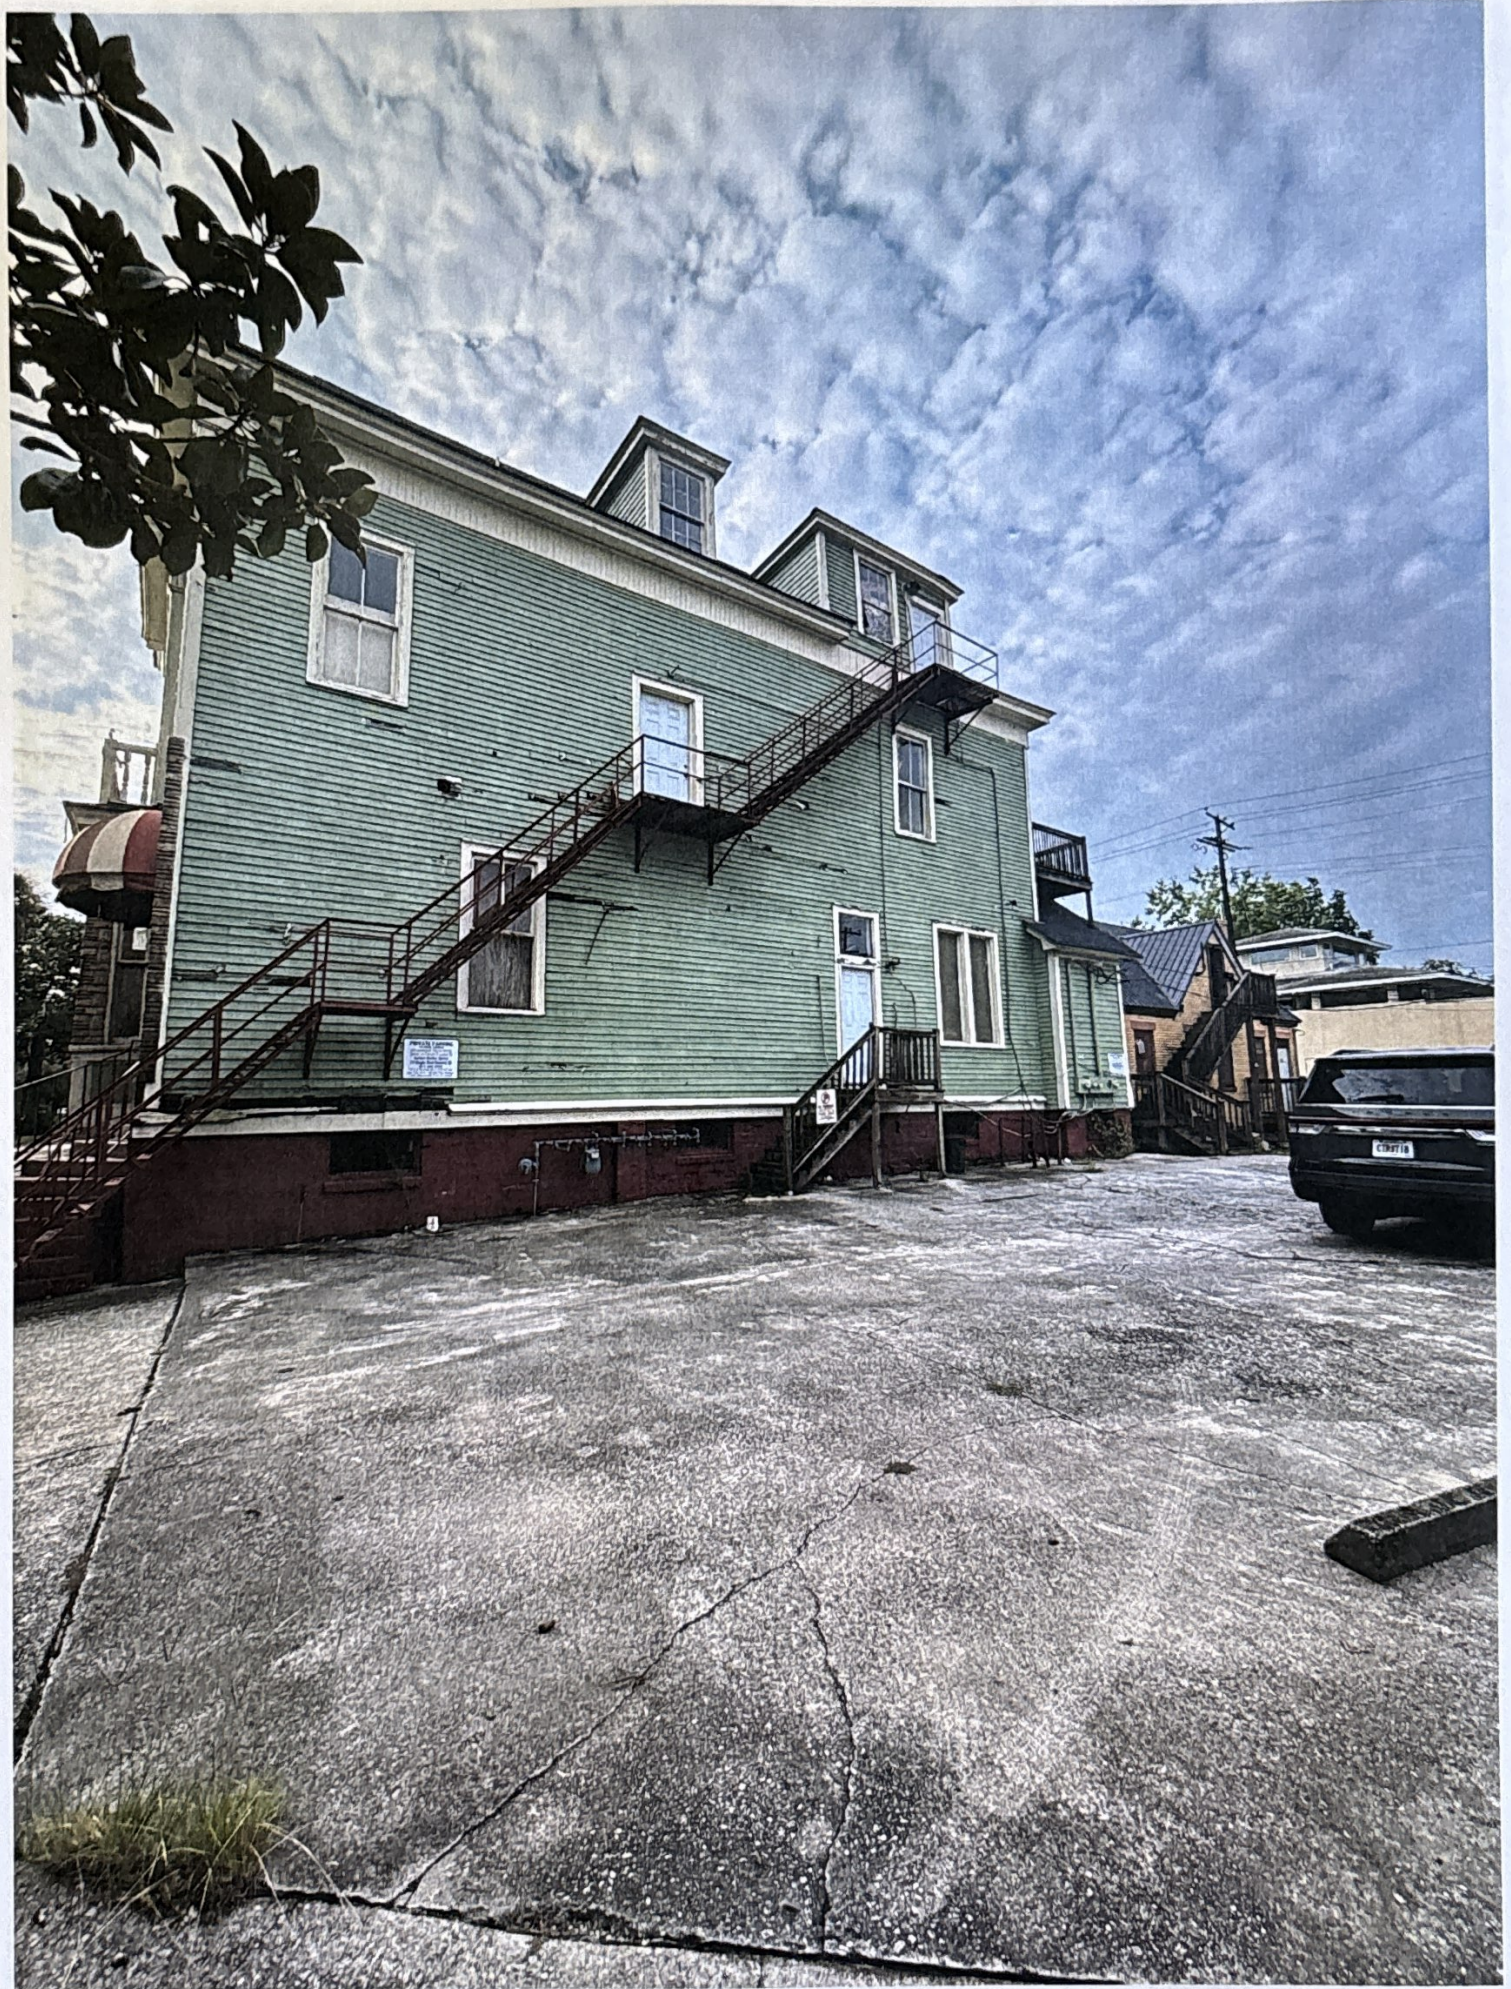
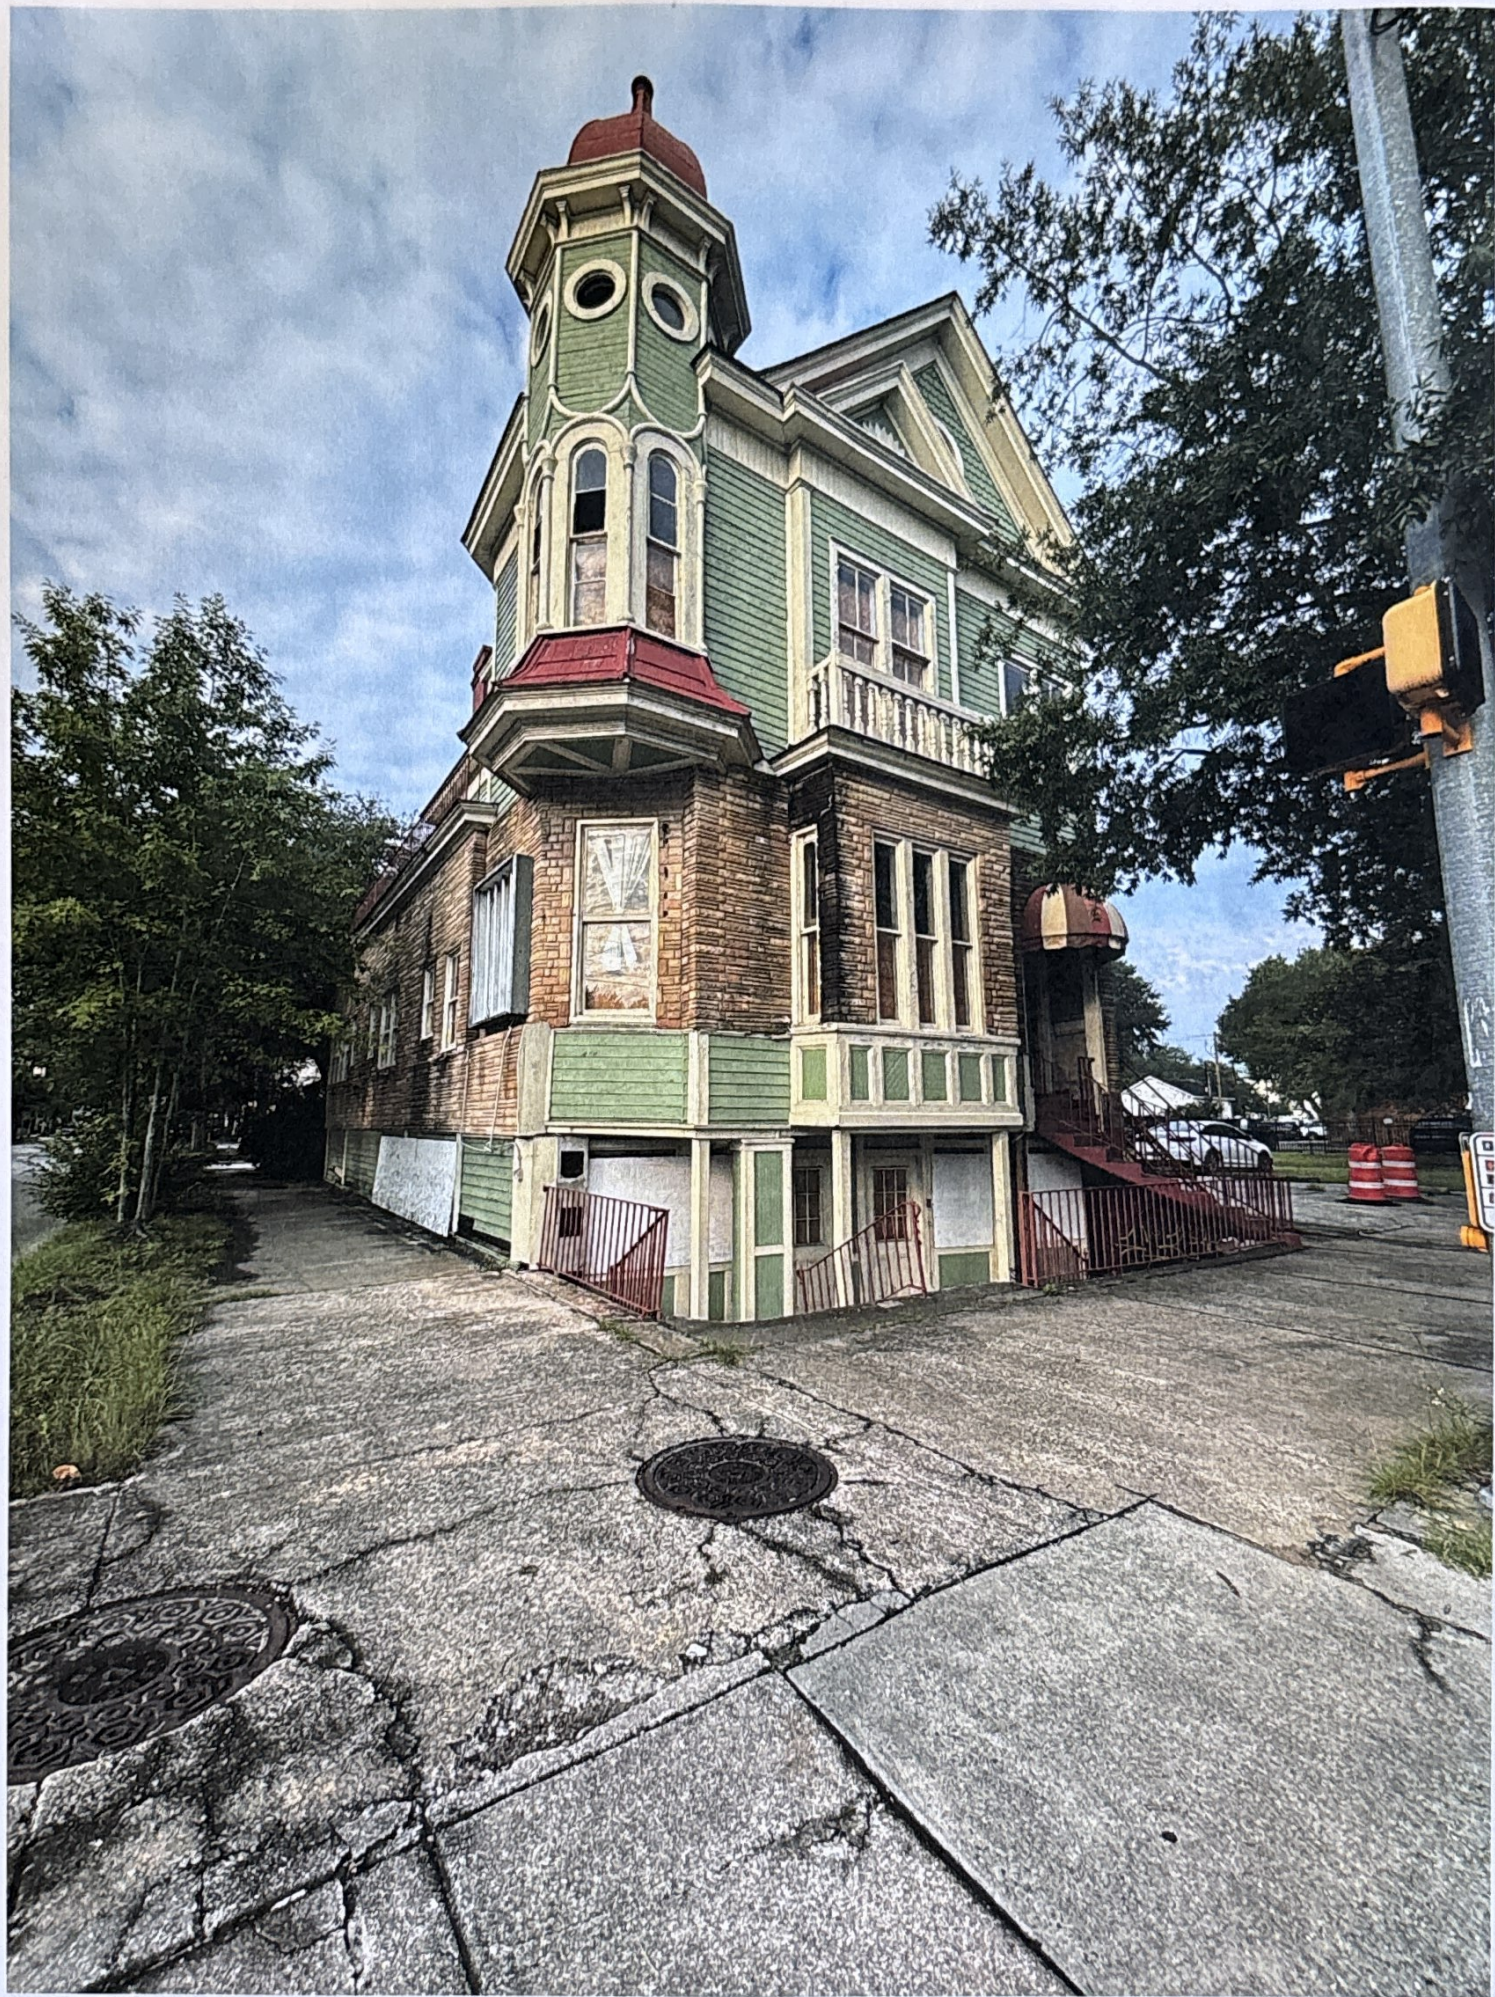
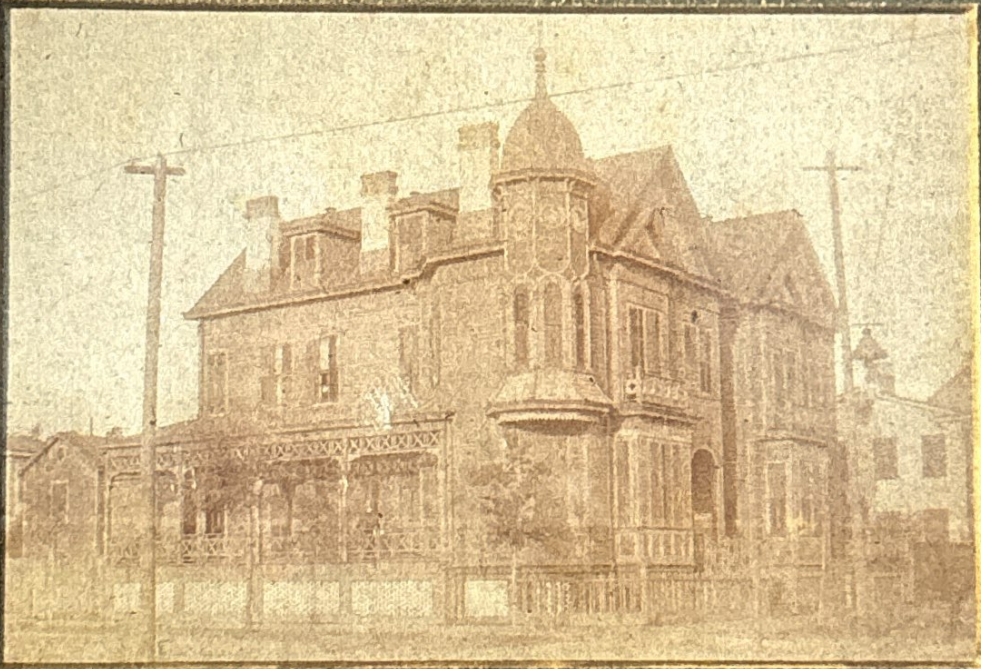
The Roche -Walker House has several types of siding present. The house is predominantly clad in standard wood siding, the condition of which is most visible. On the west façade. The wood siding is obscured by a faux stone finish called permastone that covers most of the first floor on the east and north elevation.

There are several different types of windows on the Roche-Walker house, 75% are without glass. The windows are in a severe state of deterioration

The front doors to the Roche-Walker House are a set of tall, narrow double doors that once had elongated windows in the upper half. The glass has been replaced by plywood. There is signs that the hardware has been moved several times. There are modern metal doors on

the west elevation that were once windows. Both of these doors are accessed by climbing a fire escape.

The permastone would be removed in its entirety. While the condition of the original wood siding under the permastone is unknown, it is anticipated repairs will need to be made. If there is damage or lost fabric underneath then it will be repaired and replaced in kind. The existing wood siding will likewise be repaired or replaced with every effort made to preserve as much original fabric as possible. A sample of the existing siding is being matched by Guerry lumber. The tin shingles in the gable and the tin siding on the dormers will be preserved, sensitively cleaned, prepped and repainted. The East side of the house originally had a second floor porch that was completely closed in with siding, the porch in its entirety still exists behind the siding. The porch will be restored to its original state as pictured in the original picture of the building Photo.

The original windows that have survived will be restored and returned to an operable state of use. Those windows where a portion of the original window exists will be restored with missing elements recreated in kind. Where the original window is missing entirely a craftsman will recreate new windows based on the appearance of the originals.

It is questionable as to whether the front doors are original. If upon further analysis, the doors prove to be from a later improvement, a pair of appropriate salvaged historic doors would be acquired to replace them. The doors on the west façade that were once windows would be returned to such, and the opening reconfigured to match other existing windows. The fire escape would also be removed. The basement door at the back of the house has been kicked in many times and is currently being held together with several boards. A secure door will need to be installed in this location. The doors at the front of the basement level are also modern doors that have been kicked in several times and are currently covered with plywood. A door appropriate to the style of the house will be obtained and installed.
