Re: 301 Alice Street Demolition

LIMITED CONDITION ASSESSMENT REPORT FOR:

301 Alice St
Savannah, GA

Harley Krinsky | January 2, 2023

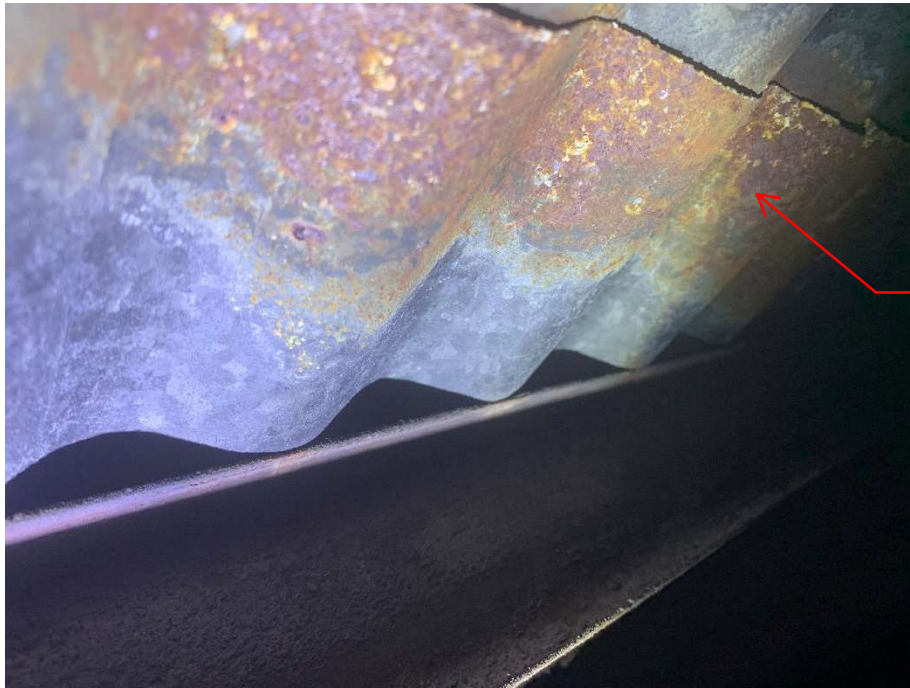
At the overlapping areas of the roof deck panels, there is corrosion of the deck that is consistent throughout (Photo 1). It is believed that the overlapped areas are holding water between the sheets that is causing accelerated corrosion in these areas.

CORROSION AT DECK OVERLAP

Photo 1: Roof decking – corrosion at overlaps

For a restoration, it is anticipated that insulation and roofing would be required to utilize the building. It is expected that this insulation and roofing would be added above the existing corrugated decking to provide thermal and environmental protection for potential occupants. Additionally, the eave condition would be required to be reinforced to ensure that roof workers can safely stand on the roof in all areas. The added roofing thickness and required edge reinforcement would change the low-profile eave aesthetic that currently exists.

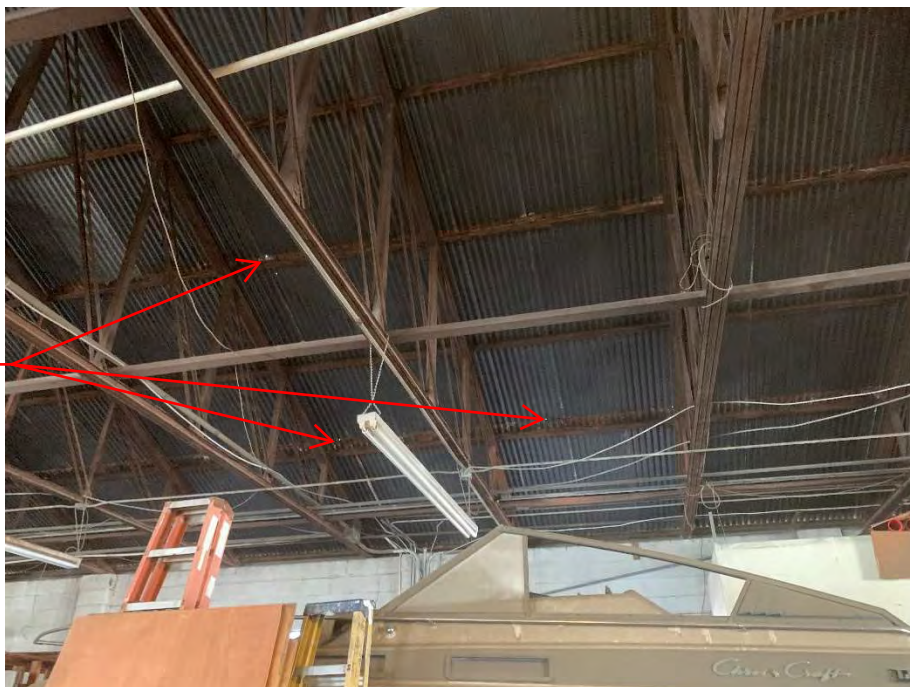
Also, randomly positioned throughout the roof, there are holes seen by shining light into the building throughout (Photo 2). The roof is also uninsulated; the corrugated metal decking is the only roofing element protecting the interior from environmental exposure.

HOLES (LIGHT SHINING THROUGH)

Photo 2: Roof decking - Holes in decking

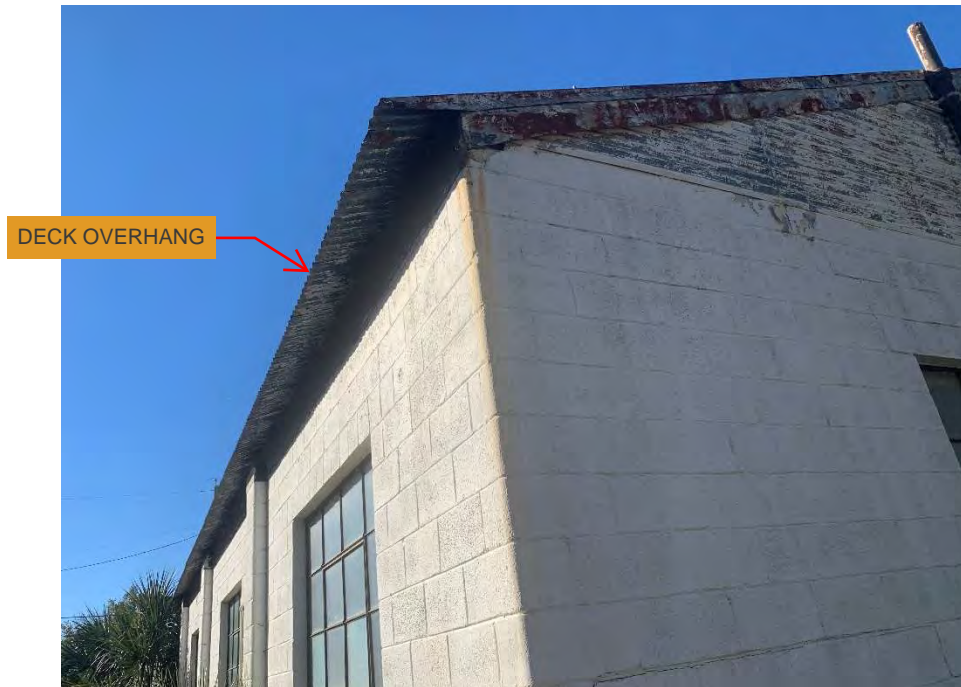
At the eave overhang of the building, the existing roof deck cantilevers out from the edge approximately 1 foot (Photo 3). The analysis of the deck shows that this edge is not capable of supporting live loading along the edge.

Photo 3: Roof decking – Cantilevered eave

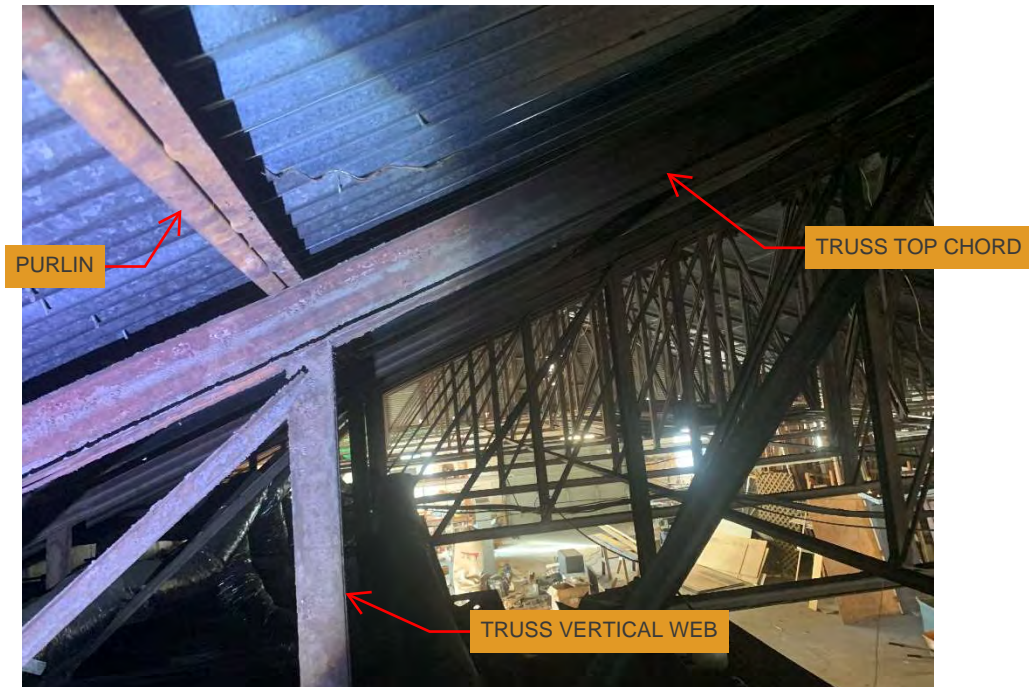
The roof purlins are constructed with back-to-back light gauge metal channels that are 2-1/2 inches deep and a metal thickness of approximately 18 gauge (0.05 inches) (Photo 4). The purlins are spaced approximately 4 feet - 3 inches apart. An analysis shows that the existing roof purlins are not adequate to support a code-required live load of 20 pounds per square feet. In the current condition and capacity, it is recommended that roof workers be limited to a weight of 175 pounds and maintain a spacing radius on the roof of at least 5 feet.

Photo 4: Purlins – Light-gauge and shallow member

For a restoration, the roof purlins will need to be reinforced to support a safe working load for any roof workers. The current capacity is already limited, but it is expected that a restoration would involve insulation and roofing that would add to the current load demands and further worsen the condition. It is expected that the purlin reinforcement would involve steel section reinforcements throughout the building to ensure the capacity for the code-required live load and any increase loading from additional roof materials, and to supplement for section loss or deformations.

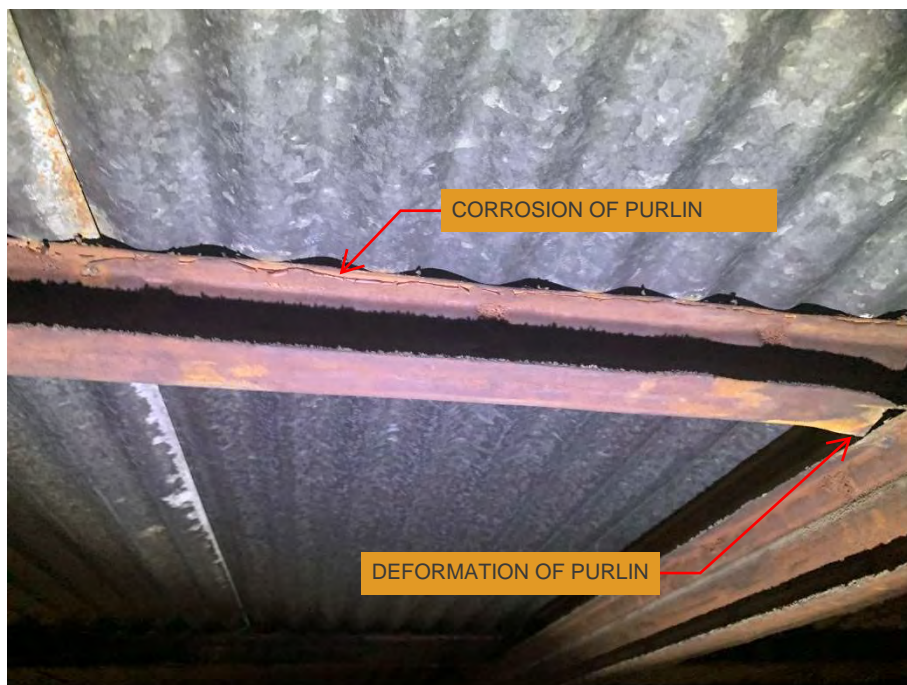
Upon inspection of some of the roof purlins, the sections show some mild corrosion and deformations that reduce the structural integrity of the members (Photo 5).

Photo 5: Purlins – Mild corrosion

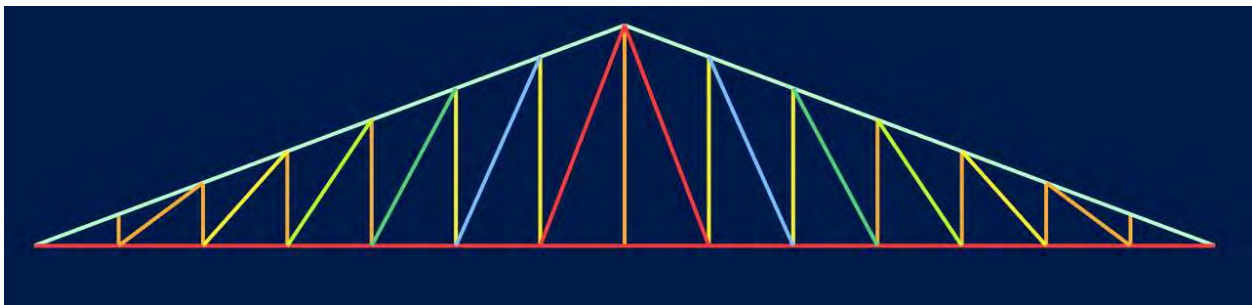
Figure 2: Truss analysis profile

From the analysis of the truss, several of the longer web elements are undersized for support a code-required live load and any mild wind uplift event. The very slender L1x1x1/8 diagonal webs are under tension loads for gravity loading, for which there is more capacity than the capacity in compression. However, in any uplift event, these diagonal web angles would be in compression and would buckle. To support any reasonable wind uplift event on the roof, it would be required to reinforce the truss elements. Even for gravity loading, the current capacity is limited and should be reinforced for additional roof materials in a roof renovation.

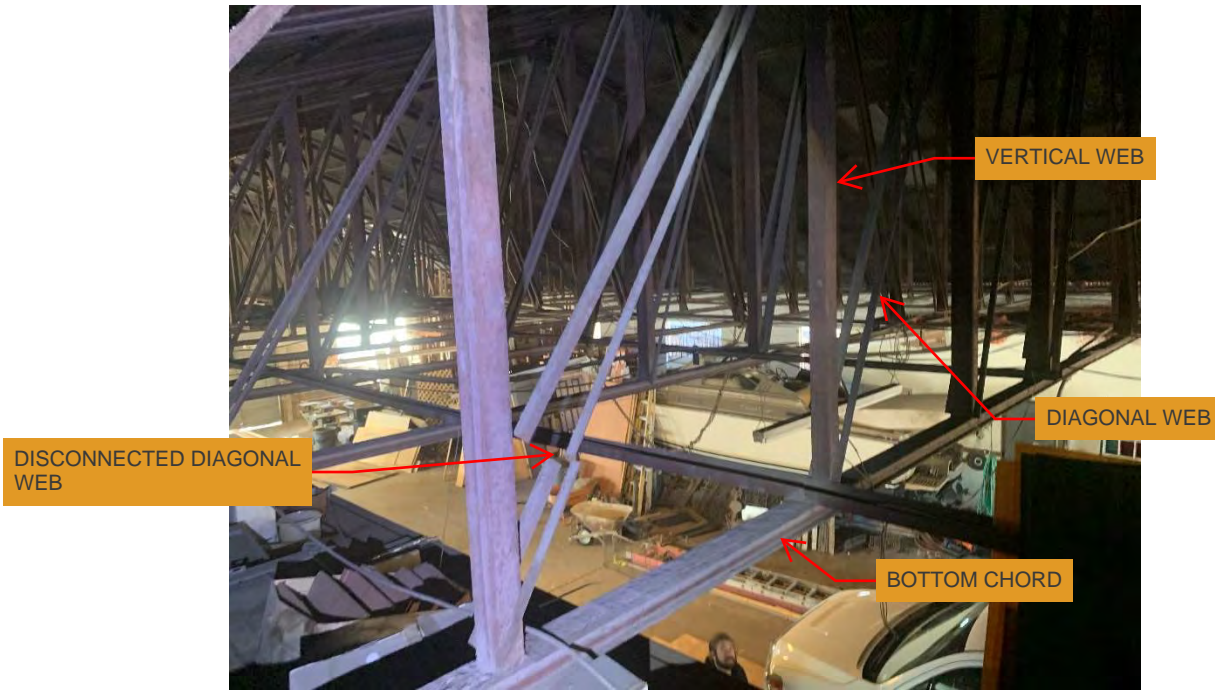
All connections of the truss appear to be welded (Photos 7 and 8). Welding light-gauge metal takes welding skill to prevent burn through of the metal. Some of the diagonals were found disconnected (Photo 6). Because these roof truss elements are slender and dependent on strong connections to transfer forces to function as a truss system, welding inspections of the connections would be prudent.

Photo 6: Roof trusses – Overall and Unconnected members

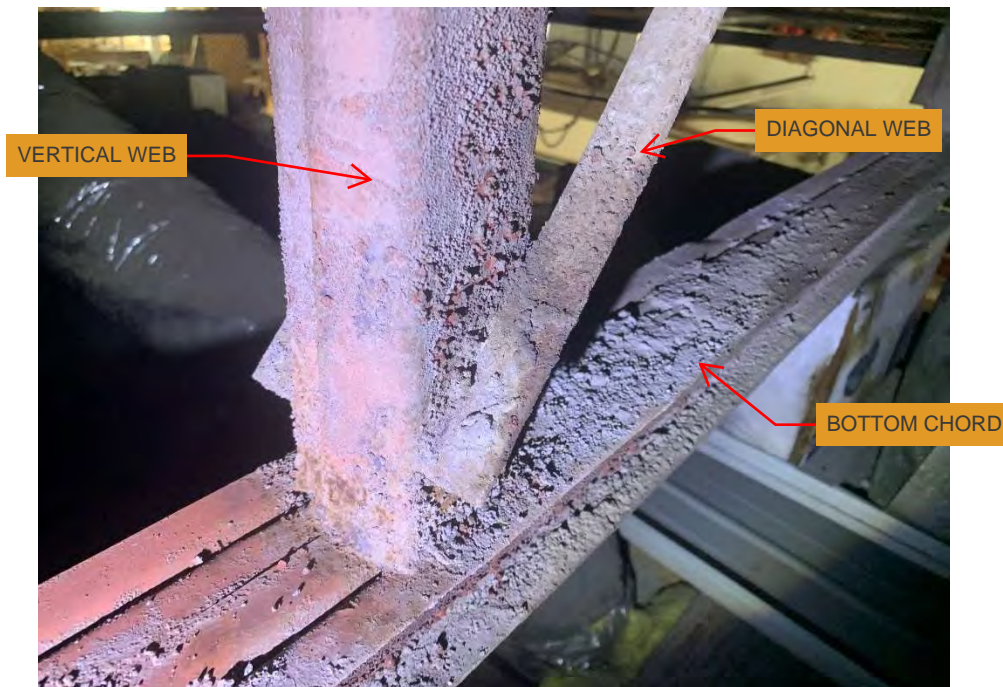
Photo 7: Roof trusses – Web and Bottom Chord Connections

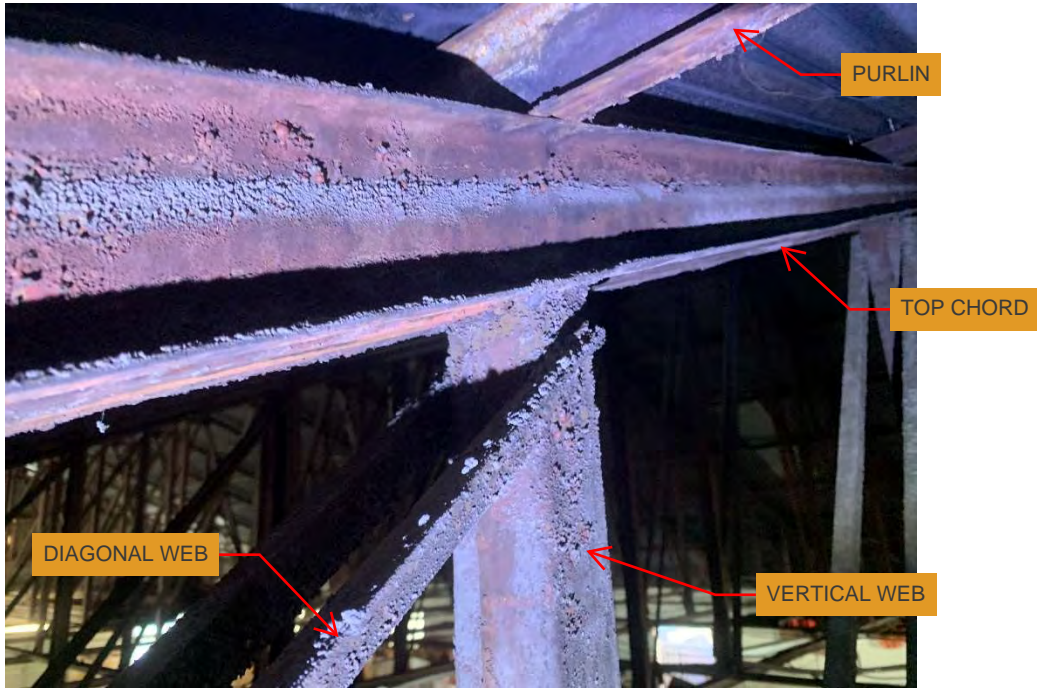
Photo 8: Roof truss – Web and Top Chord Connections

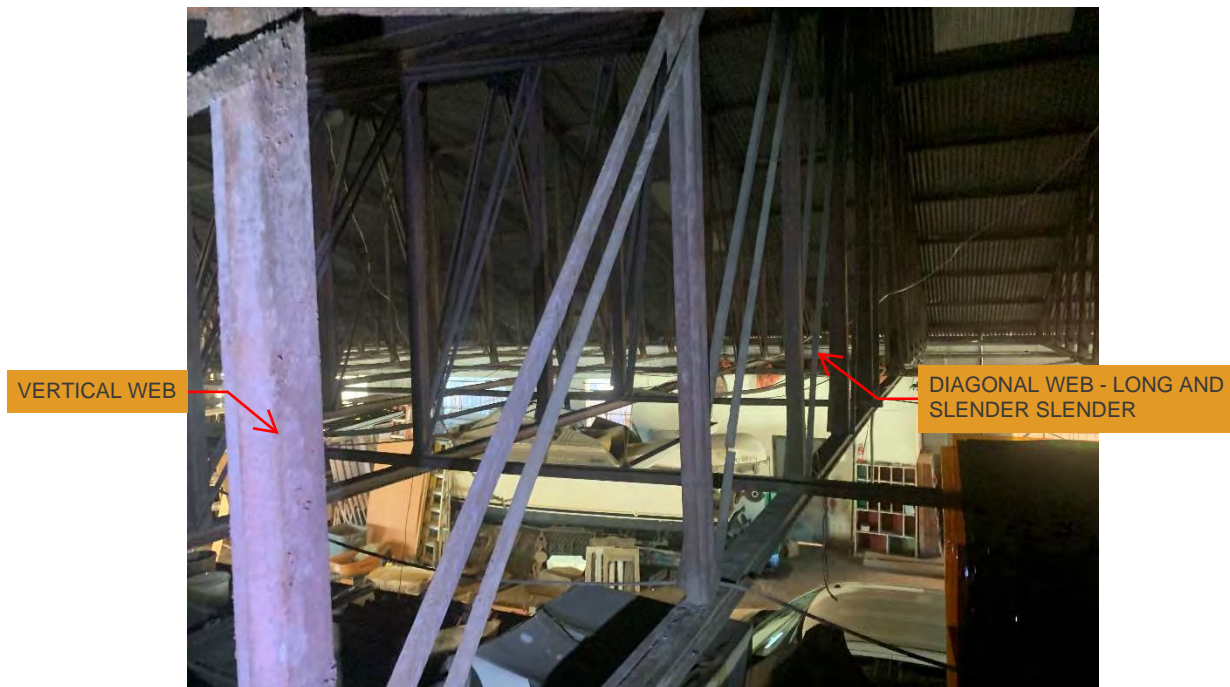
The L1x1x1/8 diagonal web angles are long and slender (Photo 9). When slender elements are under compression, such as with truss webs, buckling of the element could significantly reduce the capacity. Many of the diagonal webs are longer than would be recommended to prevent buckling from compression forces or even general recommendations for slenderness for use as tension members.

Photo 9: Roof truss – Slender webs

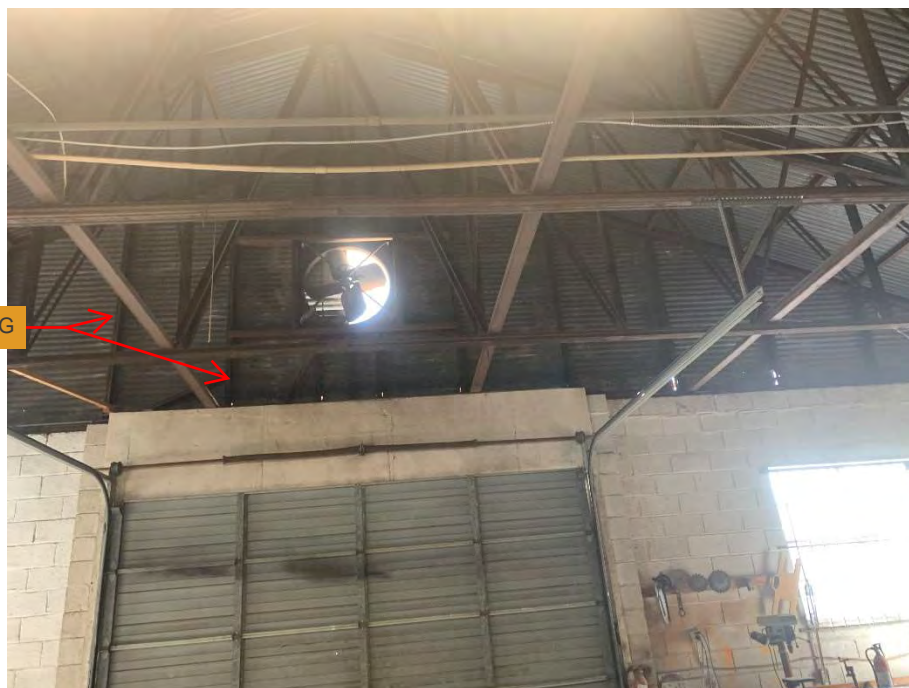
The gable end walls are framed with back-to-back light-gauge metal channels that are 3-1/2 inches deep and a metal thickness of approximately 18 gauge (0.05 inches) (Photo 10). From a structural analysis with a wall wind pressure, this light-gauge metal framing is insufficient for a smaller-scale hurricane event.

Photo 10: Gable end walls – Unbraced

For a restoration, the gable end wall framing would need to be reinforced or braced to the trusses for additional support for the out-of-plane wall pressure.

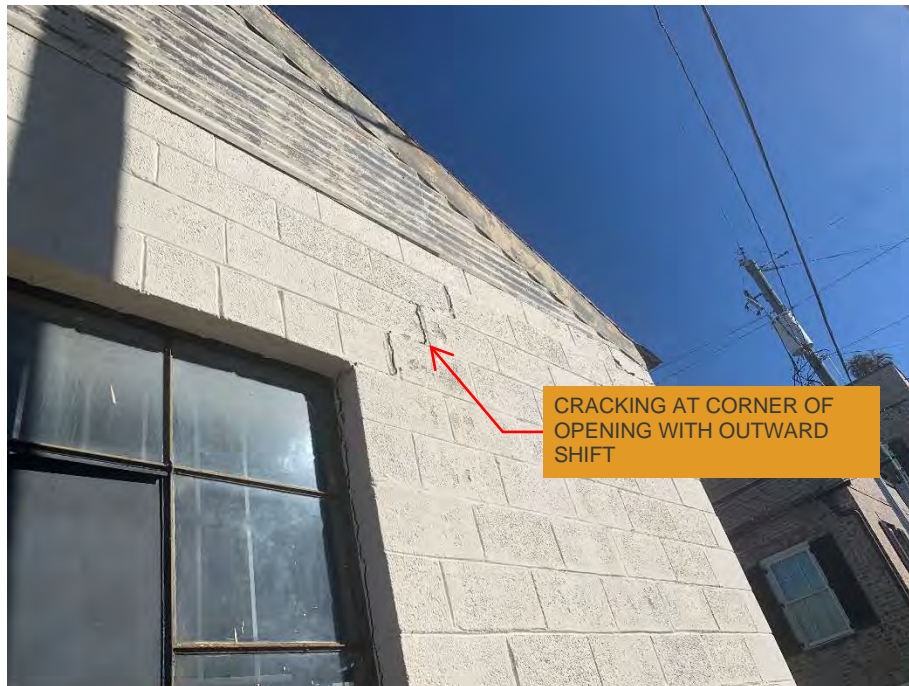
There are cracks in the exterior walls near the corners of the building. These cracks are approximately 3/16 inches to 1/4 inches throughout. The cracks generally start near opening corners and extend to the top (Photo 11).

Photo 11: Exterior Wall – Cracking/shifting

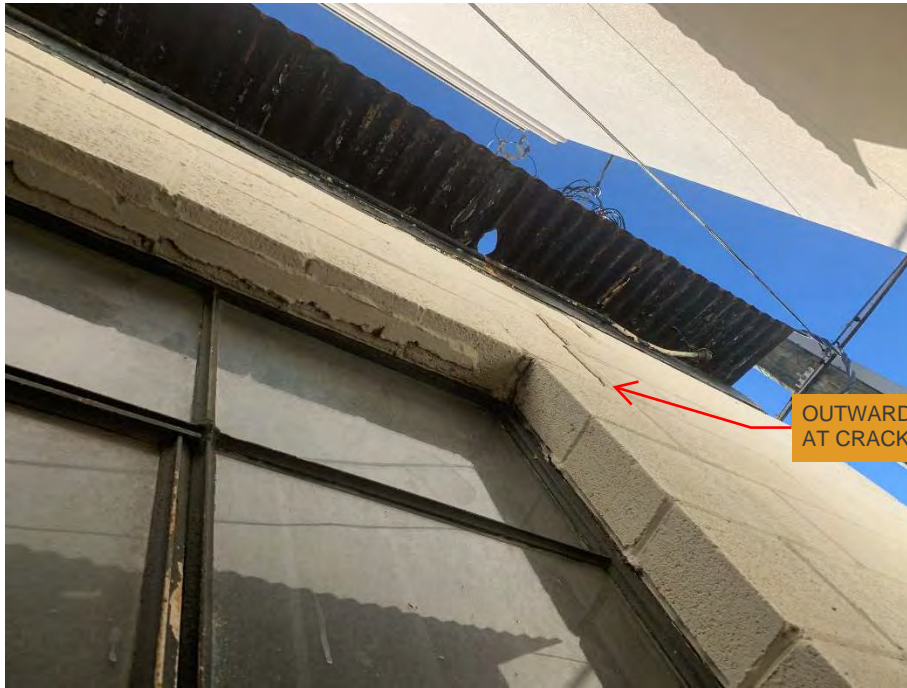
The cause of the cracking could be settlement or thermal expansion. There are some offset lips at the cracks that could indicate some lateral movement has happened (Photo 12). The long walls are approximately 110 feet long and contain no expansion joints, which suggests that these cracks could be caused from expansion rather than settlement, however this does not rule out that settlement has occurred. At these cracks, there is a loss of connection that needs to be reconnected. As part of a restoration, some of these areas may need to be stitched with steel bars or reconstructed with fresh mortar to regain the connection.

Photo 12: Exterior Wall – Cracking/shifting

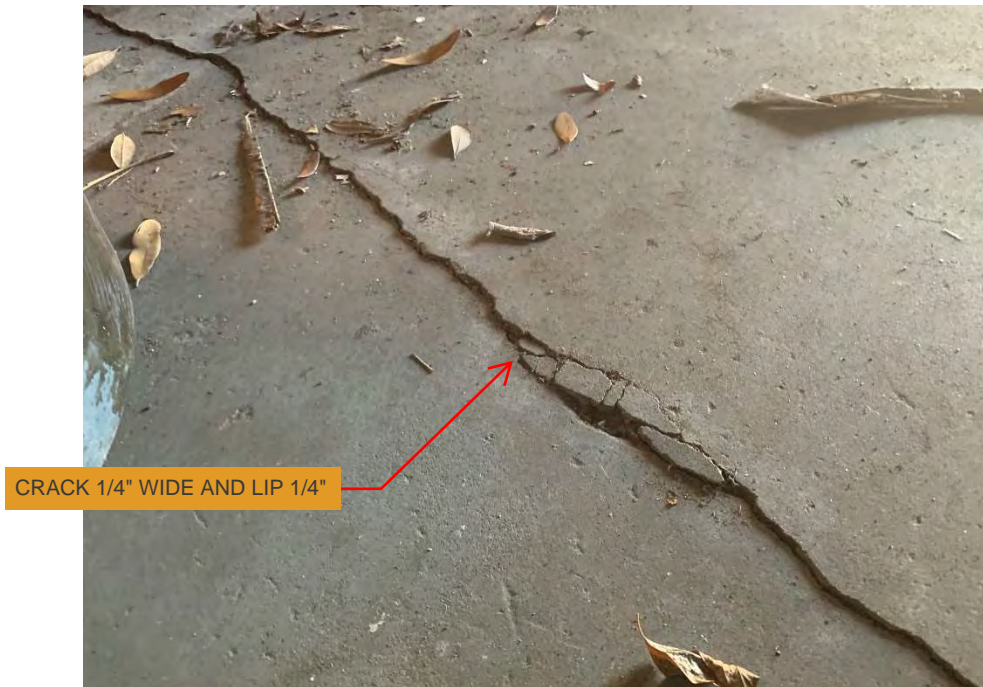
The ground slab is an isolated slab that does not appear connected to the walls or foundation. The thickness is unknown. There is a 1/4-inch-thick crack in the slab near the north end (Photo 13). Not only is the slab cracked, but there is a vertical lip that is raised 1/4" between the two slab sections. Although this is not a structural concern, the lip could indicate some soil settlement around the building.

Photo 13: Ground Slab - Cracking
