DESCRIPTION of Porch #1706 OGEECHIE RD.

1706 OGEE CHEE RD.

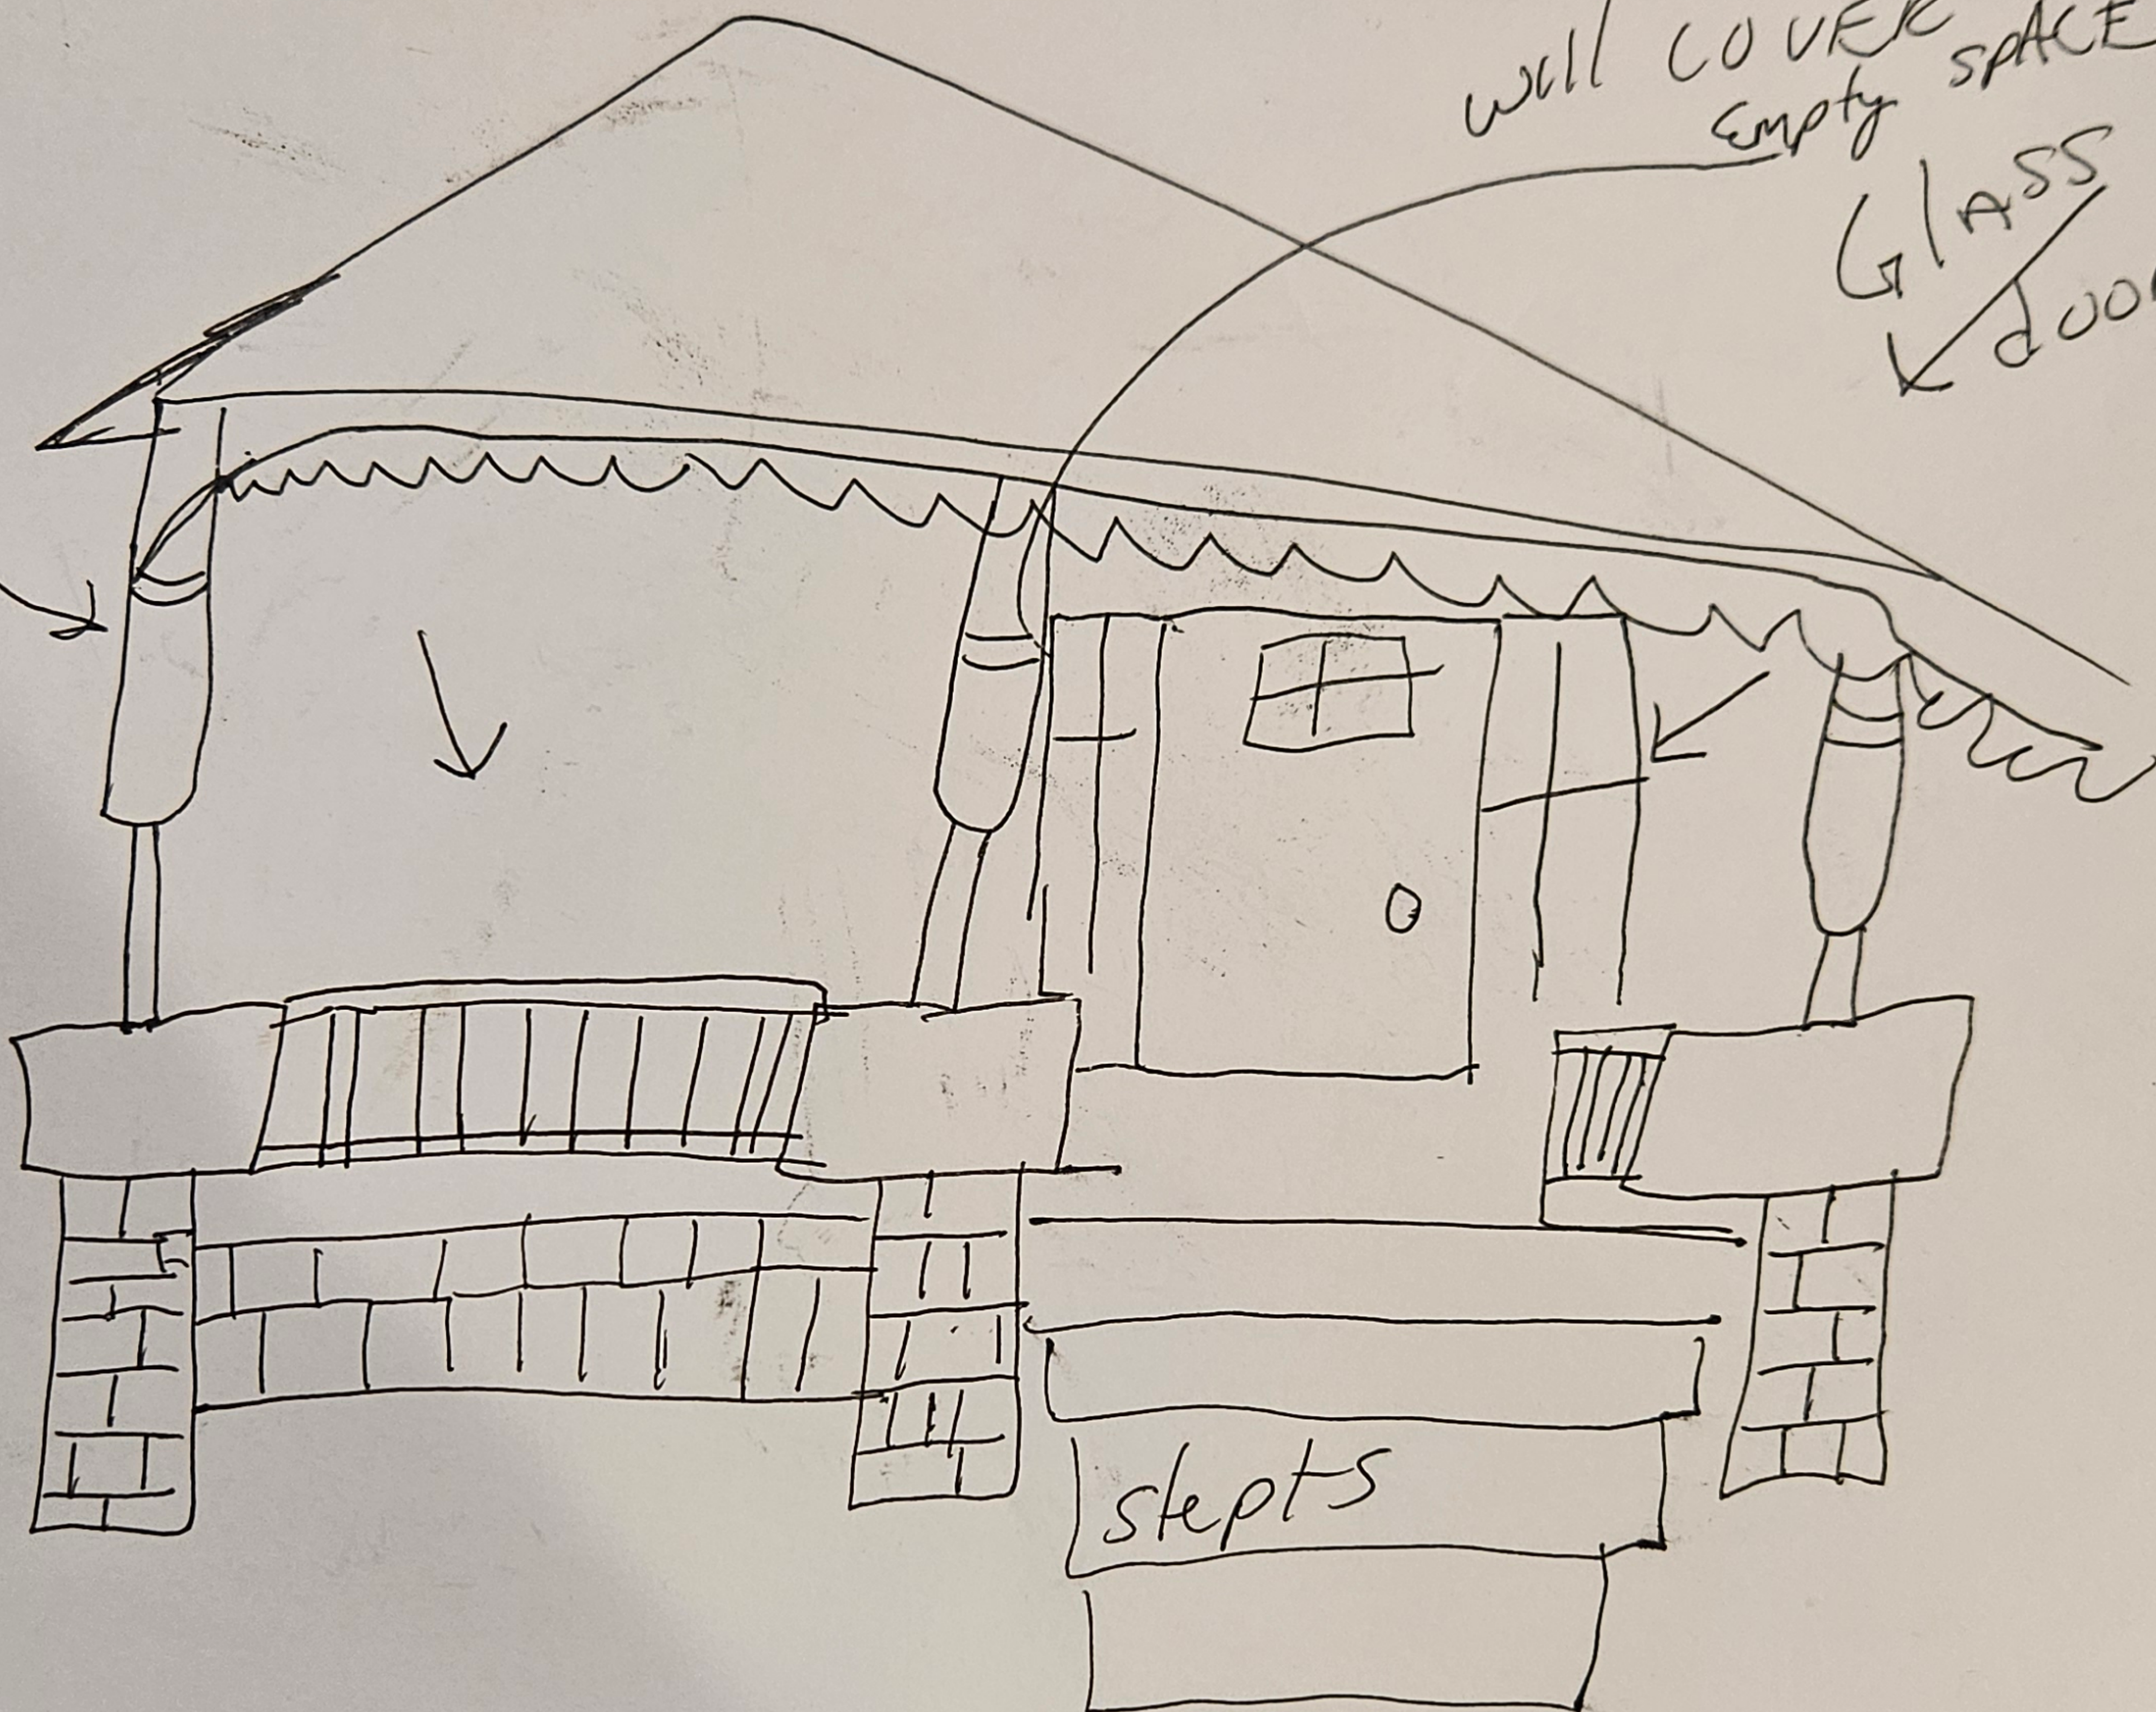
will COVER  
empty SPACE  
GLASS  
door

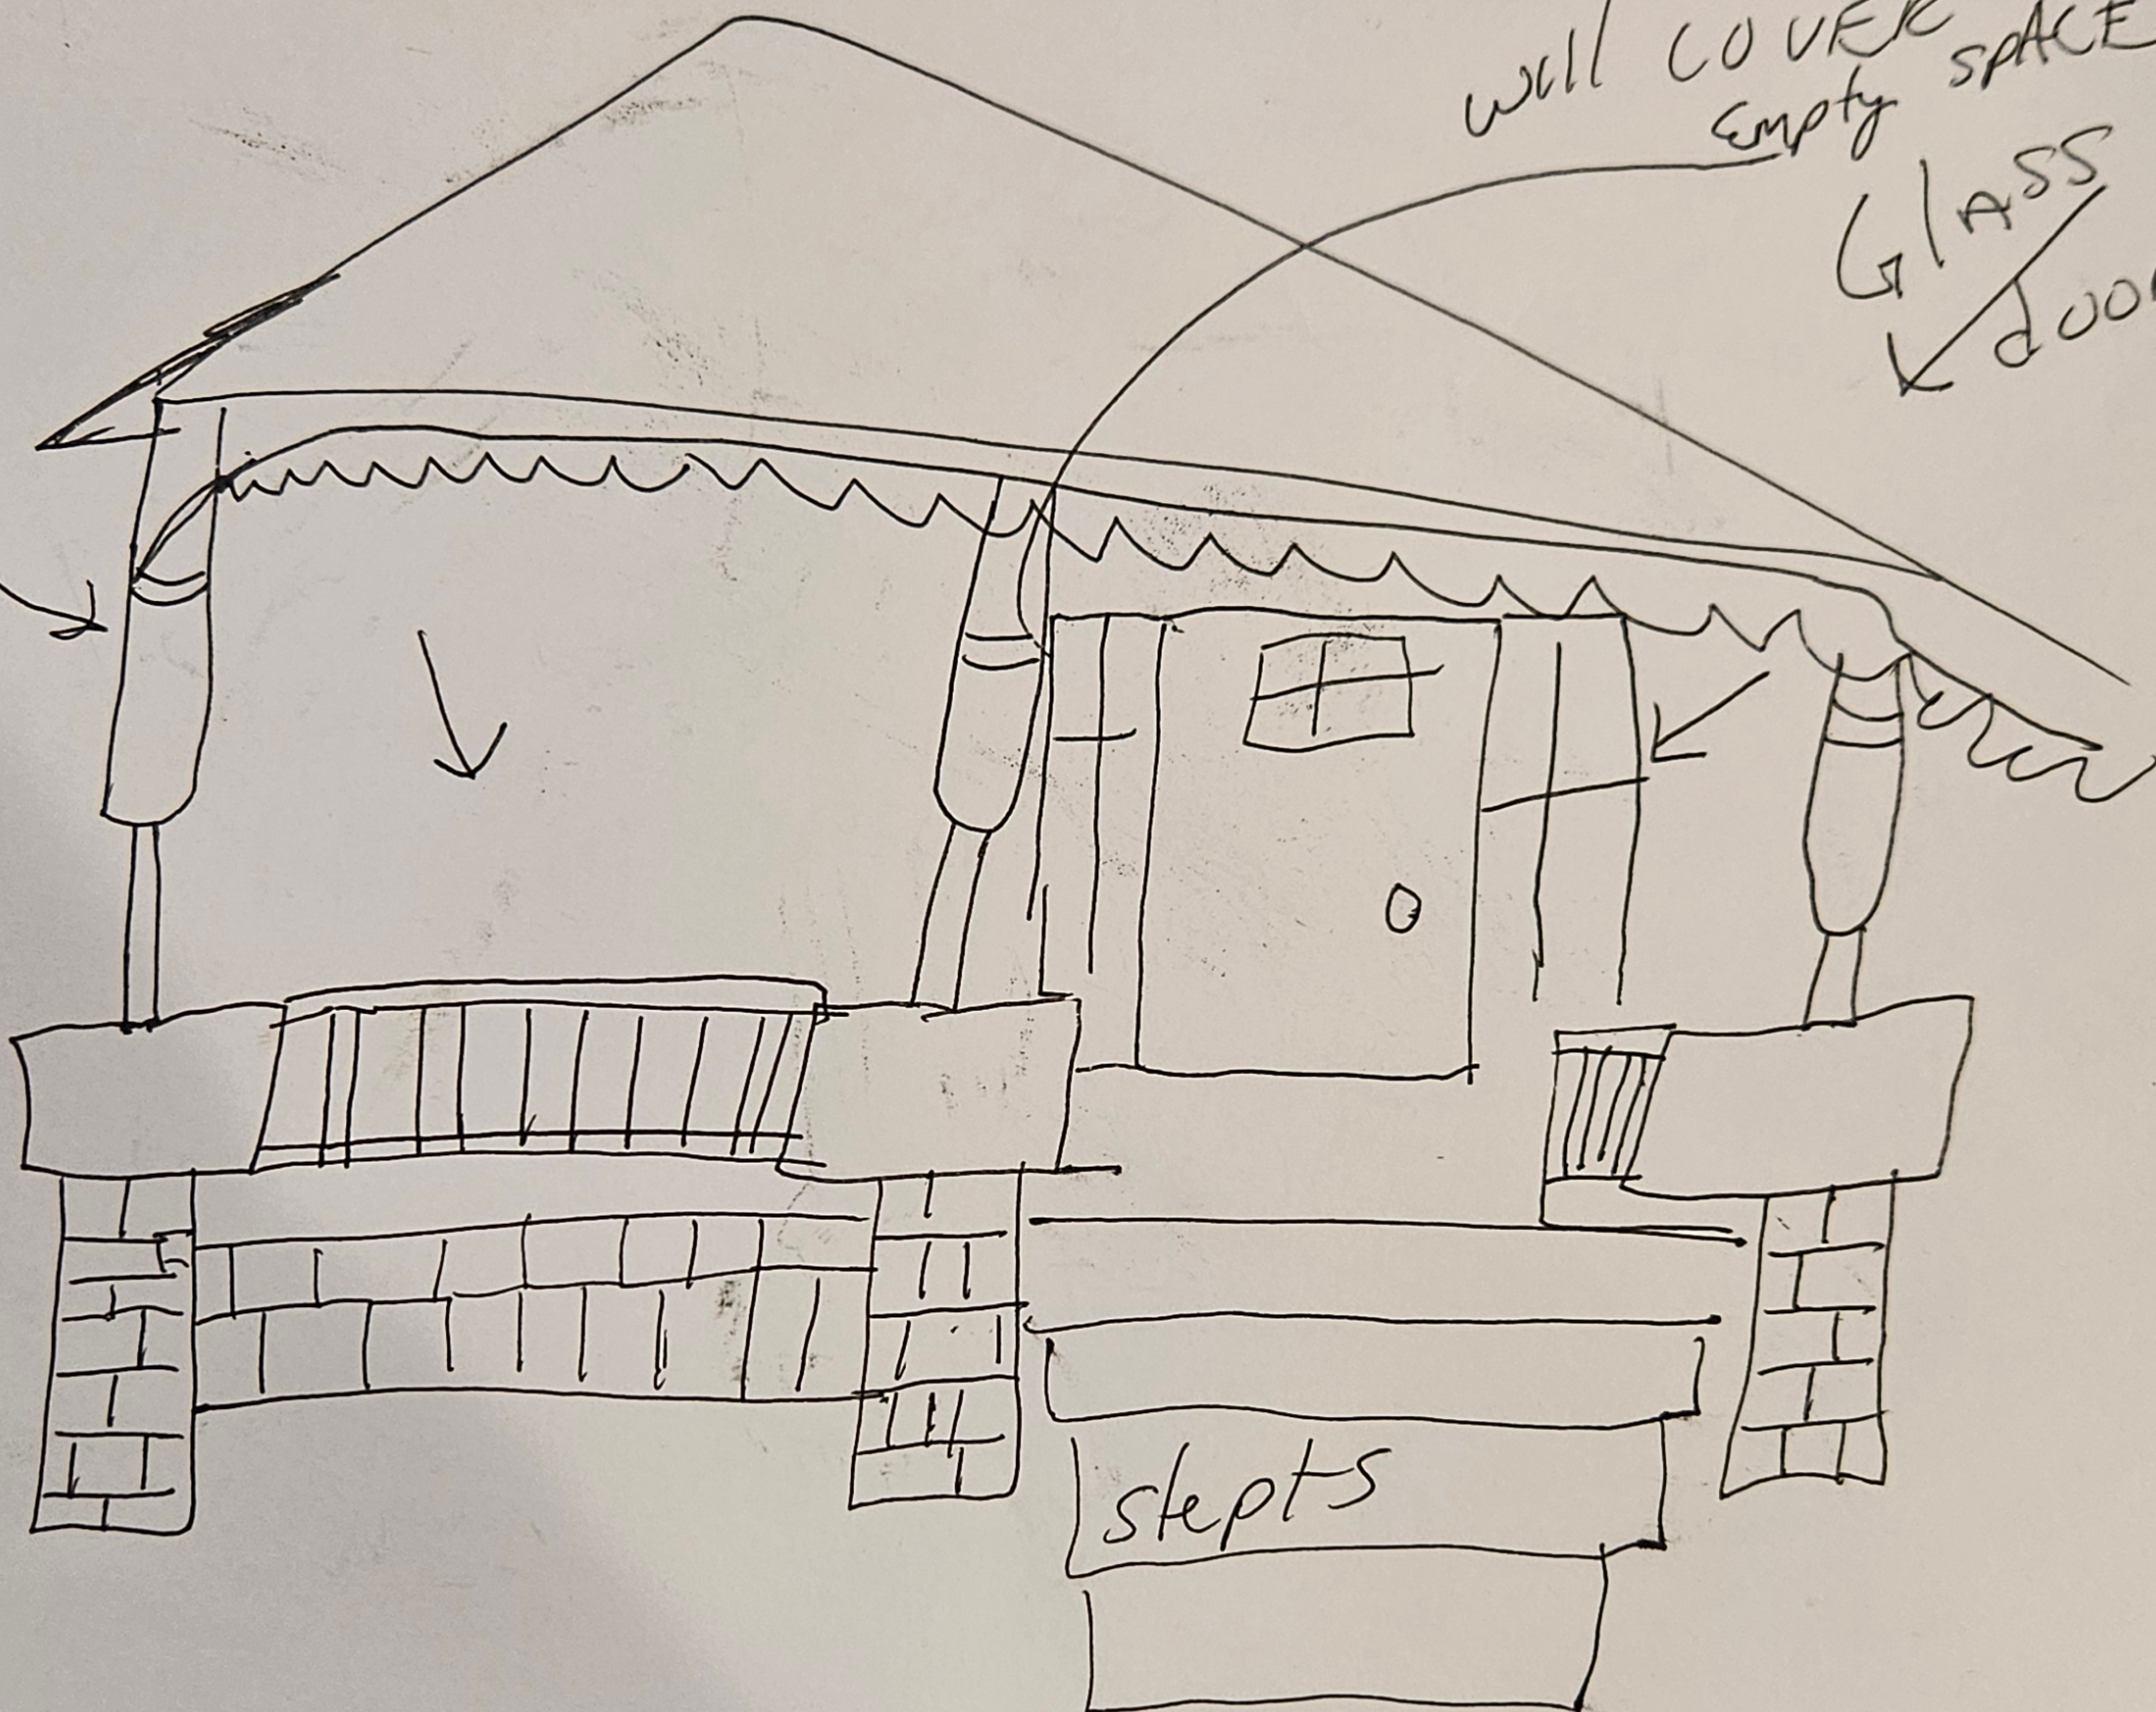
will COVER  
empty SPACE  
GLASS  
door
