Historic  
Presidents  
Quarters

225 E President St.  
Savannah, GA 31401

HDBR  
SUBMISSION

POST-  
DEMOLITION  
PHOTOS AND  
REPORT OF  
SOUTH STAIR

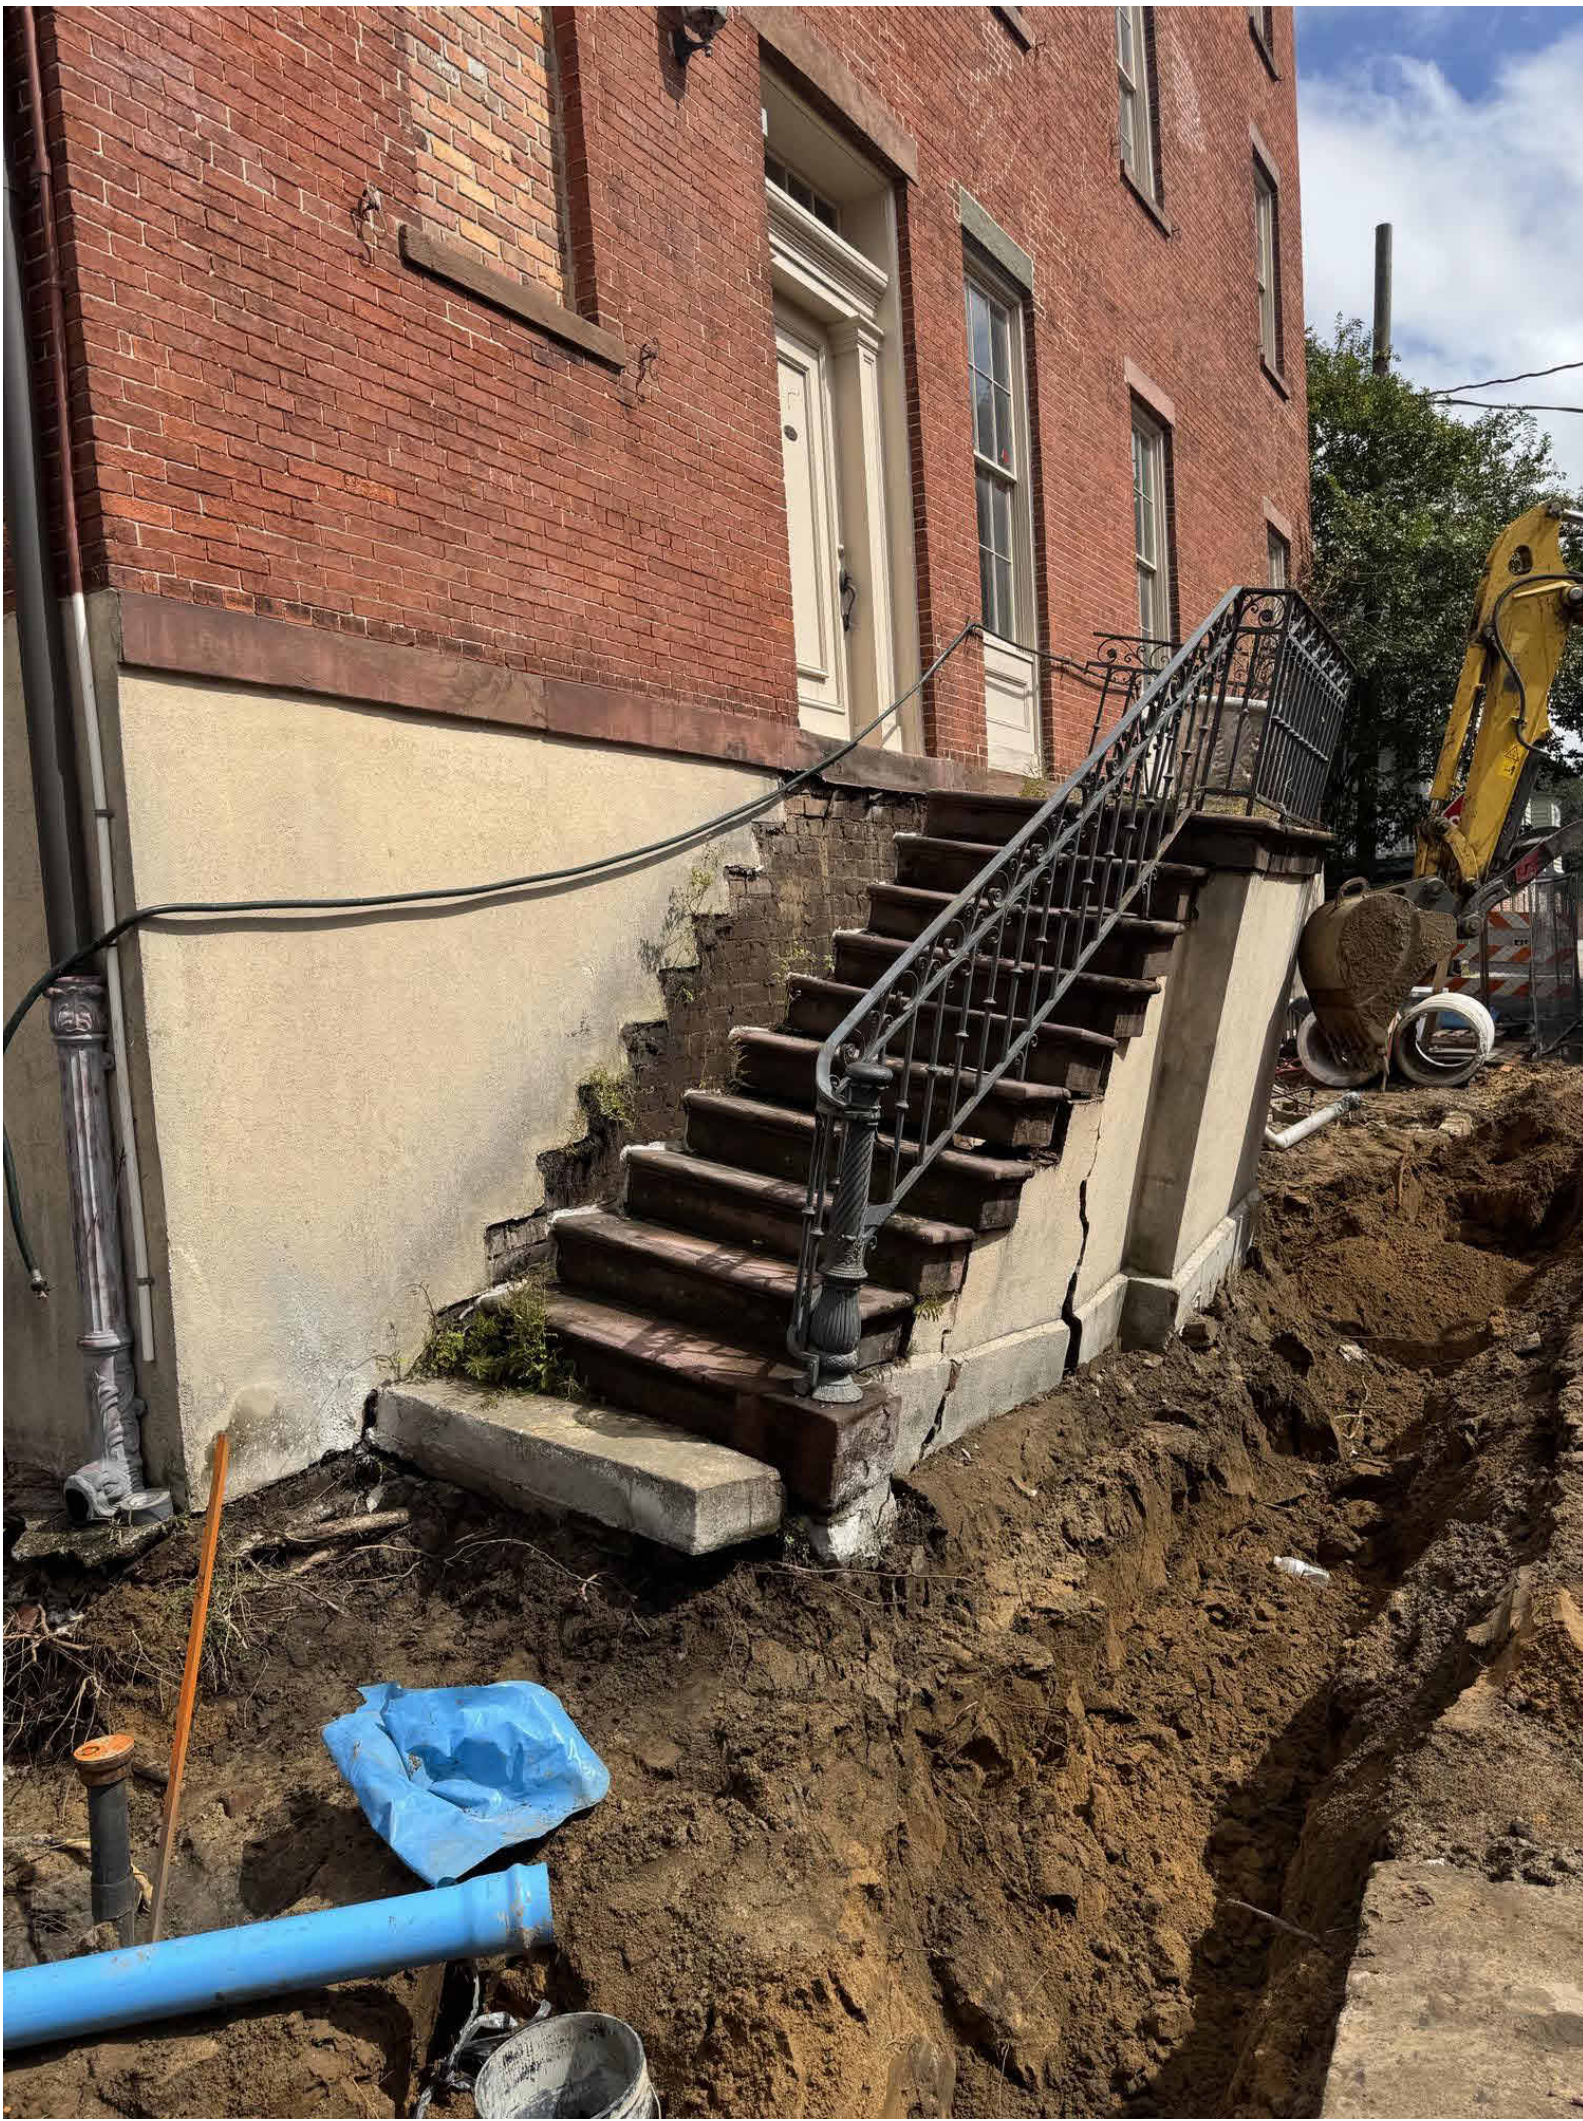
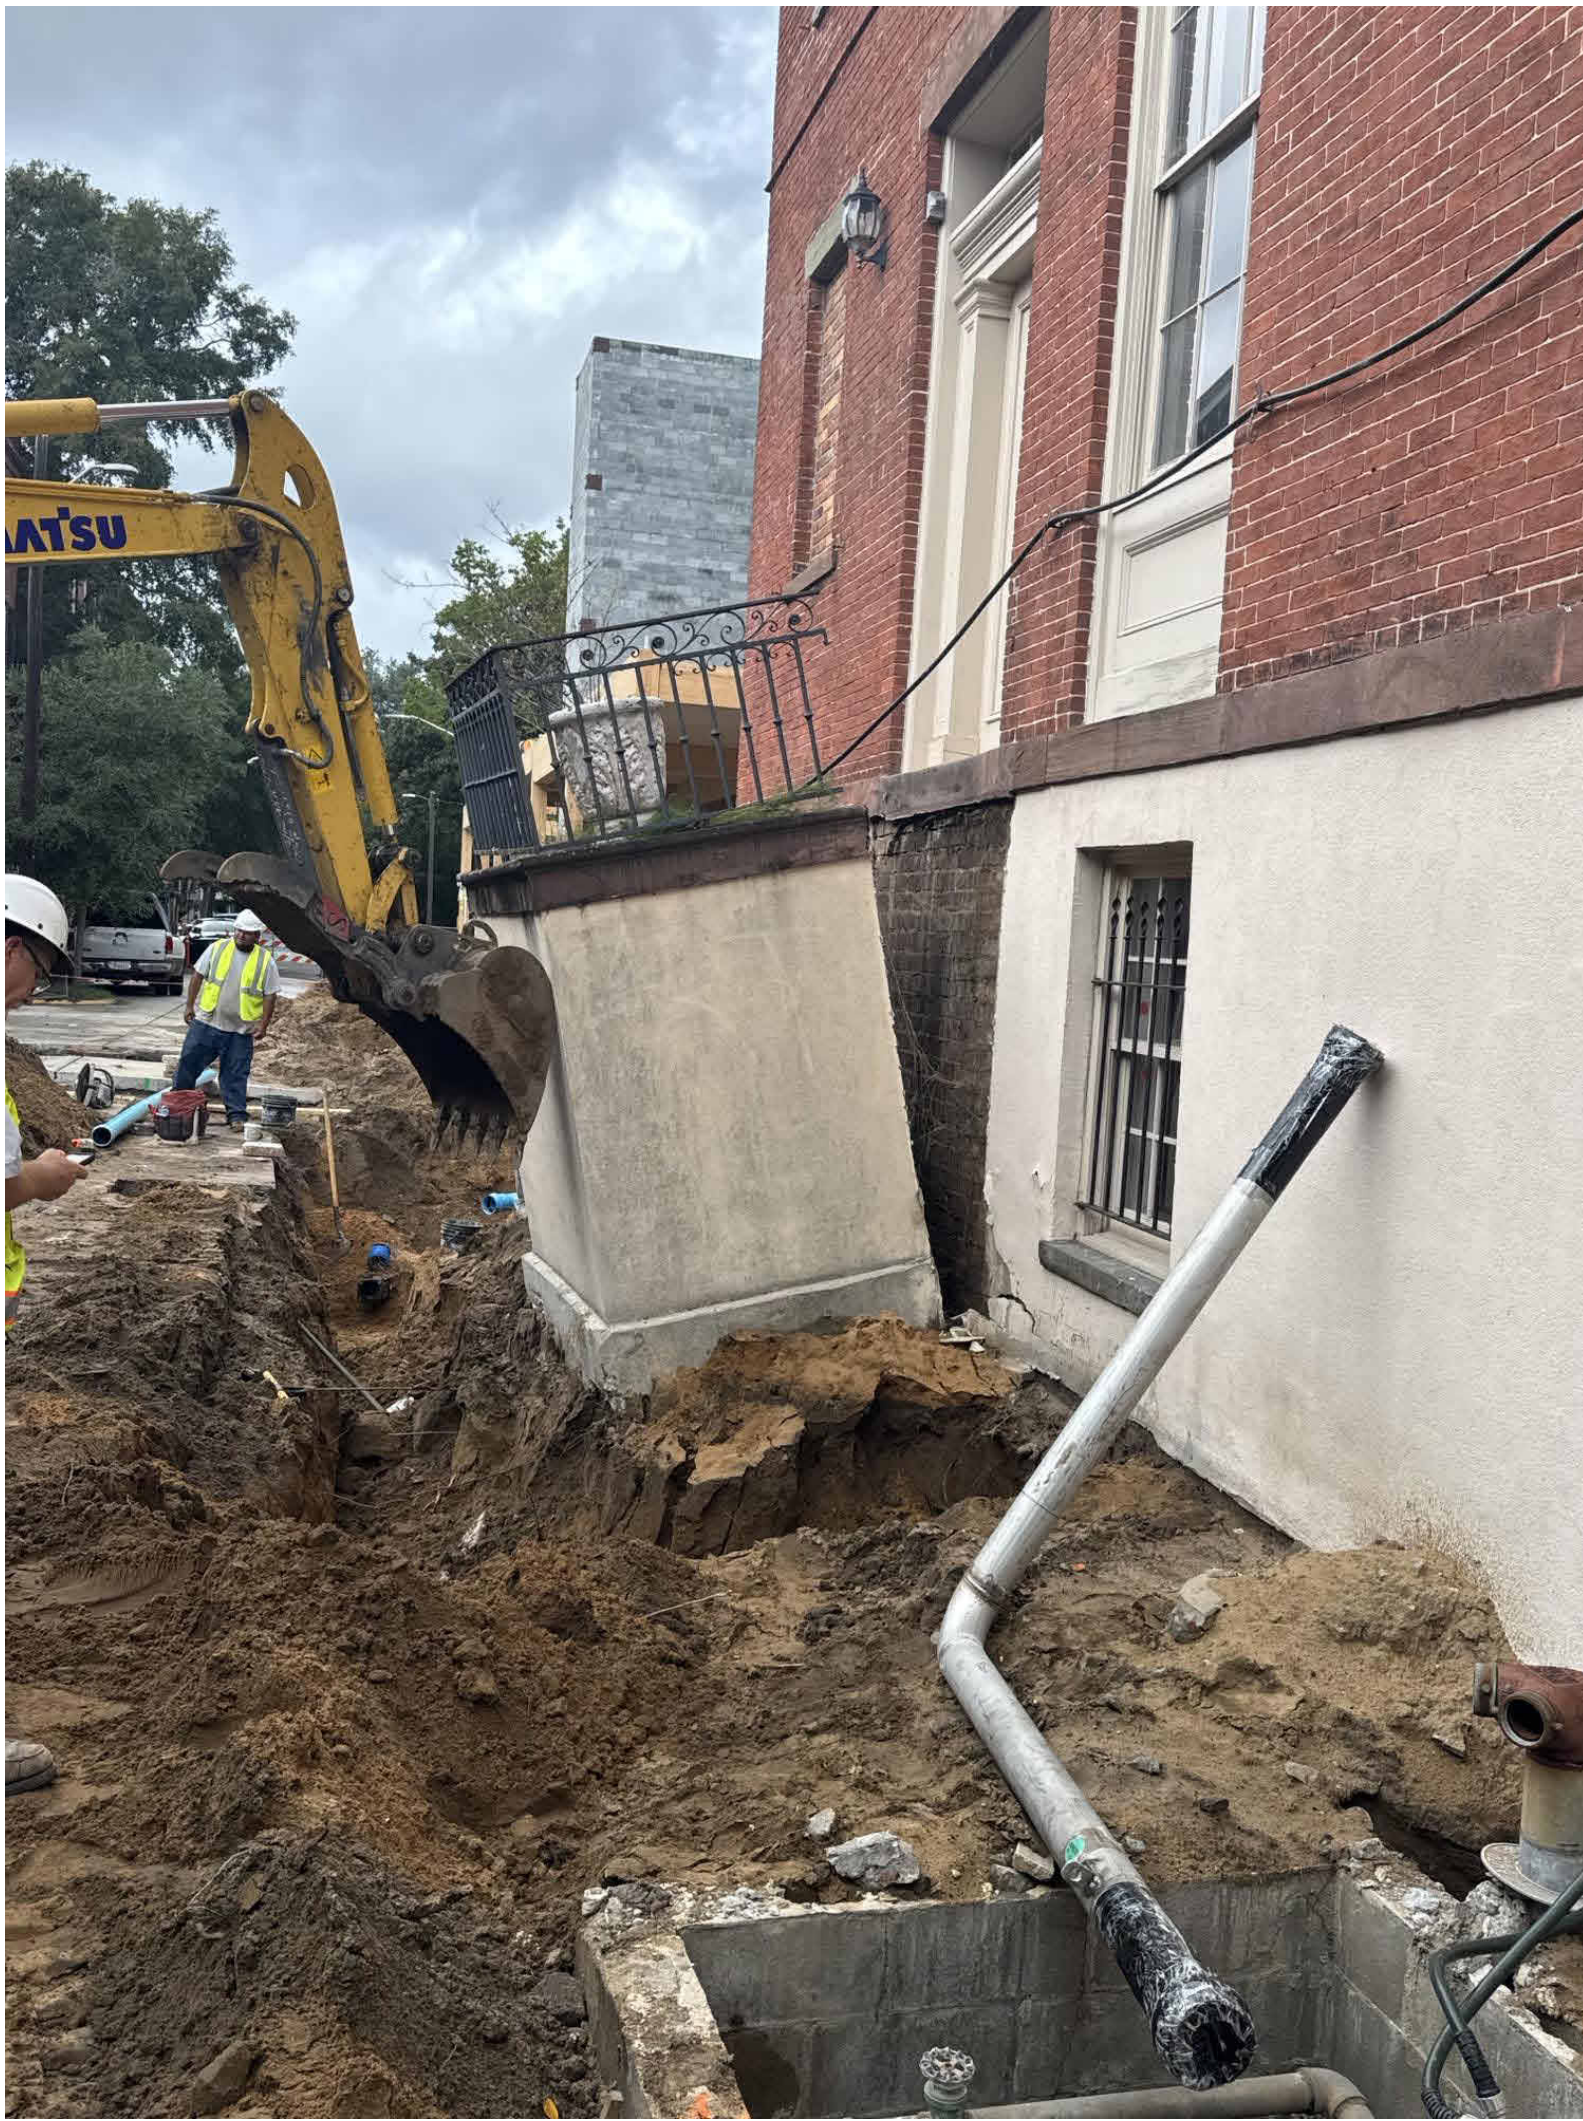
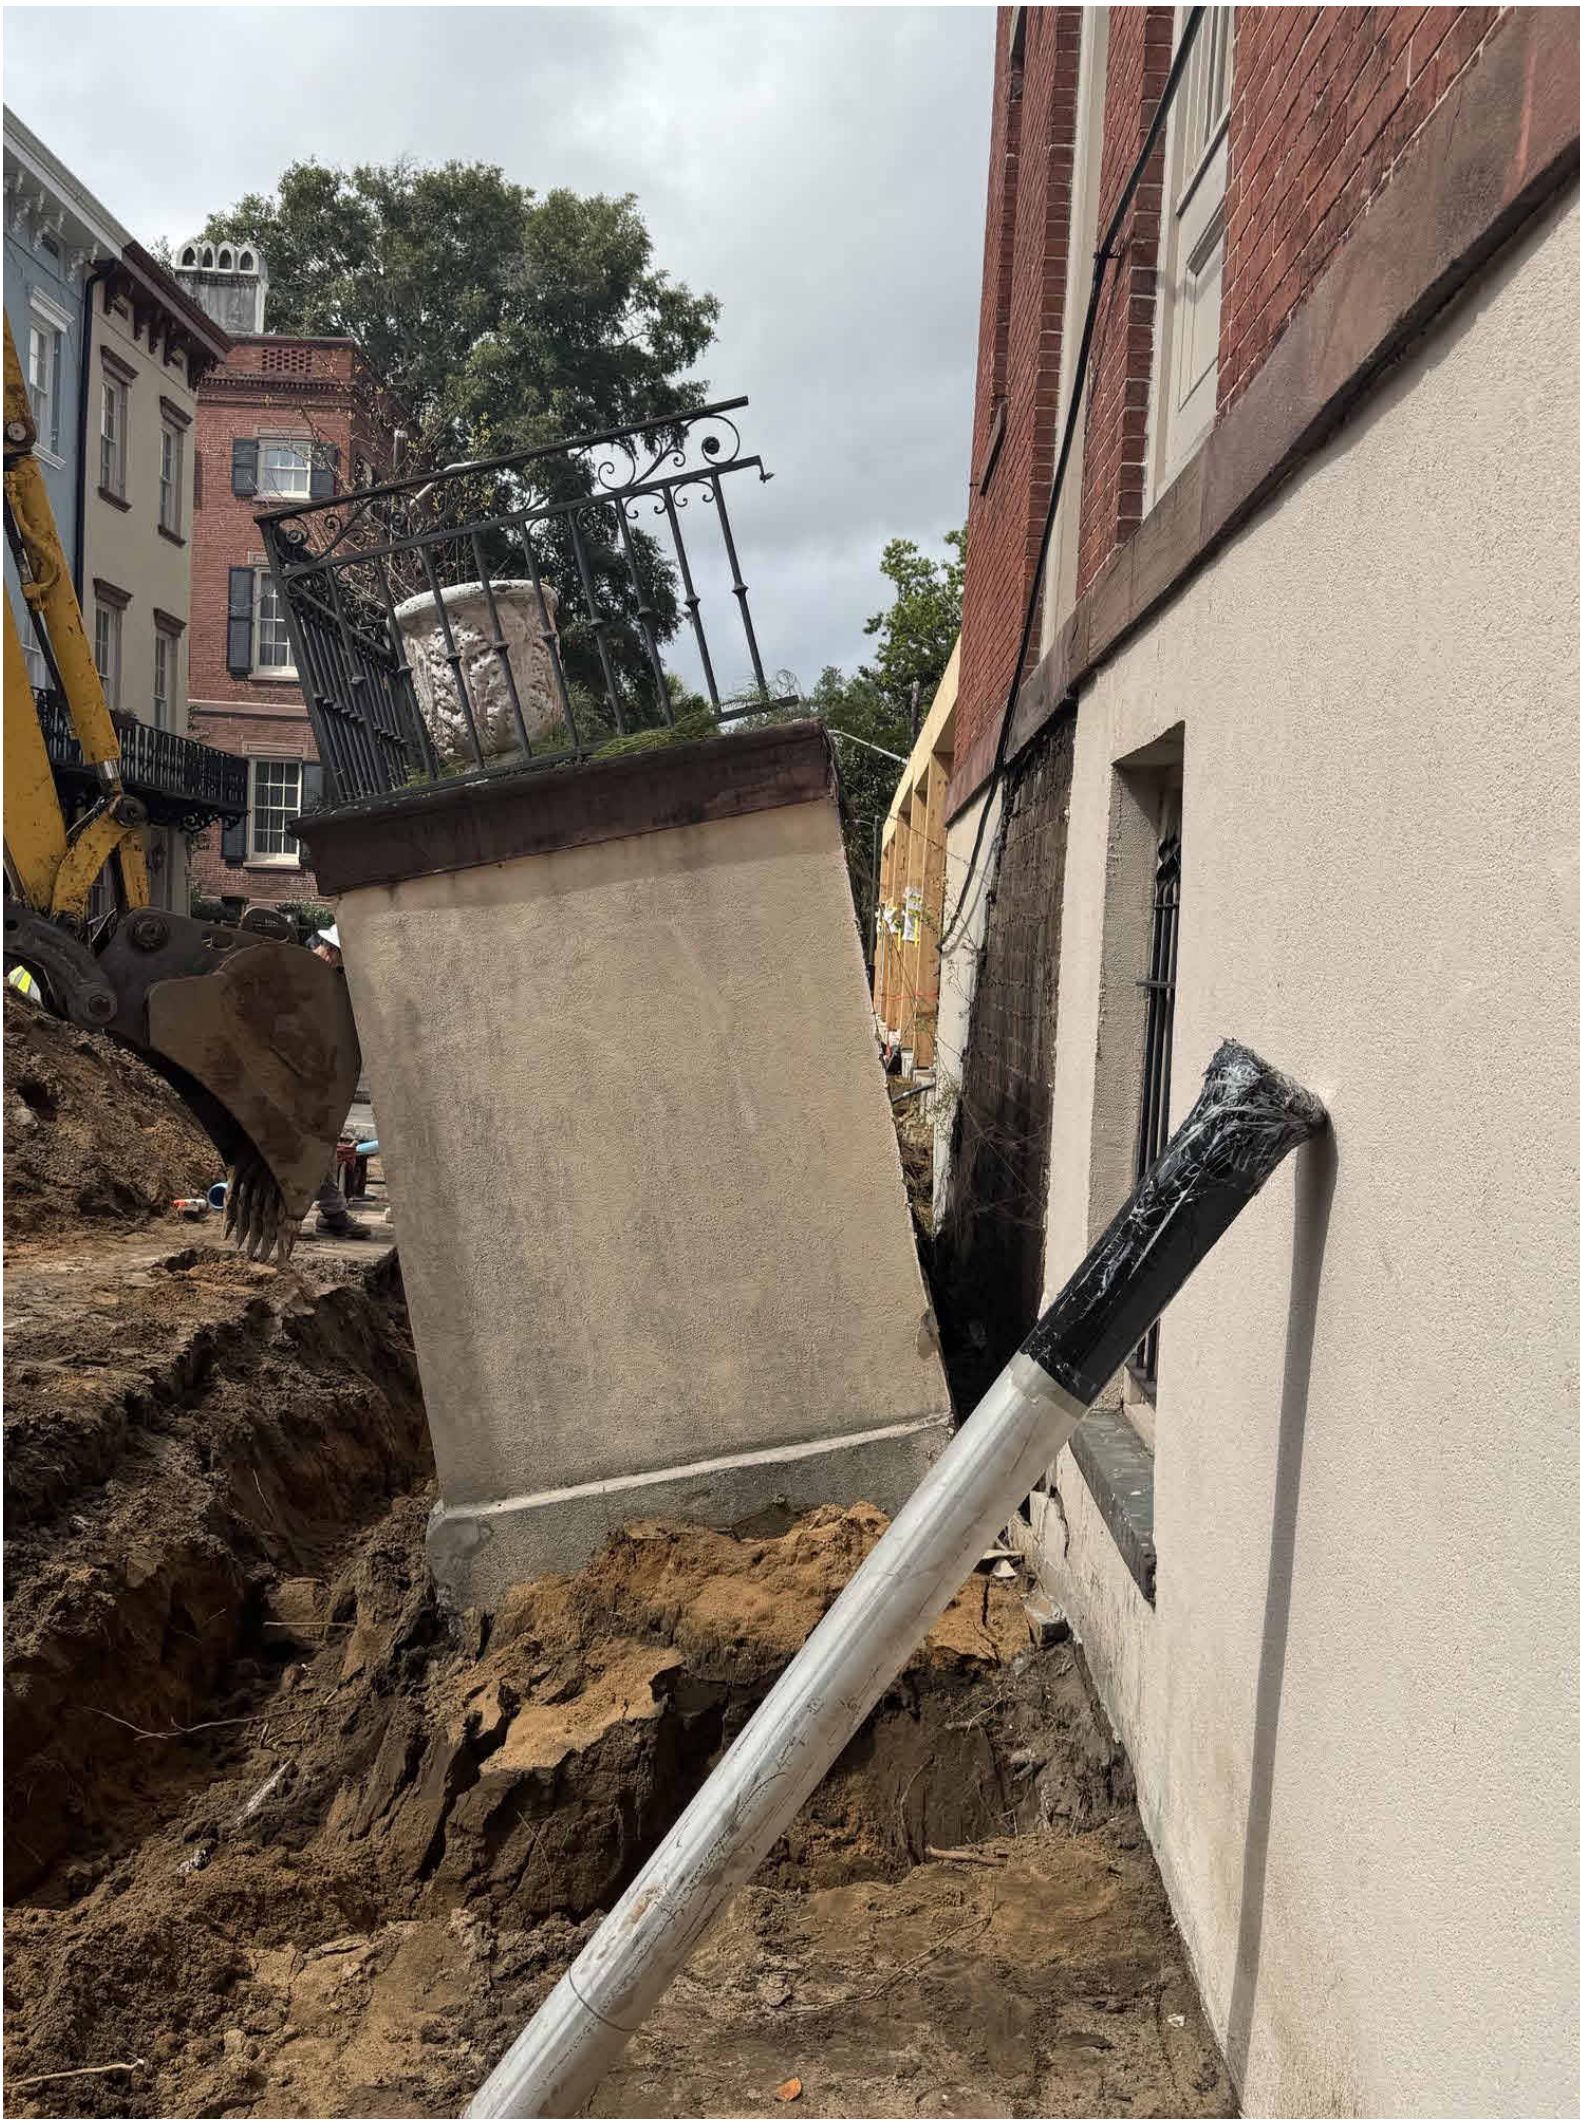
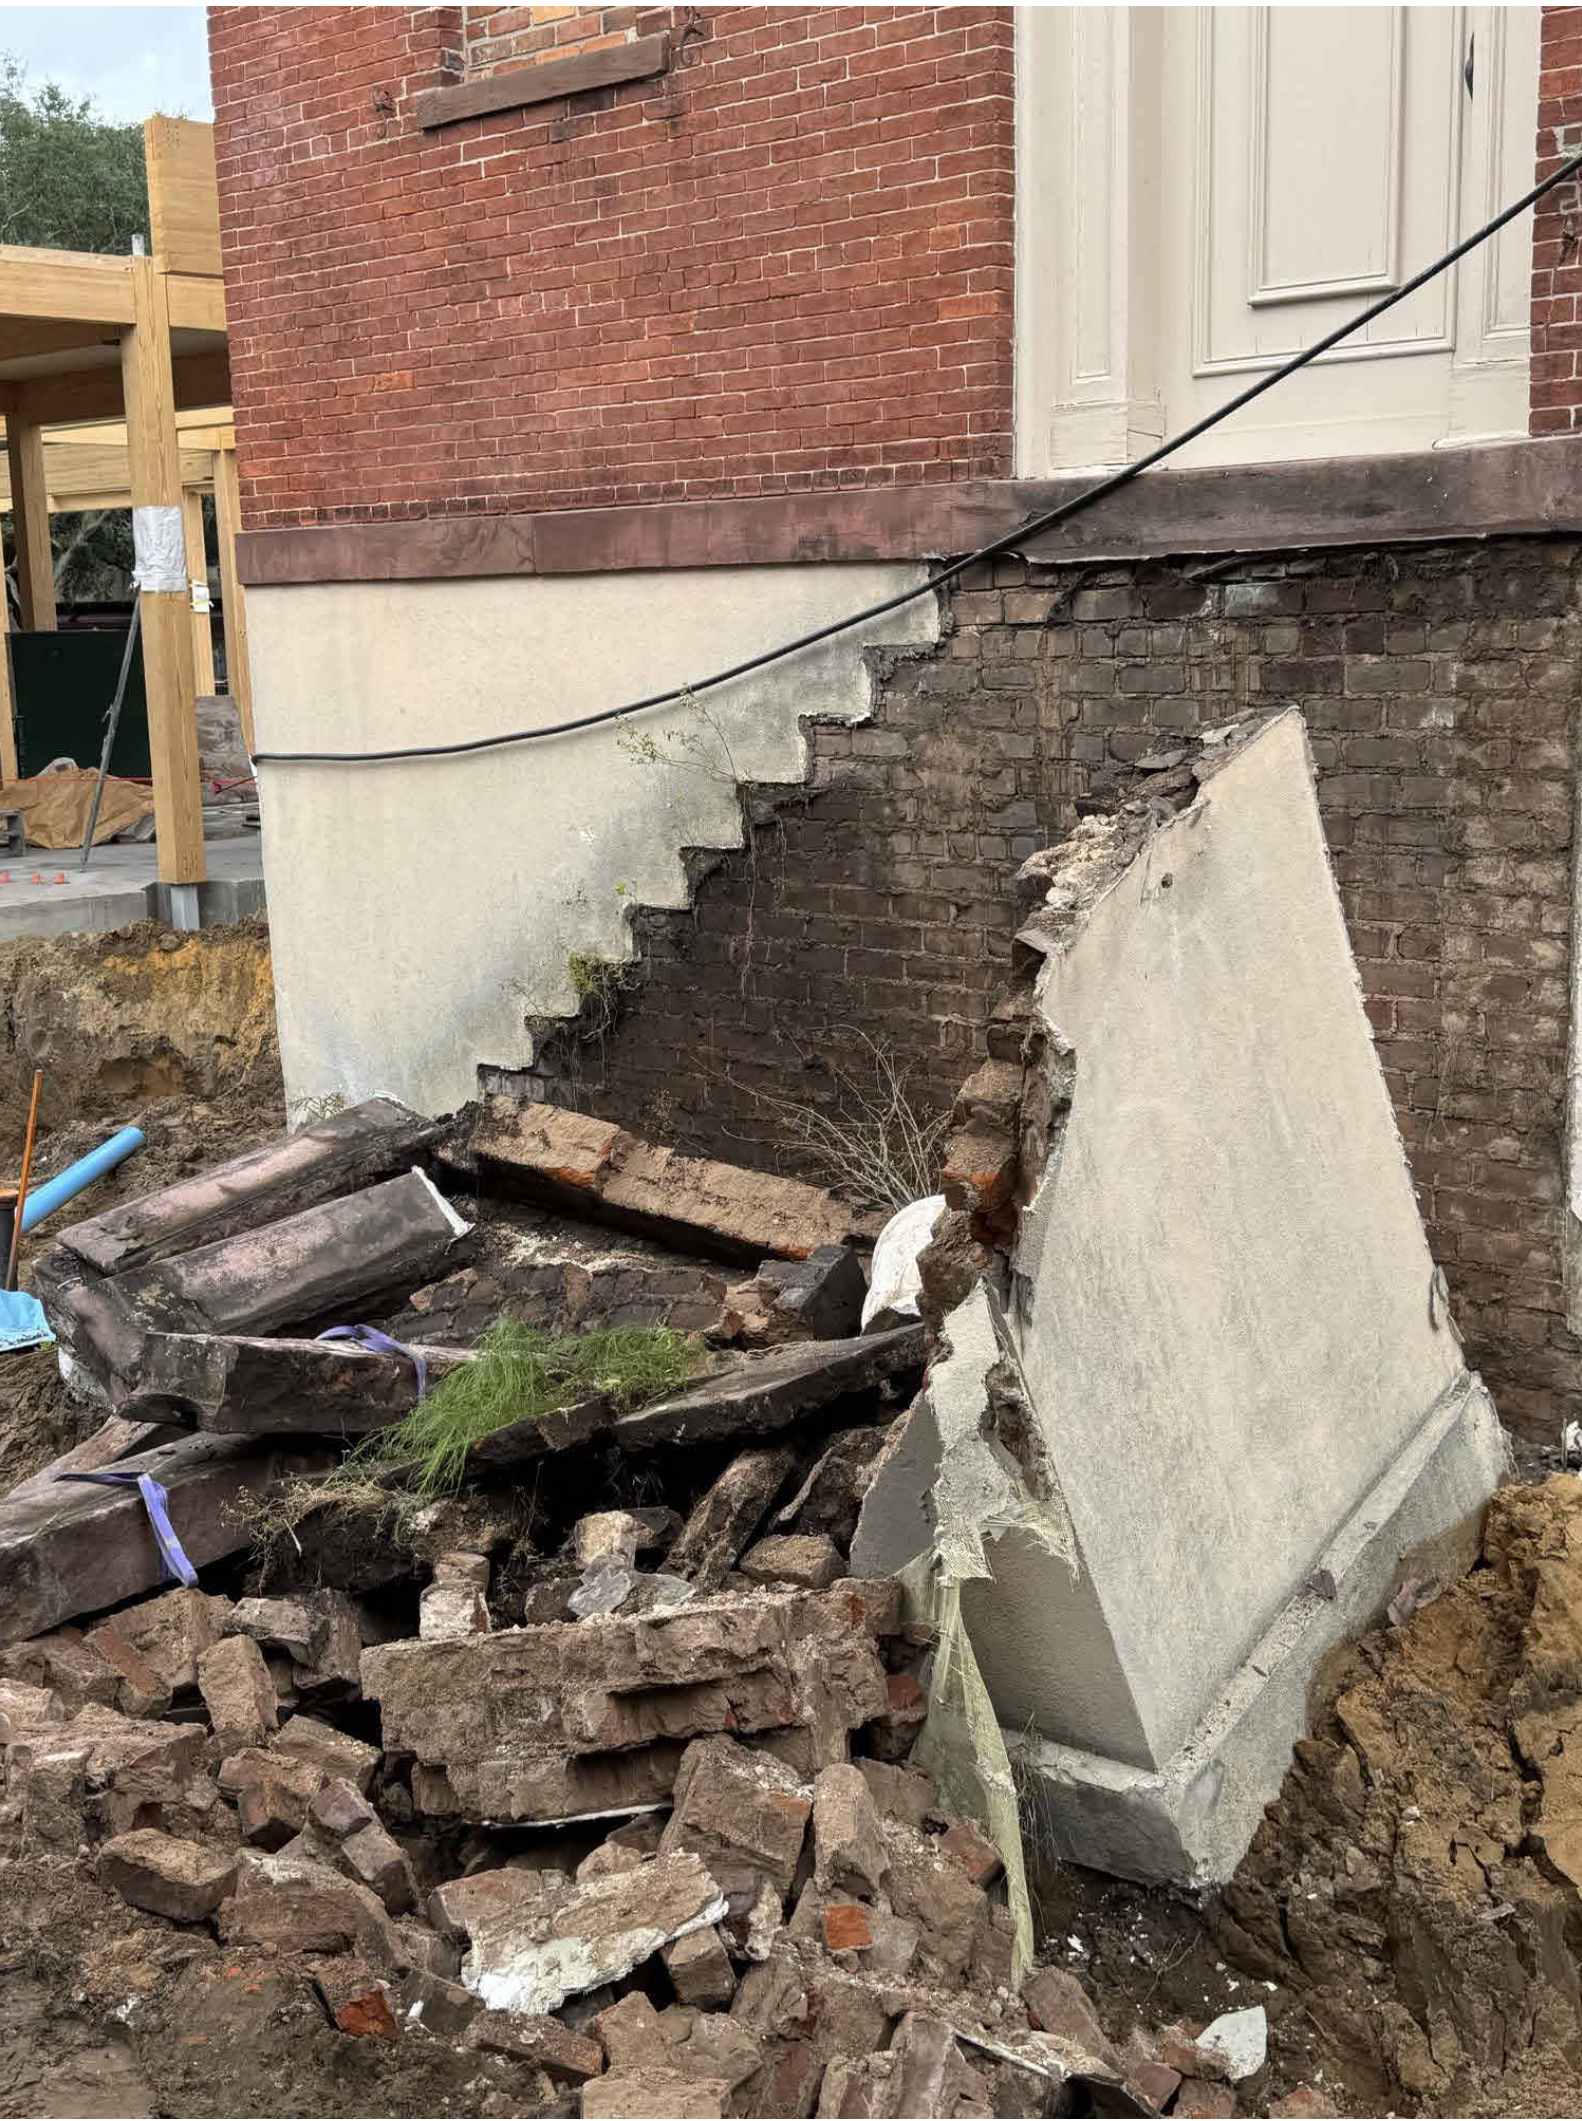
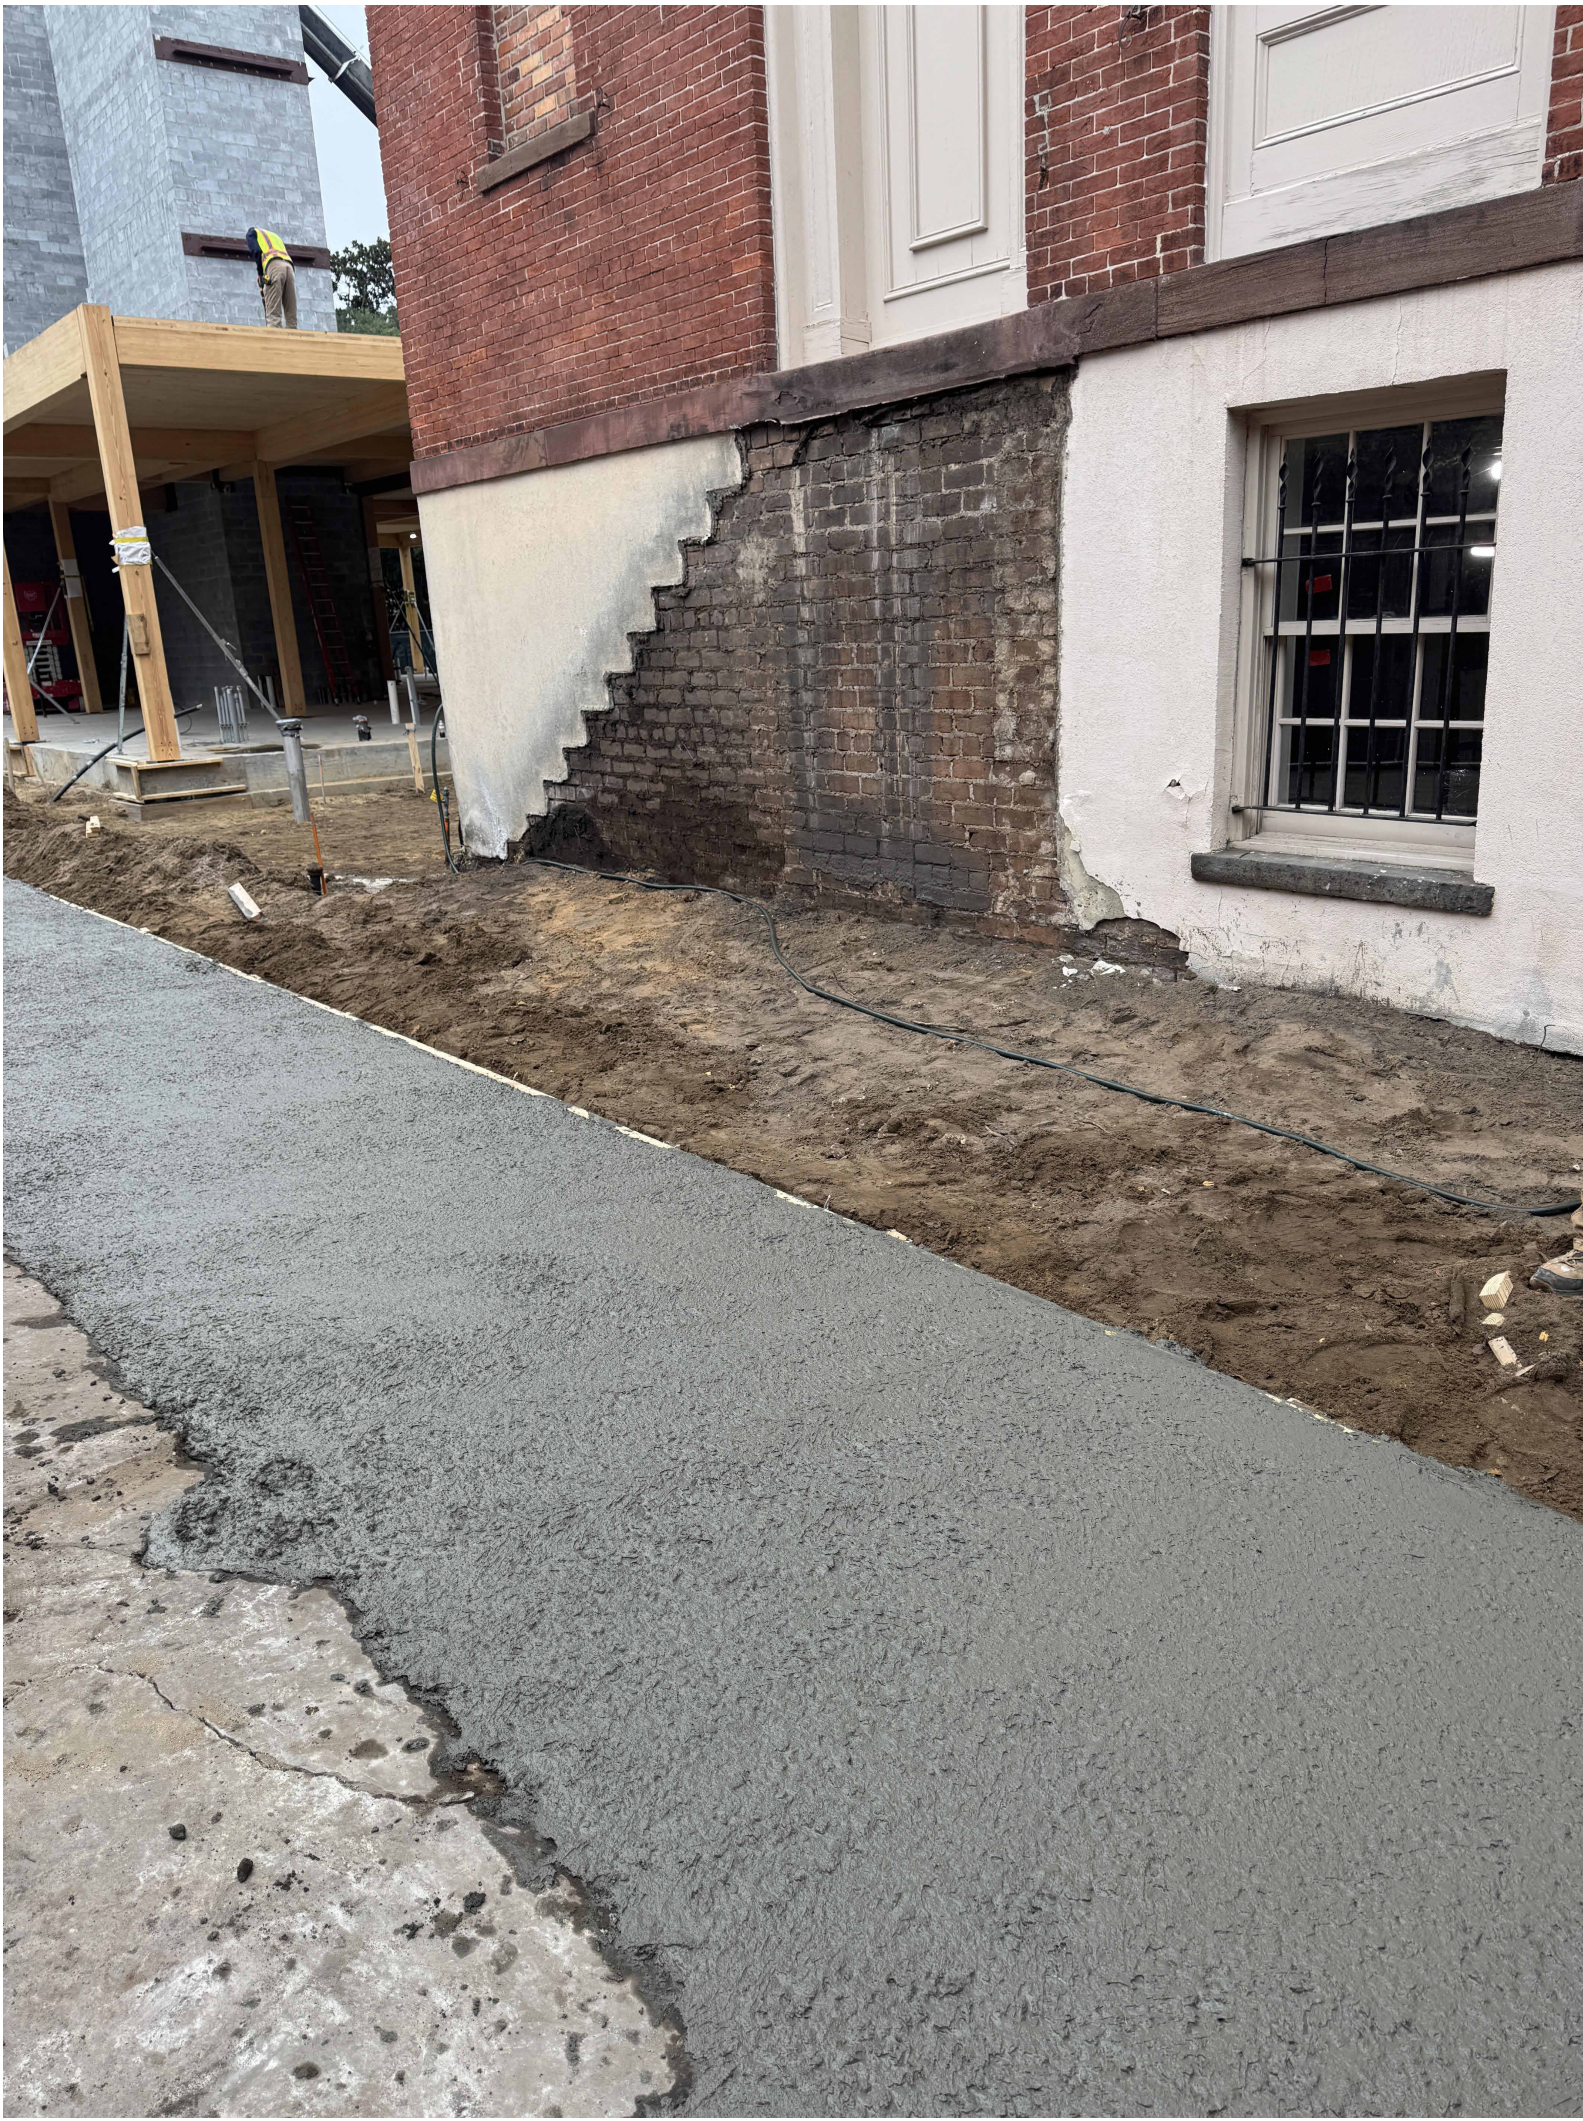
Eastern Excavating, the site contractor was in the process of installing the 4" fire suppression line from Sabal House to the President's Quarters. A trench was excavated south of the existing staircase to install the 4" line, and the site contractor noticed the staircase start to lean slightly to the south. The site contractor braced the staircase with the excavator bucket to try and keep the staircase from falling over. The staircase proceeded to slowly lean outward and eventually fell over and collapsed. The line was dug in the location shown on the civil engineering plans and normal precautions were taken.

During the collapse, we noticed the staircase was originally built with no foundation and was not tied back into the main building. The construction was a combination of stacked brick and fill-dirt.

The stair treads and stair railings were salvaged and stored onsite to use in the reconstruction of the staircase. There were numerous voids in the structure of the stair, leaving the stairs themselves, unsupported in areas.
