**The Noble Hardee House**

3 West Gordon Street  
Savannah, Georgia 31401

**26-000712-COA**

**Exterior Stabilization and Repair - Amendment***Written Project Description*

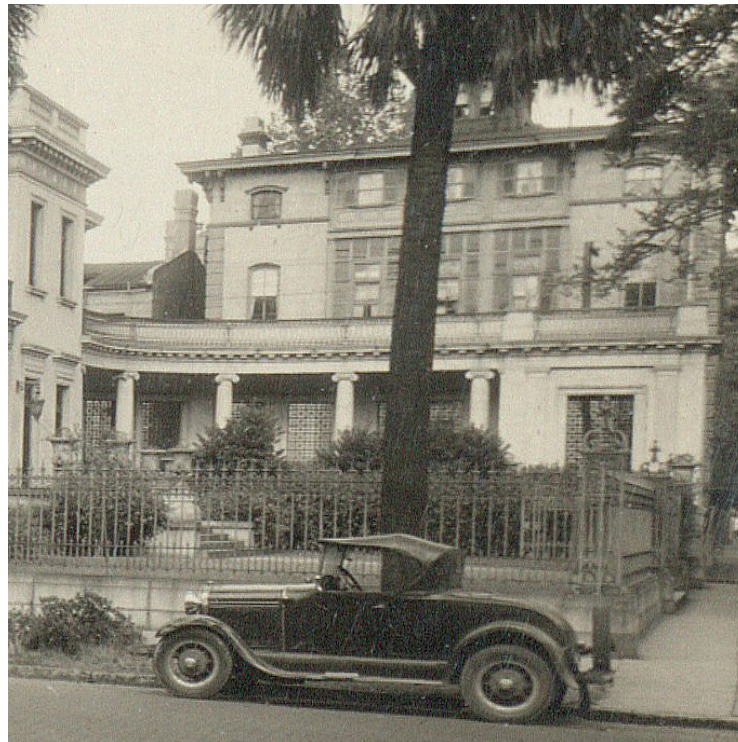
**1940**

The rear facade with the enclosed porch is visible in this photograph with the curved loggia of the Armstrong Mansion in the foreground. Note the vertical paneled wall sections between the louvers on level 2, and the paneled knee wall sections below the windows on level 3. *Georgia Historical Society, Floltz Photography Studio Collection, 1360-03-24-01.*

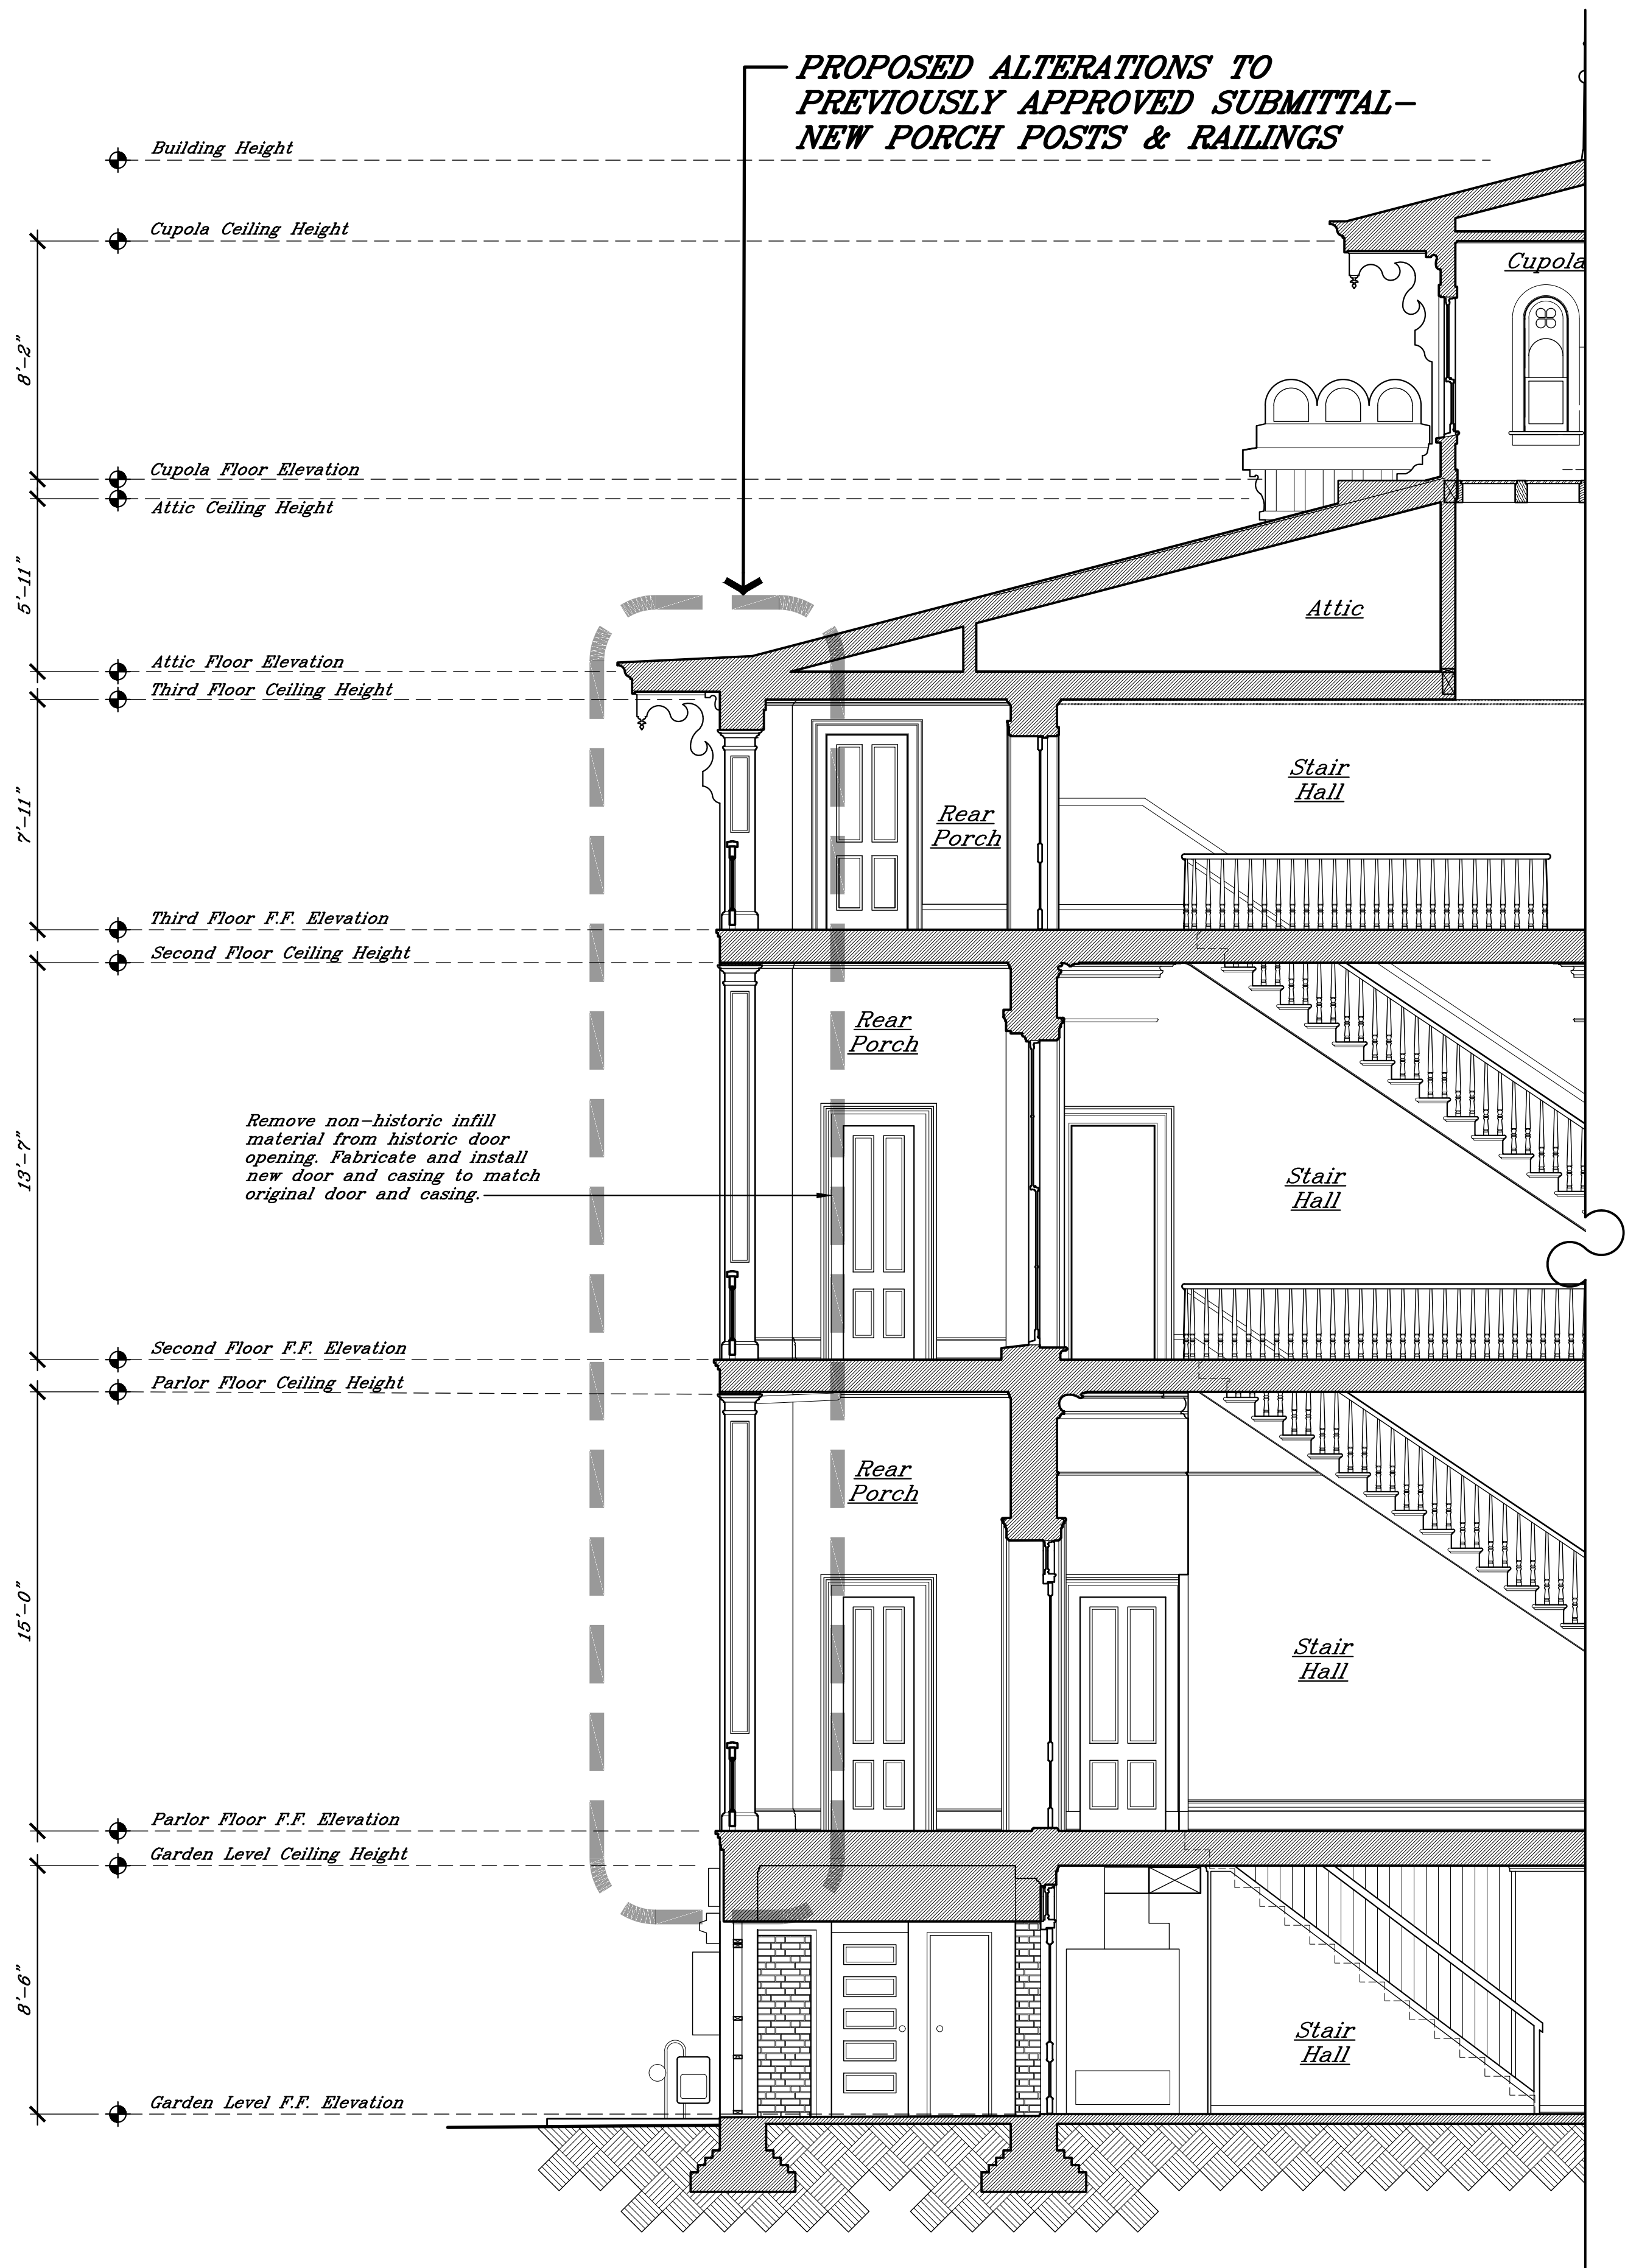
1 BUILDING SECTION LOOKING WEST  
SCALE: 1/4" = 1'-0"

These retained vertical structural elements, which were destabilized by the removal of the porch enclosure in the 1990's, are in poor condition, with visible decay and rot. Additionally, they have shifted out of position over time and have deflected due to their slenderness ratio (the un-braced vertical wall sections are 12-1/2" wide, but only 4" thick, and have a vertical span of 15'-0"). Likewise the existing paneled railings are in a state of active decay, are insufficient for safe vertical loading, and are too short to meet the minimal code requirements for guardrails under the International Residential Code by two inches.

The proposed porch alterations retain the basic configuration that exists today, due to the lack of evidence to indicate the original appearance; however, the panelized porch piers will be increased in their cross section from (11-1/2" x 4") to (11-1/2" x 11-1/2"). The width facing the public lane will be retained, while the side depth will be increased to create a square pier cross-section. Square porch piers are more in keeping with the period of the house and will solve the currently compromised structural condition resulting from the slender posts. The panelized railings will likewise be re-constructed out of solid wood millwork, but slightly thicker than the existing panels to resist lateral forces and deflection over time. They will be 2 inches taller to meet minimum modern safety standards. All new work will be constructed of high grade natural wood millwork. No artificial or synthetic materials are proposed.
