Chatham County, GA

SR 307 Corridor Study Existing Conditions Report

September 2021 © Kimley-Horn and Associates, Inc. 100 Bull Street, Suite 200 Savannah, GA 31401

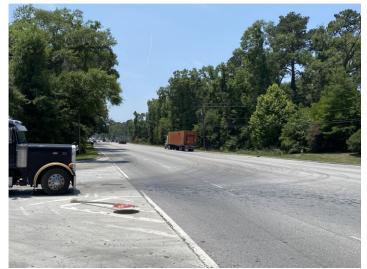
While congestion was observed at its maximum after 5:00 PM on SR 26/US 80/Louisville Road, field observations indicated that queues form and dissipate sooner on southbound SR 307. By 4:15 PM, queueing was observed through the intersection with Distribution Drive on SR 307 (approximately 0.5 miles north of SR 26/US 80/Louisville Road). These queues seemed to align with large exiting passenger car flows from the CenterPoint Intermodal facility on Sonny Perdue Drive and with increased heavy truck activity at the Port of Savannah. Field travel time runs conducted during the same period yielded an average travel speed of 14 MPH between Jimmy DeLoach Parkway and SR 26/US 80/Louisville Road, with most of the delay occurring as part of congestion observed on this segment. Based on field observations, congestion on southbound SR 307 begins to dissipate just after 5:00PM, coinciding with a moderate decrease in truck traffic along the corridor.

Photo: Queueing on Westbound SR 26/US 80/Louisville Road (PM Peak Period)

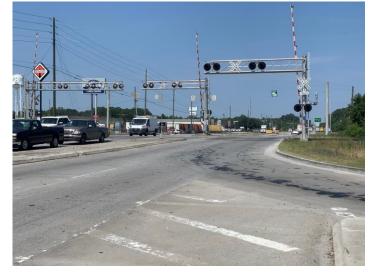
Photo: SR 307 at SR 21/Augusta Road Highway-Rail Grade Crossing (Looking West)

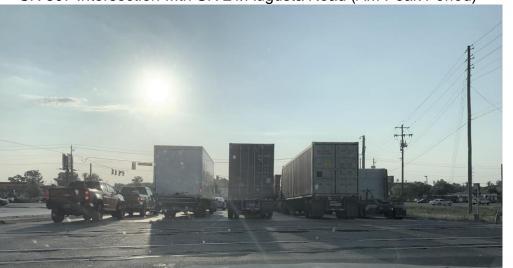
80 MPH. Though only one through train was observed in the field, at USDOT Crossing ID 855067U, these frequent interruptions to through traffic during peak periods of the day likely exacerbate existing operational deficiencies along this segment of the SR 307 corridor. Additionally, the limited spacing between USDOT Crossing ID 632473Y and SR 21/Augusta Road has the potential to present safety concerns, especially in the context of substantial heavy truck traffic.

Photo: Queueing through Highway-Rail Grade Crossing at SR 307 Intersection with SR 21/Augusta Road (AM Peak Period)

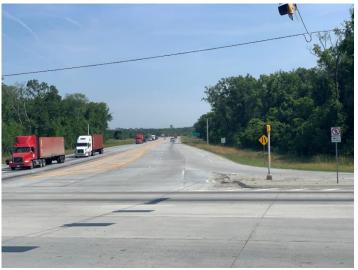
Segment 6 AADT estimates for 2021 range between 6,000 VPD entering/exiting GCT Gate 4 and 13,000 VPD east of SR 21/Augusta Road, with significant heavy truck traffic along the segment between 6:00 AM and 6:00 PM. Based on count data collected as part of this study, the portion of trucks in the traffic stream on this segment plateaus at 80% between 7:00 AM and 5:00 PM before rapidly decreasing to an average of 15% outside this time period. As noted for Segment 5, surges of truck traffic to and from the GCT coincide with elevated commuting traffic volumes on SR 21/Augusta Road and at nearby commercial activity centers (e.g., Circle K gas station and convenience store). Consequently, delay to freight and passenger car traffic on Segment 6 is focused at the intersection with SR 21/Augusta Road – particularly during the PM peak period – where field observations indicated that queues on the westbound approach of SR 307 occasionally extended upwards of 1,000 feet. During this same period, through traffic on westbound SR 307 sometimes requires more than one signal cycle to proceed through the intersection with SR 21/Augusta Road.

Photo: Queueing at SR 307 Intersection with SR 25/Coastal Highway/GCT Gate 4
