Chatham County, GA

SR 25/US 17 Corridor Study Existing Conditions Report

June 2024

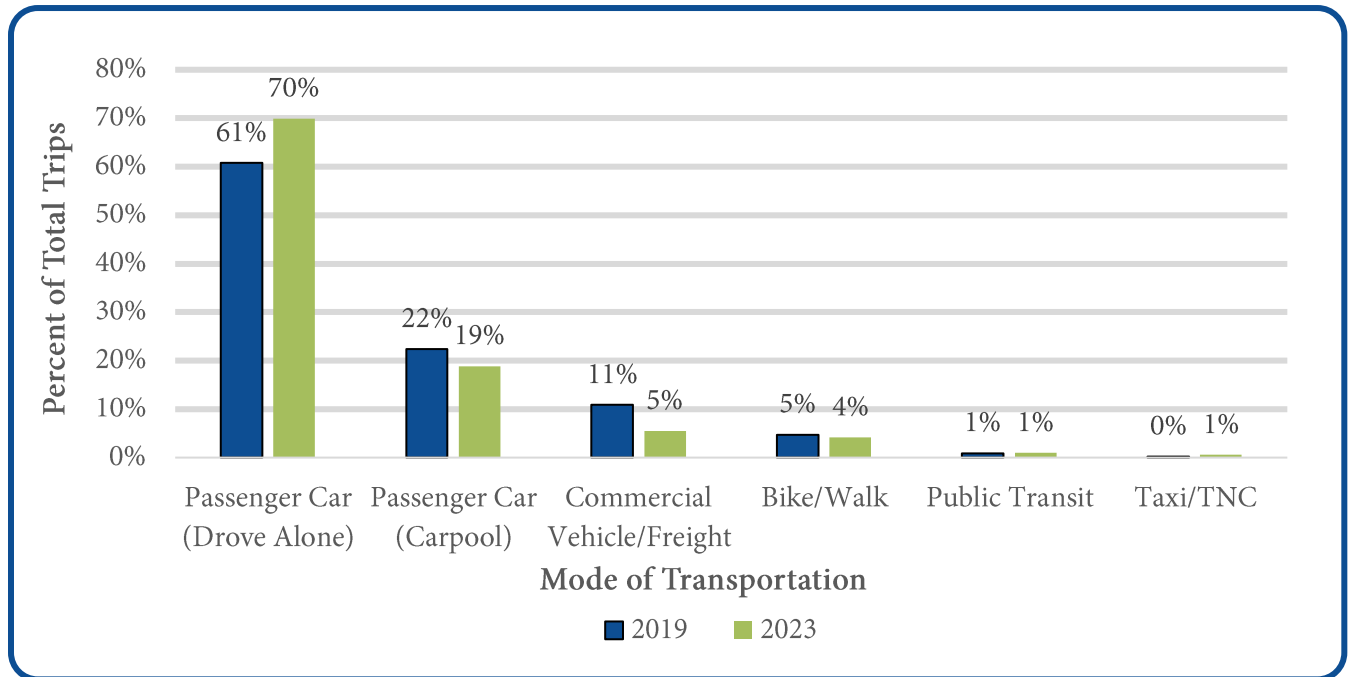
Figure 23 summarizes the primary modes of transportation used through the study area based on data from Replica’s Places dataset. Since 2019, freight trips have represented a decreasing proportion of the trips utilizing the SR 25/US 17 corridor and decreased from 11% in 2019 to 5% in 2023. This modal shift may be attributable to increases in residential development immediately adjacent to the study corridor, while industrial growth in Chatham County has been focused in areas outside the study area. Among the passenger car trips observed, approximately 70% consisted of single occupancy vehicle trips. Trips made via cycling, walking, and transit each constitute less than 5% of all trips made on the SR 25/US 17 corridor.

Figure 23: Existing Trip Characteristics – Mode of Transportation

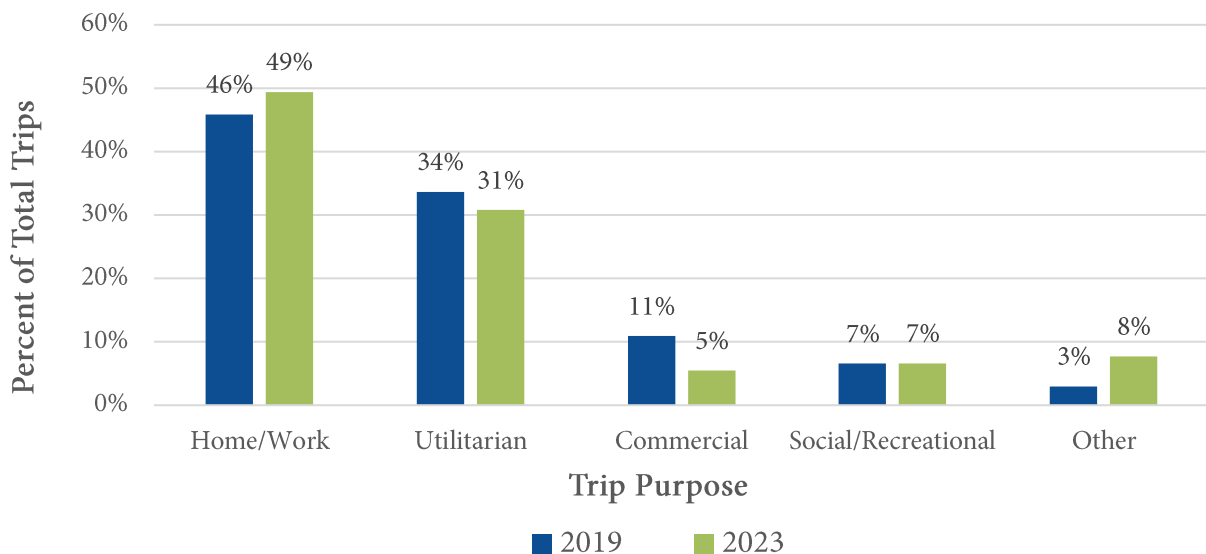
As shown in **Figure 24**, approximately half of all trips made on the SR 25/US 17 corridor are for travel to and from home and work (i.e., commuting), while approximately one-third of all trips have a utilitarian purpose (i.e., pick up/drop off at school, dining, or errands). The SR 25/US 17 corridor is currently used minimally for all other trip purposes. These trends are reflective of the surrounding land use on the corridor, which is predominantly residential with pockets of dense commercial development. As an alternate route to I-95 and I-16, the corridor serves a significant number of commuters to and from downtown Savannah, including those living in Bryan County.

Figure 24: Existing Trip Characteristics – Trip Purpose

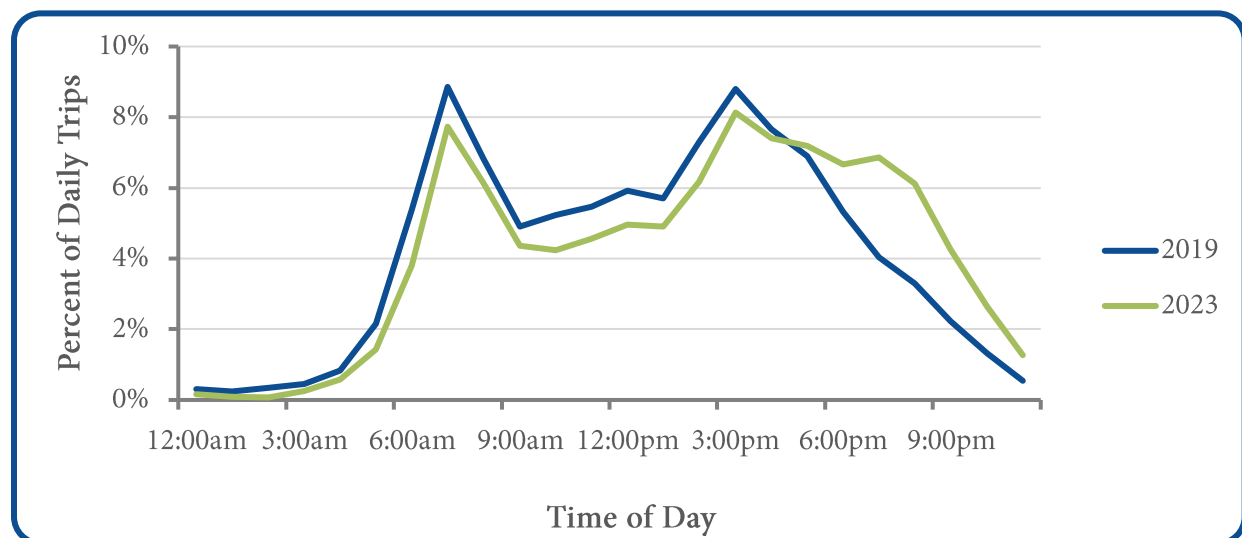
Figure 25 shows the time-of-day distribution for trips utilizing the SR 25/US 17 corridor. The trends depicted in **Figure 25** generally mirror those of the collected traffic count data and summarized in **Section 2.1**. For example, a sharp peak is observed during the AM peak period, then followed by a decrease in demand through the middle of the day and an elongated PM peak period between 3:00 PM and 6:00 PM. Comparing 2019 data to 2023 data, peak trip-making periods have generally decreased, and trips made during the evening hours do not substantially decrease until after 8:00 PM. These trends may be attributable to growth along the corridor and shifts in travel behavior following the COVID-19 pandemic.

Figure 25: Existing Trip Characteristics – Trips by Time of Day

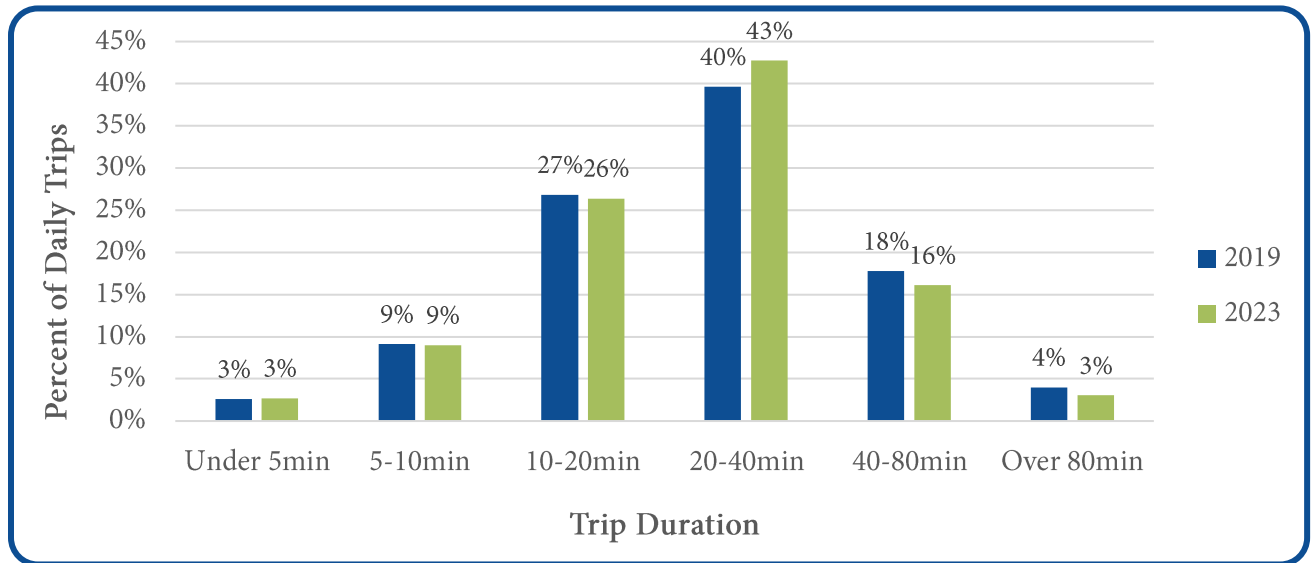
Figure 26: Existing Trip Characteristics – Trip Duration

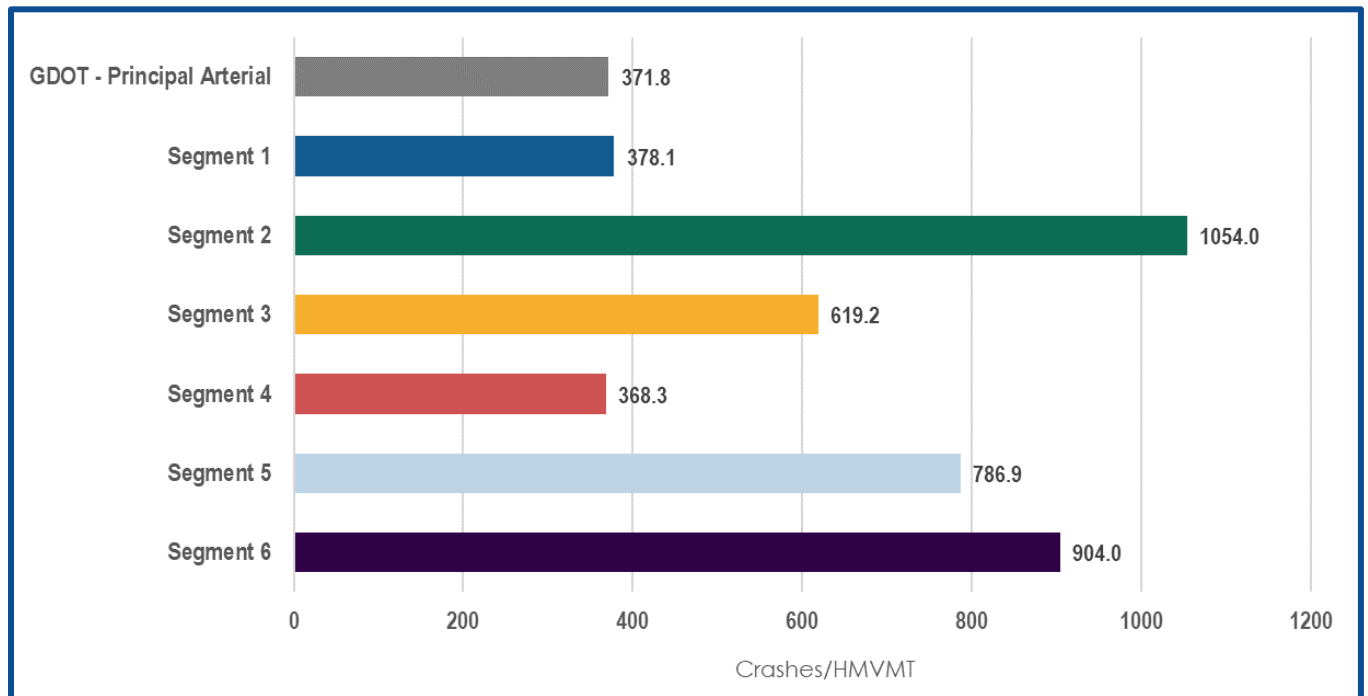
Figure 35: 5-Year Average Crash Rate Comparison by Segment

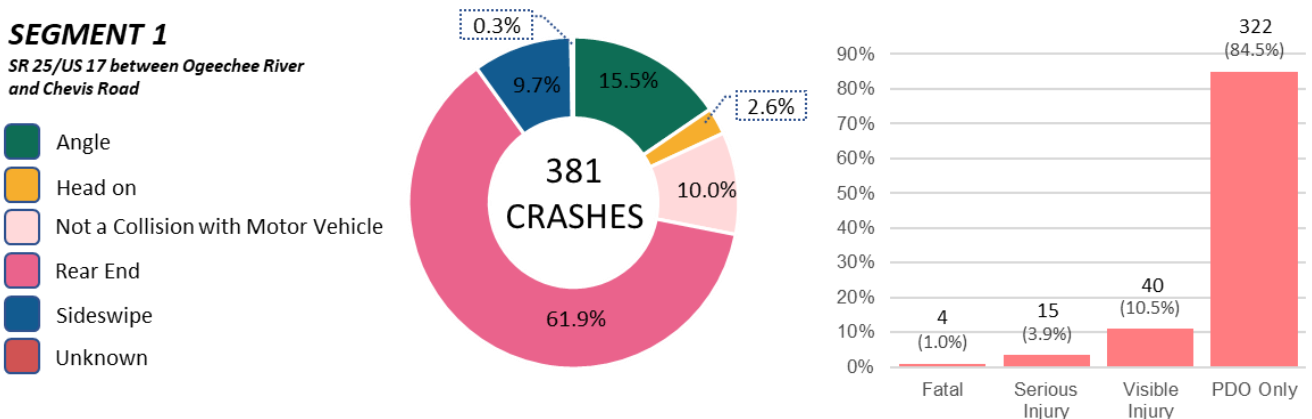
Figure 38: Segment 1 Crash Profile

As shown in **Figure 38**, rear-end crashes (61.9%) were the predominant crash type observed in Segment 1 over the study period followed by angle crashes (15.5%) and single-vehicle crashes (10.0%). Most crashes were property damage only (PDO) (84.5%). This segment exhibited 15 serious injury crashes and four fatal crashes, one of which involved a pedestrian crossing the intersection of SR 25/US 17 with Chevis Road during dark conditions. Crashes occurring along Segment 1 over the five-year study period are displayed in **Figure 39**.

As shown in **Figure 38** and **Figure 39**, 381 crashes were observed throughout Segment 1, primarily at the SR 25/US 17 intersections with Fords Pointe Circle/Bradley Boulevard, Canebrake Road, and Chevis Road. This segment had the highest percentage of single-vehicle crashes among the six

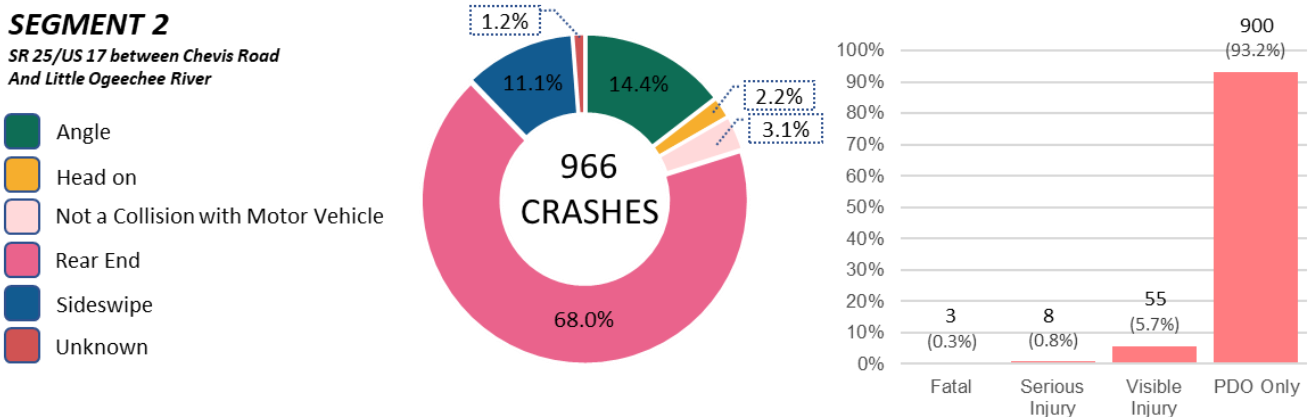
Figure 40: Segment 2 Crash Profile
