# CITY OF SAVANNAH

### REQUEST FOR CERTIFICATE OF APPROPRIATENESS

**MPC File No.:** 26-002108-COA

**Address:** 1706 Ogeechee Road

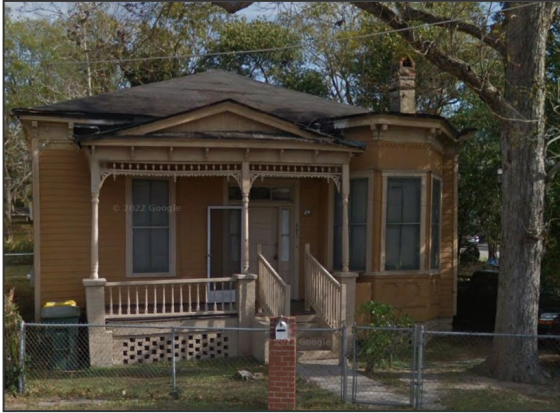
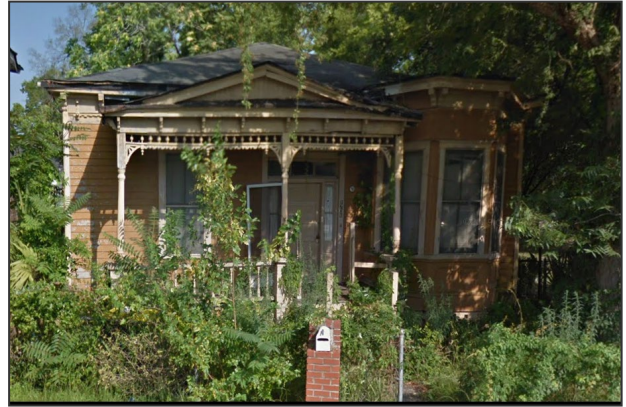
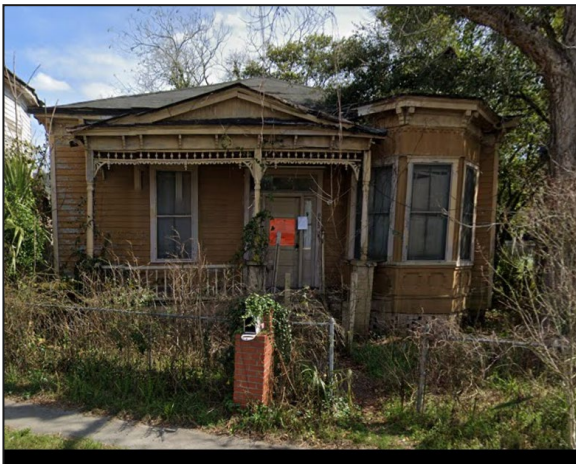
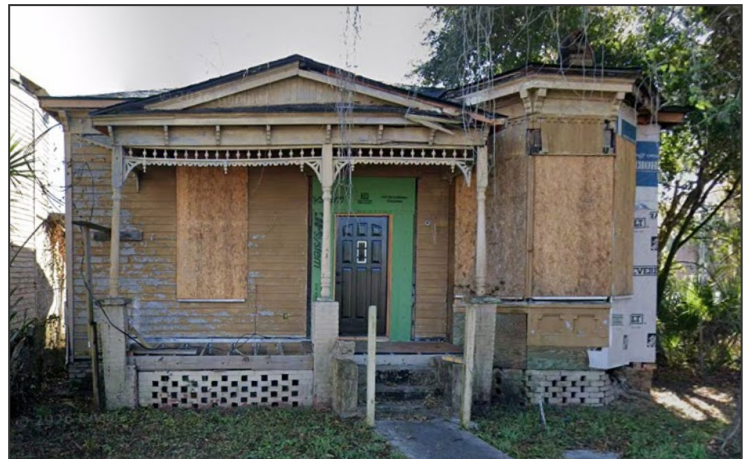
1706 Ogeechee Road was built in 1912 and is a contributing resource within the National Register Cuyler-Brownville Historic District and the local Cuyler-Brownville Historic District. It is situated on a stretch of Ogeechee Road that consists mainly of other residential contributing structures. The house appears to have remained largely in its original condition but has deteriorated over years of vacancy.

The following images from Google Street View show an earlier condition of the building and what it should be restored to. The images are from October 2012, July 2019, March 2022, and November 2025.

The applicant is not proposing any work that would alter the historic character of the house and is not adding any conjectural features. At some point recently, the siding had been removed from the house. In this proposal the plan is to install 3 ½" horizontal lap siding to replace in-kind. The same is true for the deteriorated and missing wood porch elements. The revised submittal packet includes reinstalling stairs and railings in-kind.

The porch is in need of rehabilitation in various areas. The wood decking is gone and will be replaced in kind, there is also rotted trim that will be replaced in kind. The porch railings and balusters will be replaced as seen in photos as well as the handrails for the steps. This work meets the standard.

- 1. Install the replacement siding to match the reveal of what is seen in Google Street View photos from when the siding was still intact.**
- 2. Ensure that the wood siding is painted to maintain the character of the house and surrounding contributing resources.**

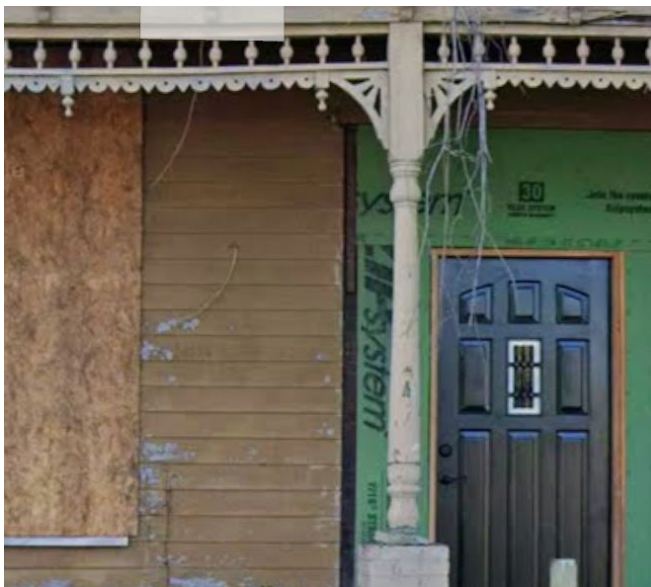
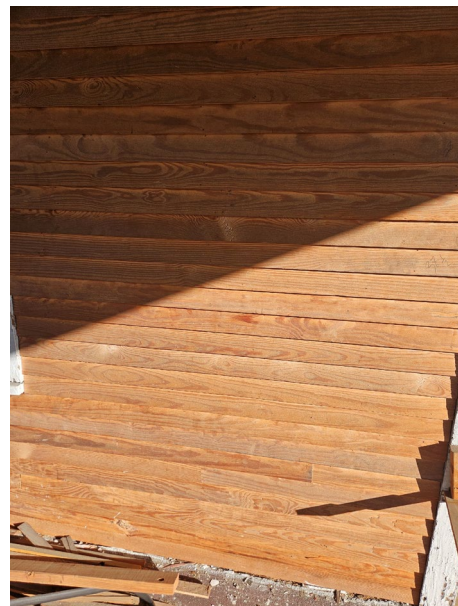
The applicant did not acquire the property until after the siding had been removed, and thus he did not have anything more detailed than what is seen on the Google Street view images. 3 1/2" siding from Guerry Lumber had been installed on a nearby rehabilitation site at 2101 Ogeechee Road which photos were provided to give detail on what is proposed as the replacement siding, which visually appears to be a size match (see below images) but staff recommends installing the siding in a manner consistent with the Street View photos which appears to be a different reveal than the 2101 Ogeechee Road siding.

For the siding, though color is not reviewed in this district, staff recommends that the wood is painted rather than left bare like what is seen at 2101 Ogeechee Road, to be more visually compatible with the neighborhood and of a Queen Anne type of house.

All of the siding was removed. The plan is to reinstall the same wood that was there. The applicant provided information about another recent project nearby at 2101 Ogeechee Road, where the size seems to be accurate to the photos but the reveal should be followed as seen in the Google Street View photos rather than what was done at 2101 Ogeechee Road.
