## 214 West Bolton Street

(PIN: 20044 09006)

### Project Description

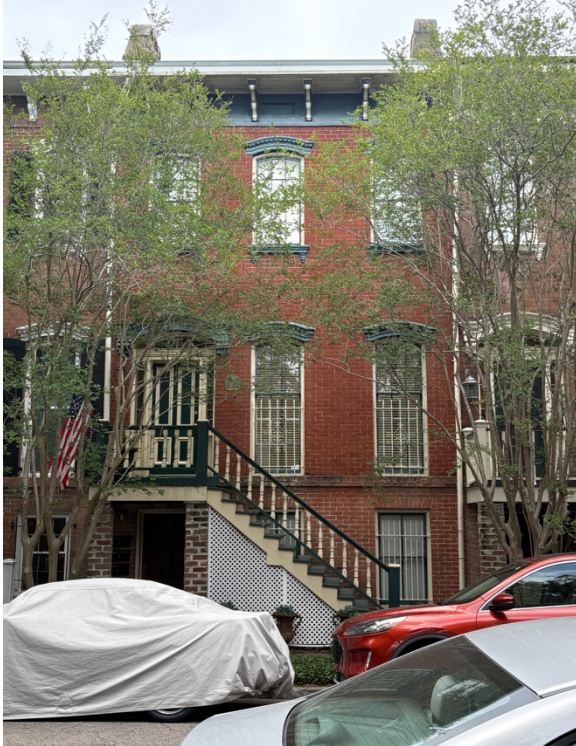
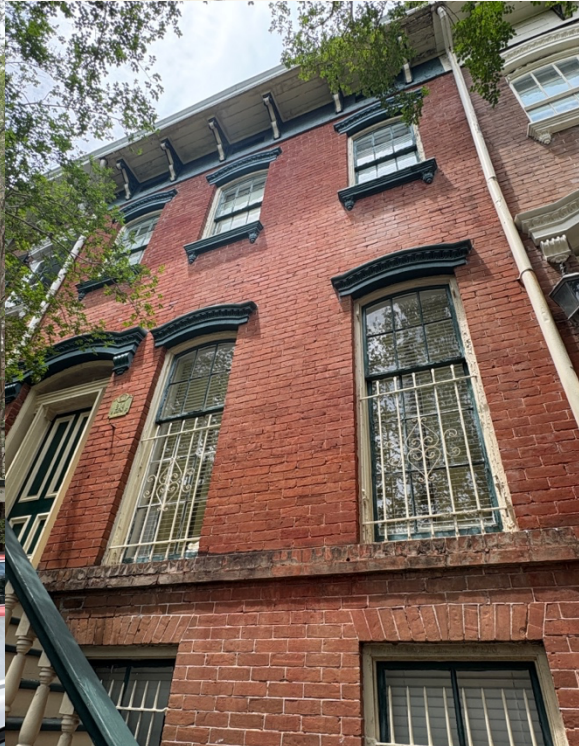
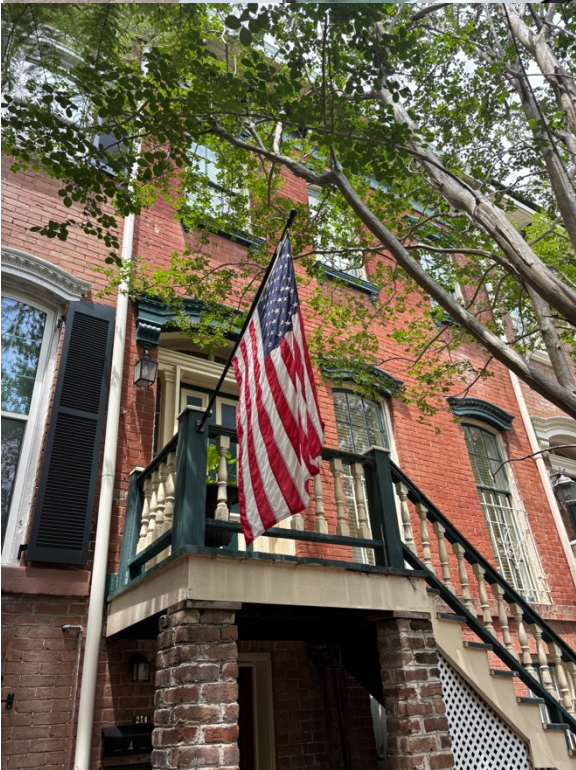
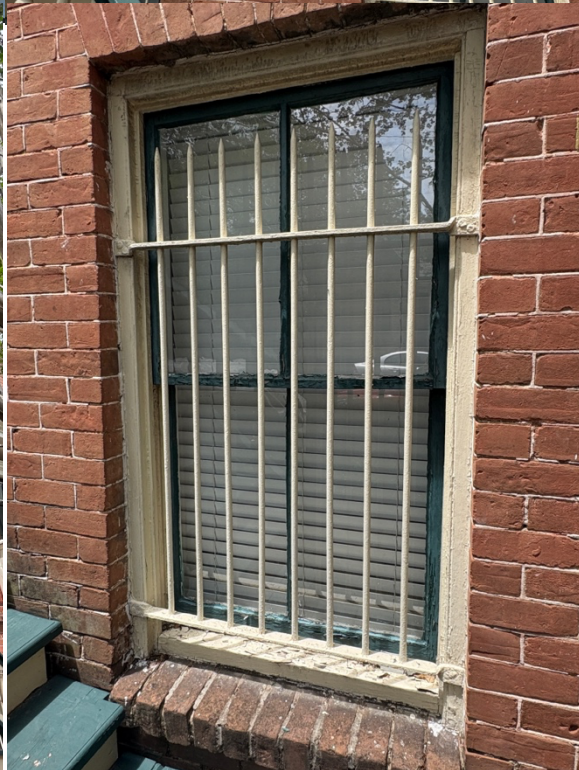
The project consists of window repair on the seven (7) single pane true divided lite wood windows located on the façade, which faces West Bolton Street to the south. Overall, the windows are in fair condition, although paint is flaking off and the glazing is either missing or failing. A few mullions are also missing or broken.

See page 2 for photos of the façade of 214 West Bolton Street and a detail shot of a garden level window. Note the failing glazing and peeling paint visible.

Each window will be removed, labelled so its original location is known, and have the glazing and paint scraped off by hand. Broken or missing mullions will be replaced in kind with matching custom-milled wood pieces. The units will be reglazed and painted before they are reinstalled in their original openings. All window units will be operational after they are reinstalled.

The decorative metal grates will be removed to allow access to the windows and reinstalled after the windows are back in place. The grates will be lightly sanded to remove any rust and flaking paint before being repainted, prior to their reinstallation.
