S A V A N N A H   H I S T O R I C   D I S T R I C T  
B O A R D   O F   R E V I E W

**REQUEST FOR CERTIFICATE OF APPROPRIATENESS**

**MPC File No.:** 26-002466-COA

**Address:** 512 East Hall Street

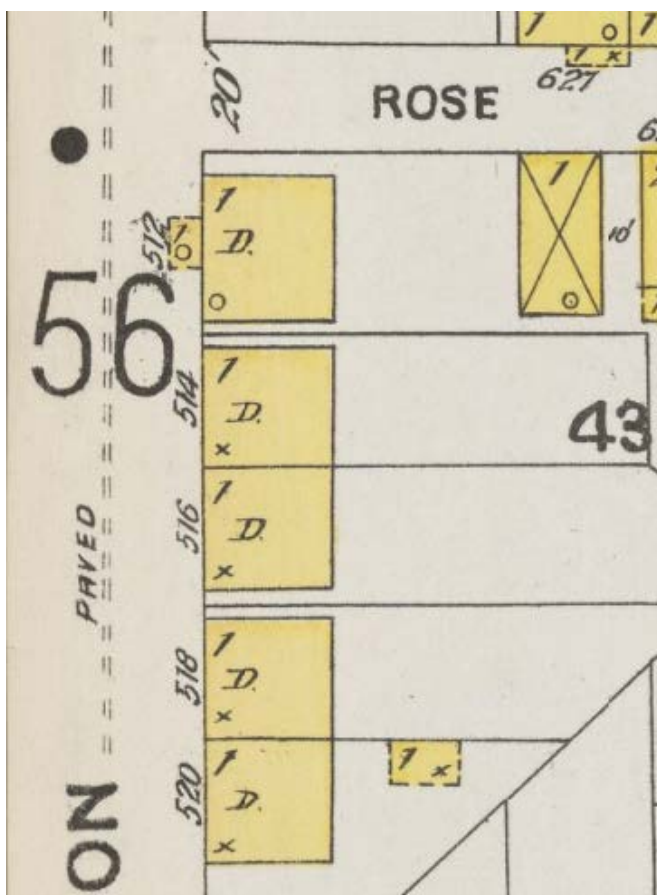
2. The 1898 Sanborn, subject property at the top showing a front porch

Historic Sanborn Maps show some alterations were made in the years after construction, specifically, a front porch appears in the 1898 map, a rear porch appears in the 1916 map, and the rear porch appears to have been enlarged by the 1955 map. At no point does it specifically show an exterior chimney being added. Additionally, the Cadastral Survey conducted in 1937 shows that there was no exterior chimney at that time. Finally, the Georgia Historic Resources survey, conducted in 2000, notes that the building was renovated and altered in 1960, although it does not provide details on the changes that were made. At some point, the front porch was enlarged and enclosed and the house was covered in a brick veneer, and it is possible that these were the 1960 alterations referenced by the survey, although this is unclear. It is also possible that this is when the chimney was added, but this is also unclear, as the earliest definitive photographic evidence that we have for the existence of the chimney is a 2000 image that was included in the GHR survey. At some point between 2007 and 2012, the porch enclosure and the brick veneer were removed, bringing the house closer to its historic configuration.

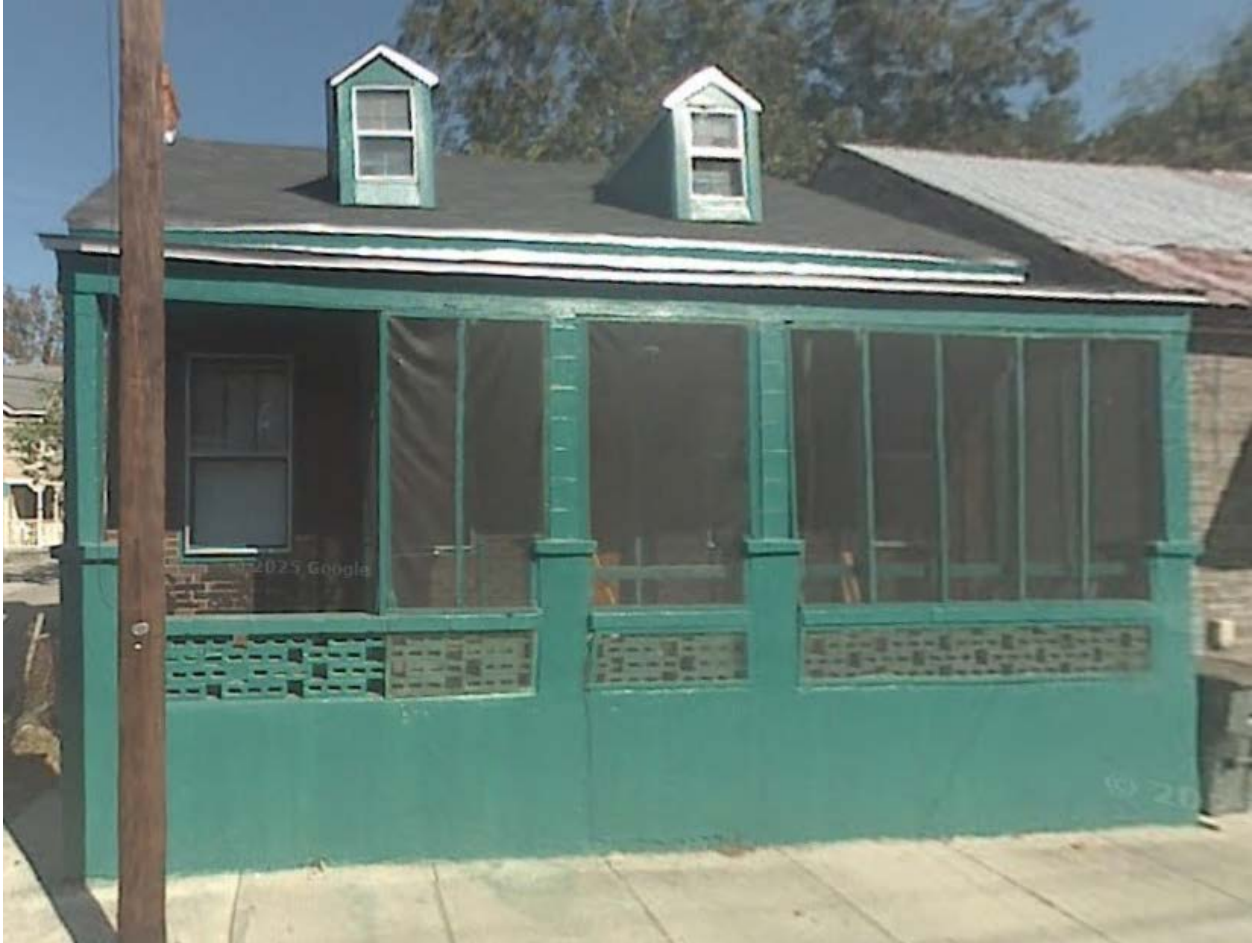
6. Google Street View from 2007 showing the altered porch, color, and brick veneer before being restored to its more historically appropriate form. The brick veneer wrapped around the entire house

The house has undergone multiple changes in its lifetime in multiple different stages. Both the front and rear porches were added and expanded at different times respectively, and the exterior has been covered, uncovered, and had its color changed as well. Available evidence shows that this chimney was among these later changes that did not gain historical significance in its own right.

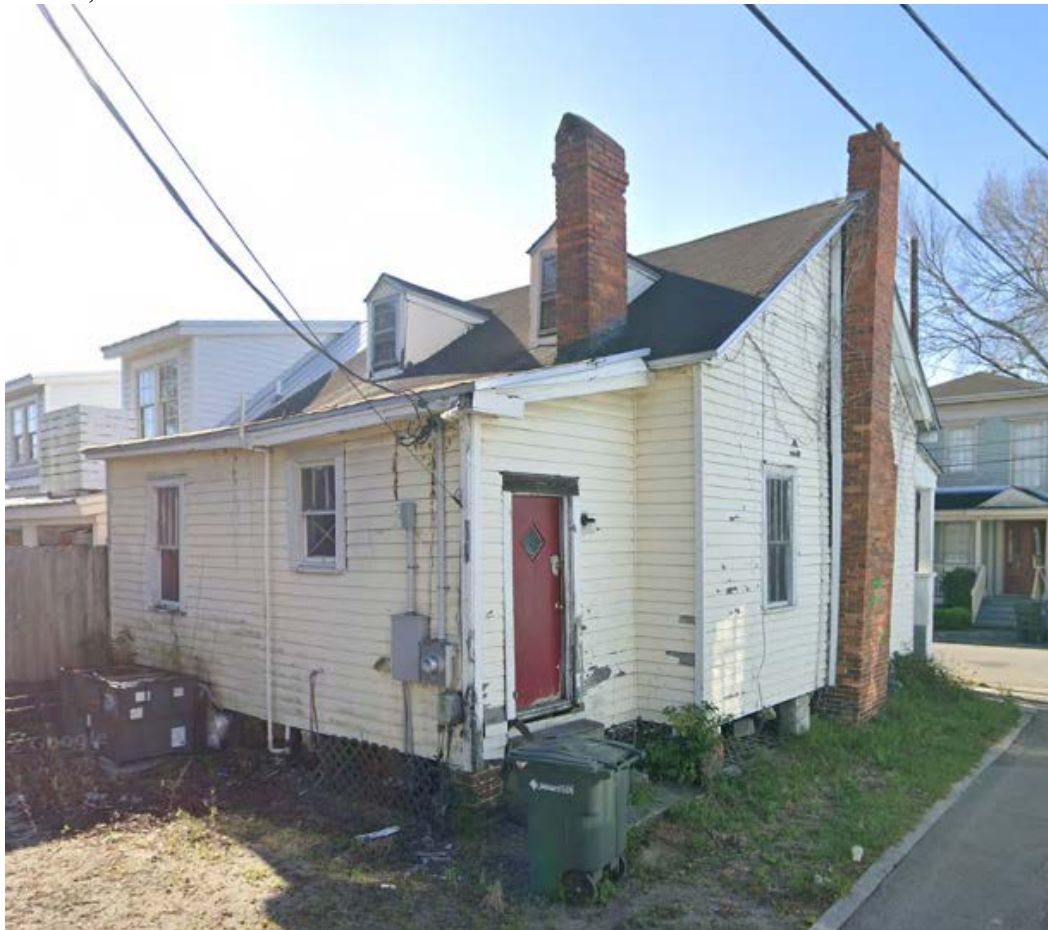
The chimney, although seemingly made of old bricks, was not historic to the home, as shown in the Sanborn Maps and the Cadastral Survey. Also, among its neighboring houses, many of which were built around the same time, it was the only one to have this exterior chimney, as all the other homes (including this one) have interior chimneys. It was removed because it was an immediate safety hazard, and it should not need to be rebuilt.

**7. Photo showing the unoriginal exterior chimney and the interior chimney, most likely original**

As noted by Code Compliance and shown in photographs provided by the applicant, the chimney was detaching from the side of the house and was an immediate hazard. Documentary and pictorial evidence shows that this chimney for at least the first 60 years of the home's existence, likely almost the first 80 years of its existence. Therefore, the homeowner should not be mandated to rebuild it.

**Approve the After-the-Fact chimney demolition at 512 East Hall Street because it was a safety hazard that required immediate demolition. Also, staff recommends that the applicant not be made to rebuild the chimney because it was not historic, had not achieved historic status in and of itself, and is not in keeping with the character of the surrounding area.**

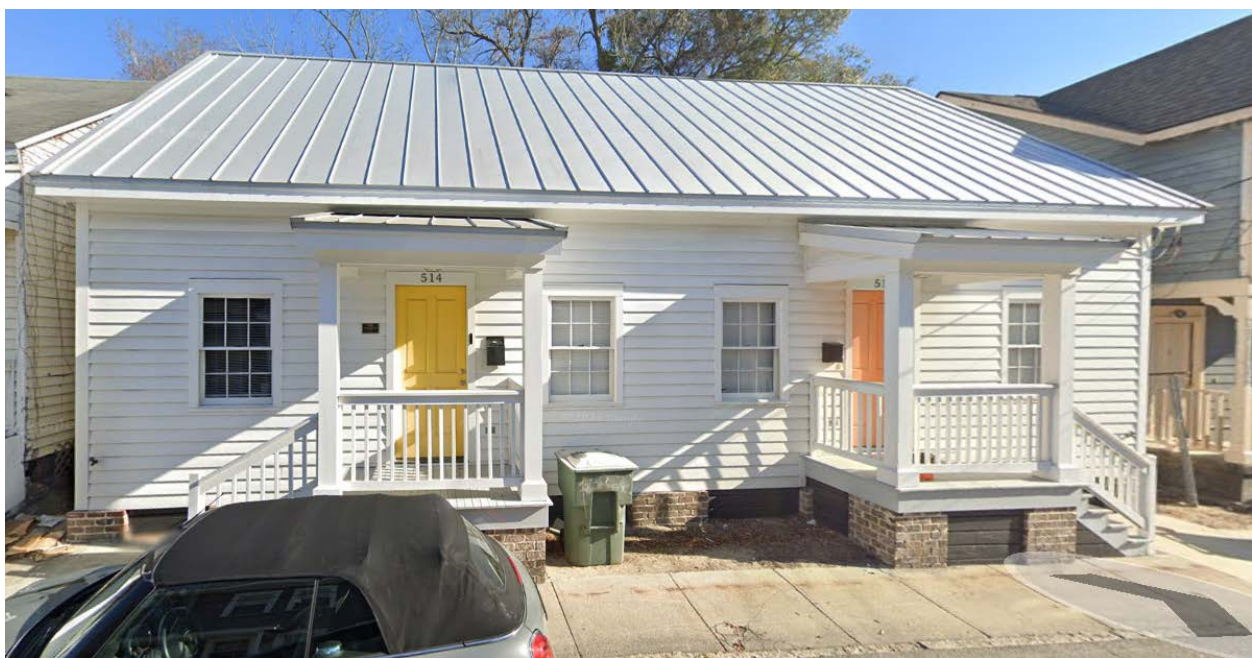
**8. 514-516 East Hall, adjacent to the east, built in the same year without exterior chimney**

Within this part of the Beach Institute Character area, houses of similar styles and ages do not have exterior chimneys, but rather interior chimneys. The exterior chimney on this house was the outlier in the area and wouldn't be considered visually compatible if newly proposed today.

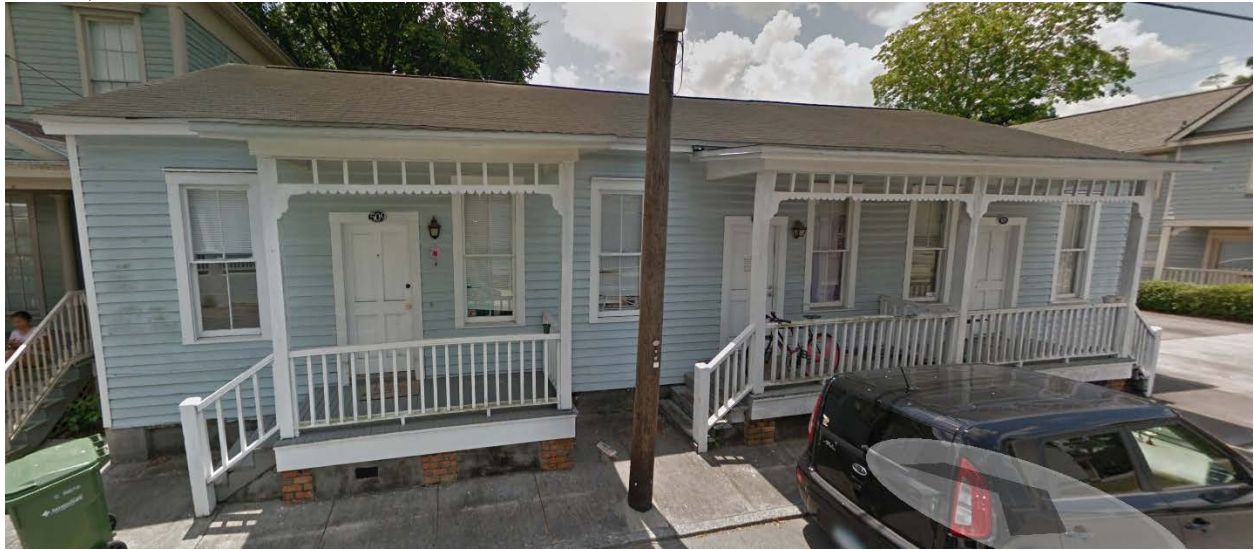
9. 505-509 East Hall, across the street, built in 1888 without exterior chimney

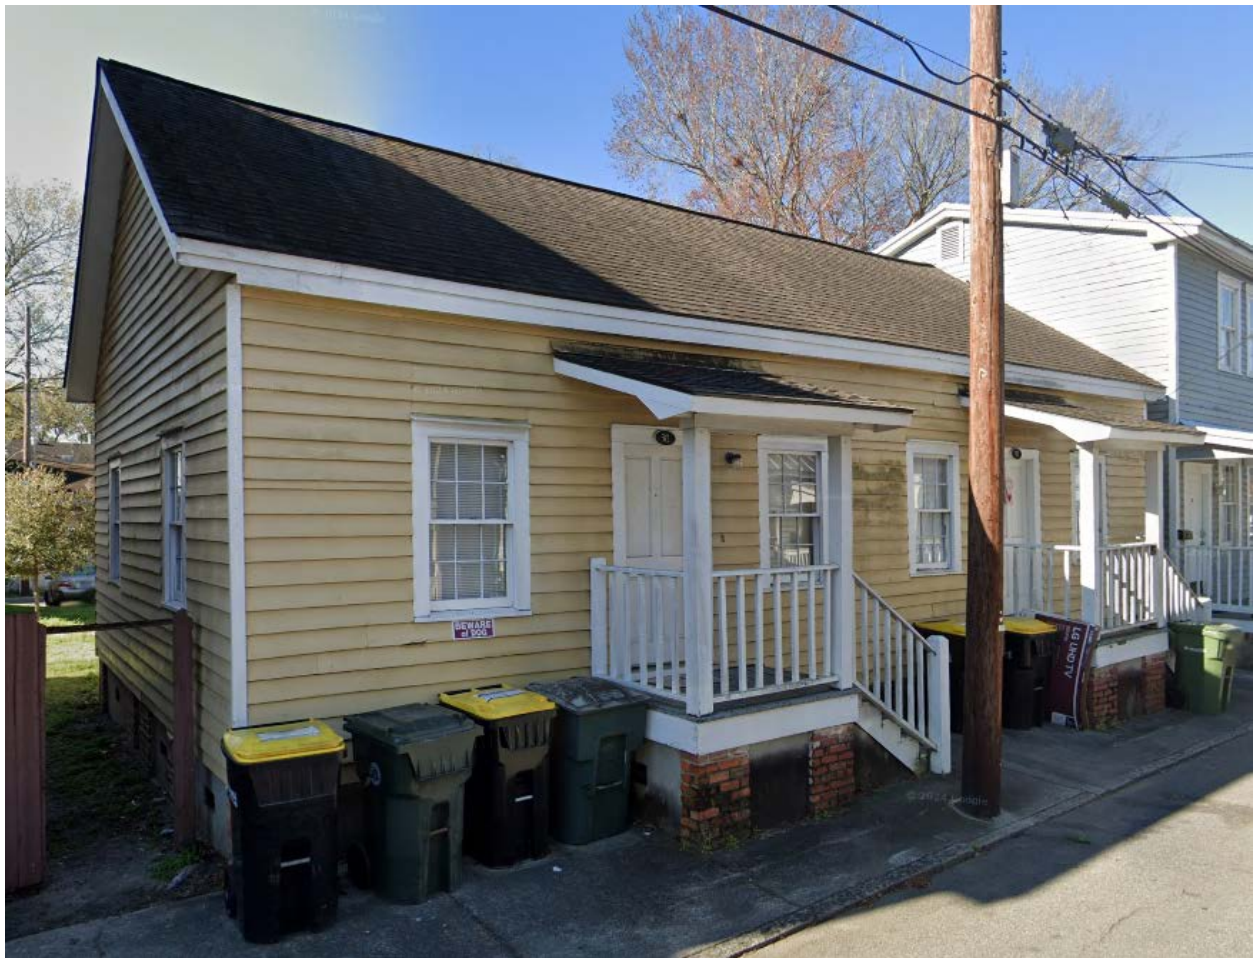
10. 515-517 East Hall, across the street, built in 1867 without exterior chimney
