## **Project Description of 206 E. Gwinnett Street — Fire Escape Repair**

Project:  
FIRE ESCAPE REPAIR

206 E Gwinett St.  
Savannah GA, 31405

ELEVATION  
A-1.3

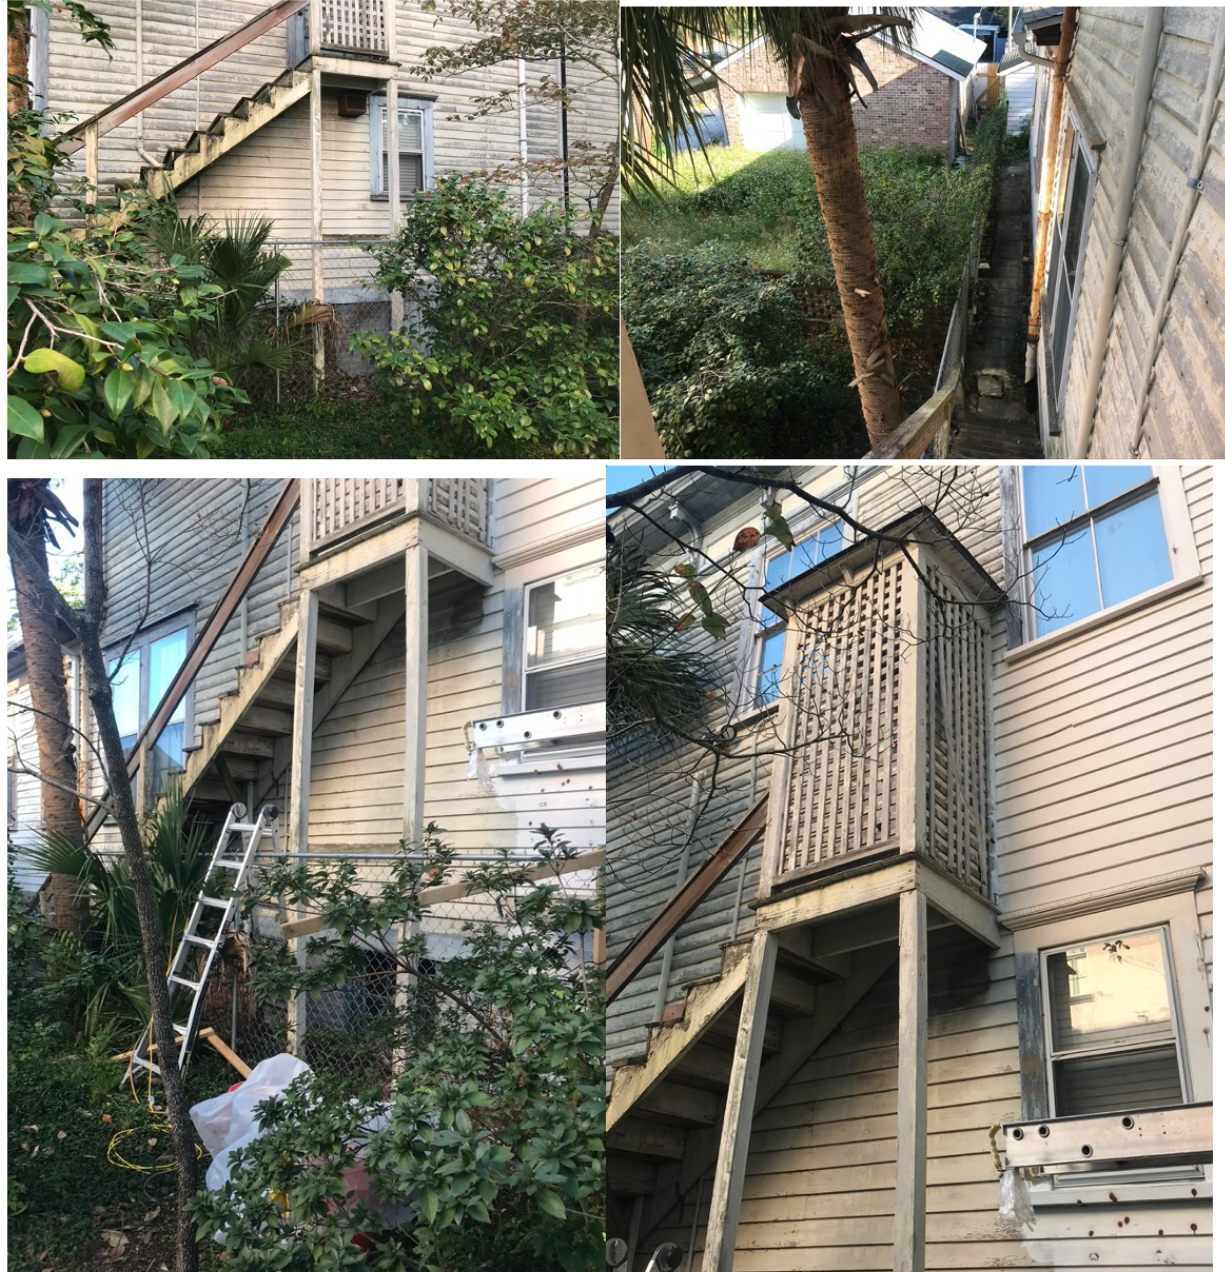
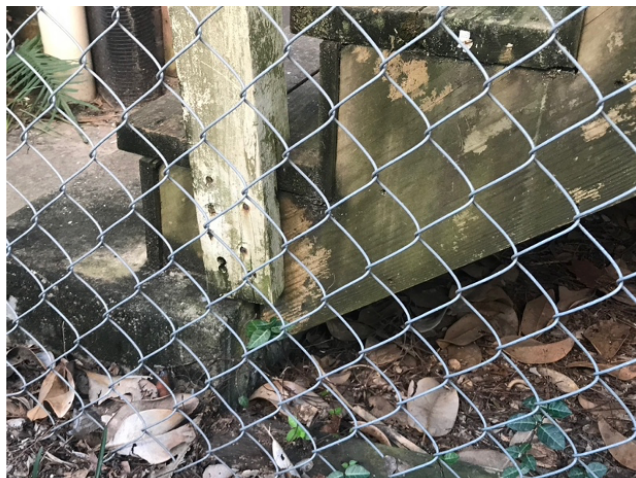
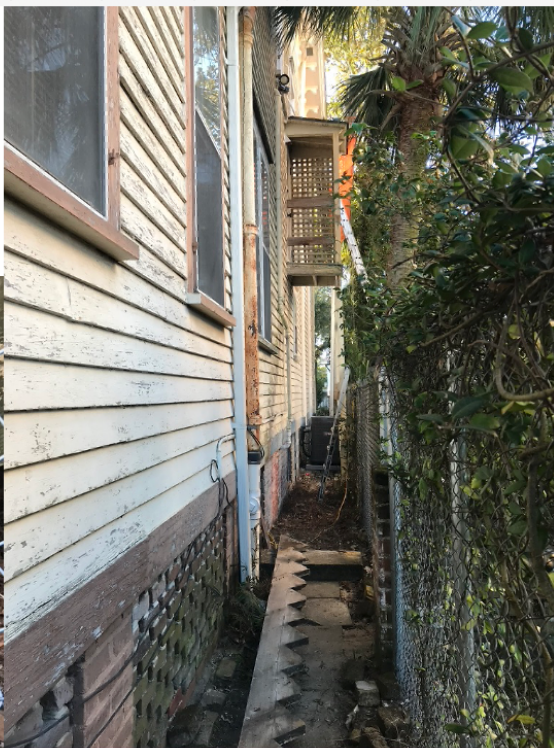
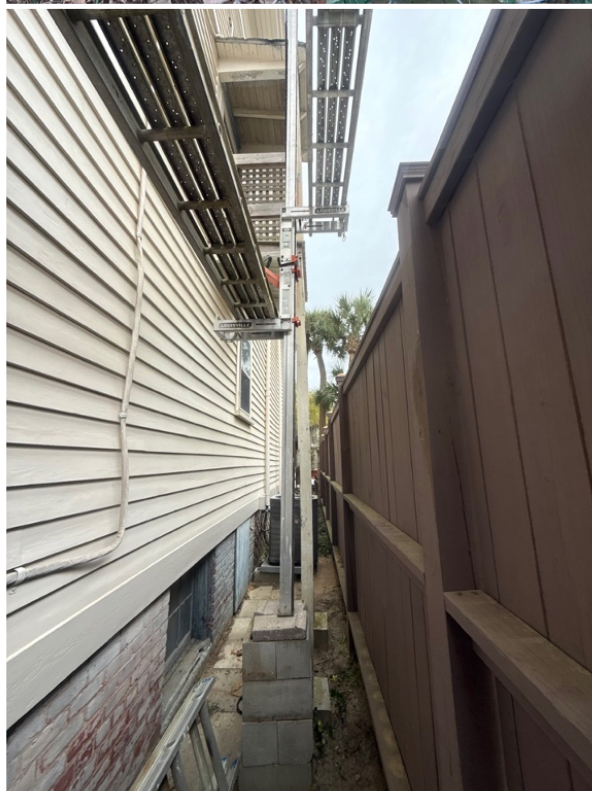
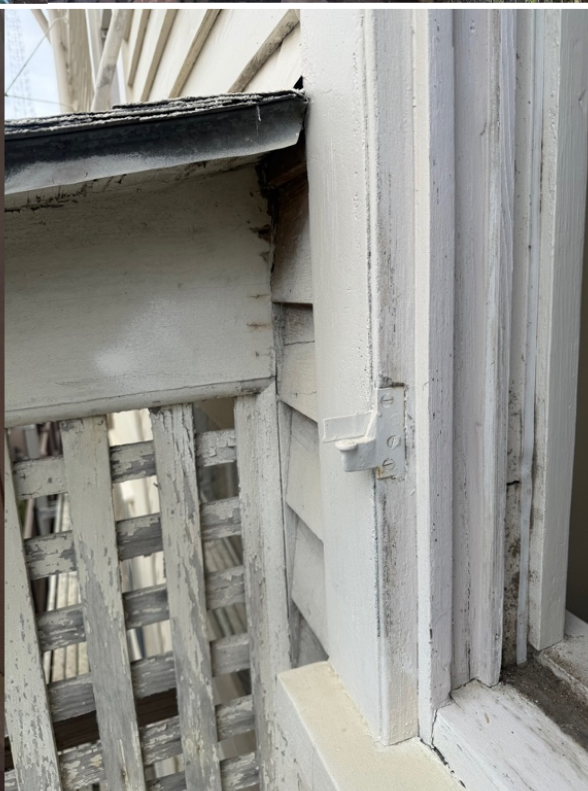
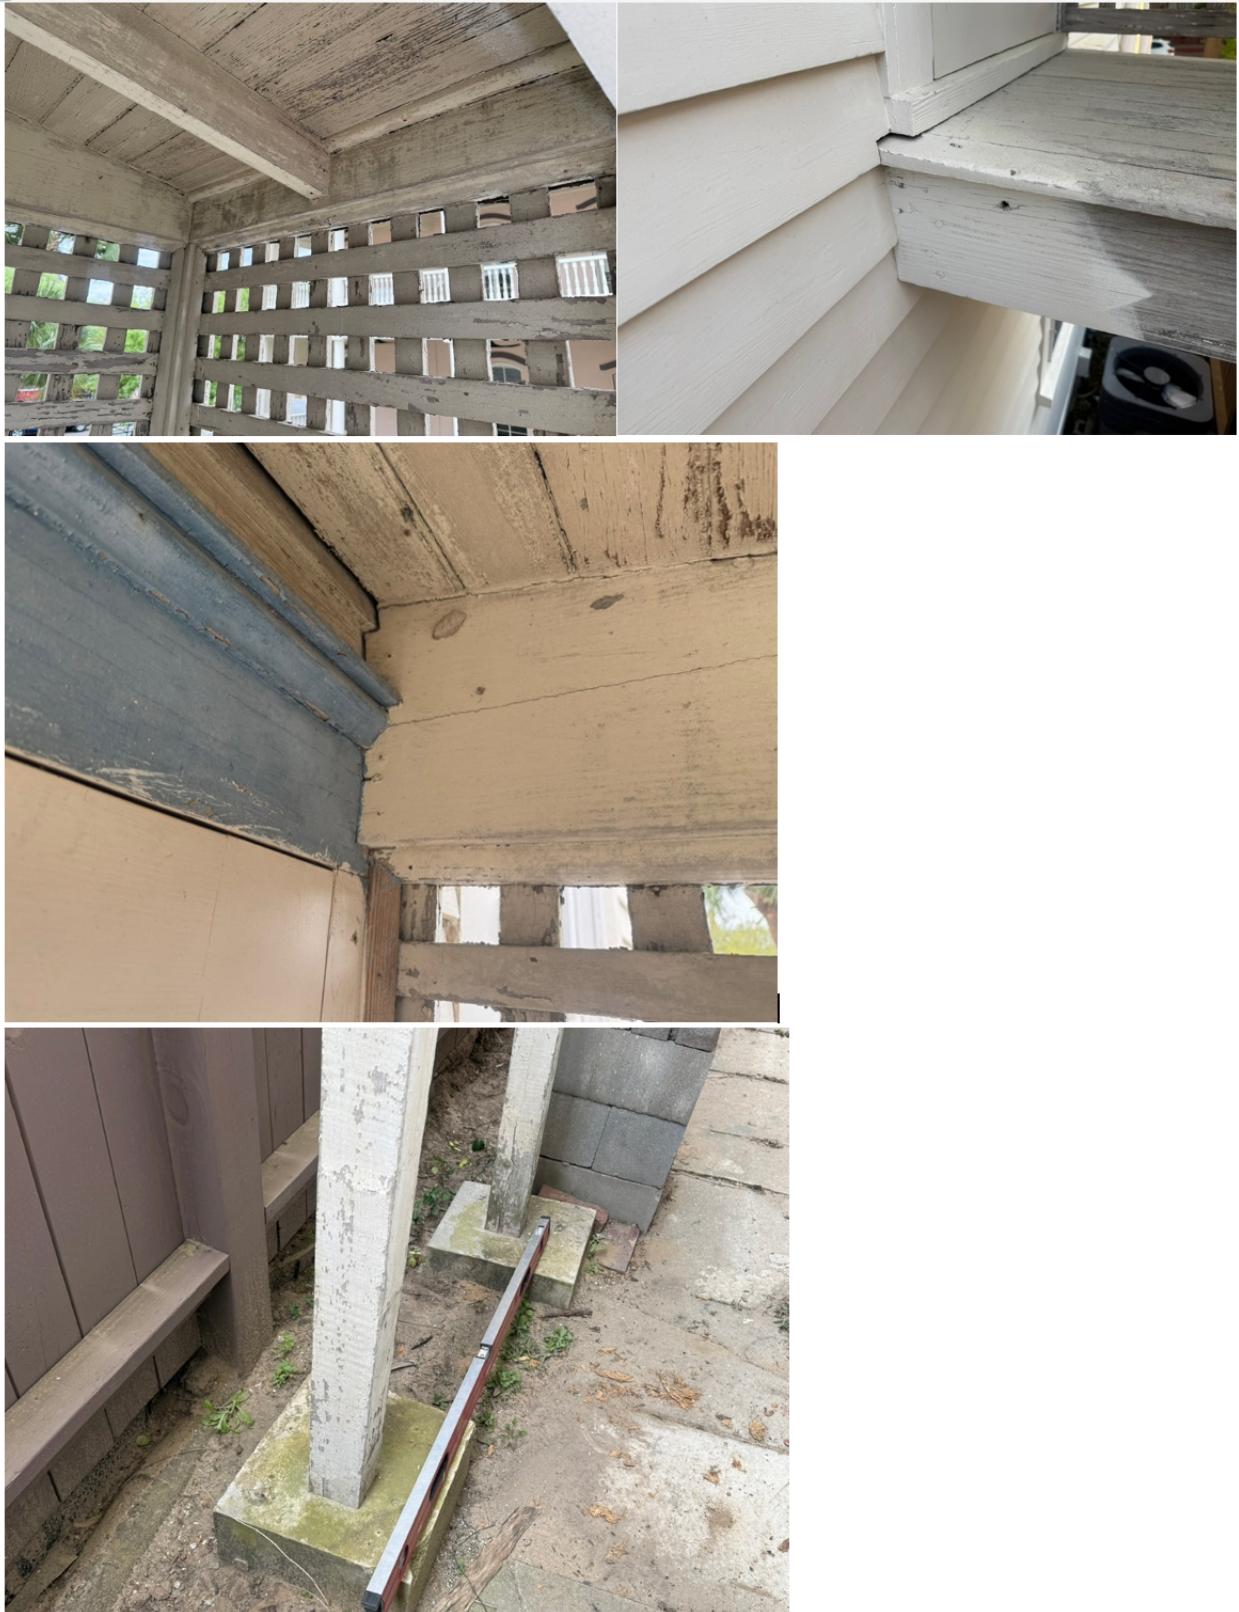
In the early 2020s, the stringers, treads, and risers were removed to allow for necessary repairs to the house prior to repainting. Rot had developed in the siding and lower band where one stringer ran against the house. The treads and risers were disposed of due to rot and damage sustained during removal. The stringers were similarly compromised, with one exhibiting ongoing deterioration from a repair made decades earlier. The handrail system consisted of a continuous board running from the base post at grade to the corner post at the latticed landing at the upper door. The two posts supporting that landing were found to be out of plumb by 1½" and 2½" respectively, lacking adequate bracing, and set on footings that were irregular both in shape and height above grade.

Below: Photos pre-demolition followed by current condition.
