DEMOLITION OF 32 MLK JR BLVD.

PIN # 2-0016-09-004

SAVANNAH HISTORIC DISTRICT REVIEW

COVER

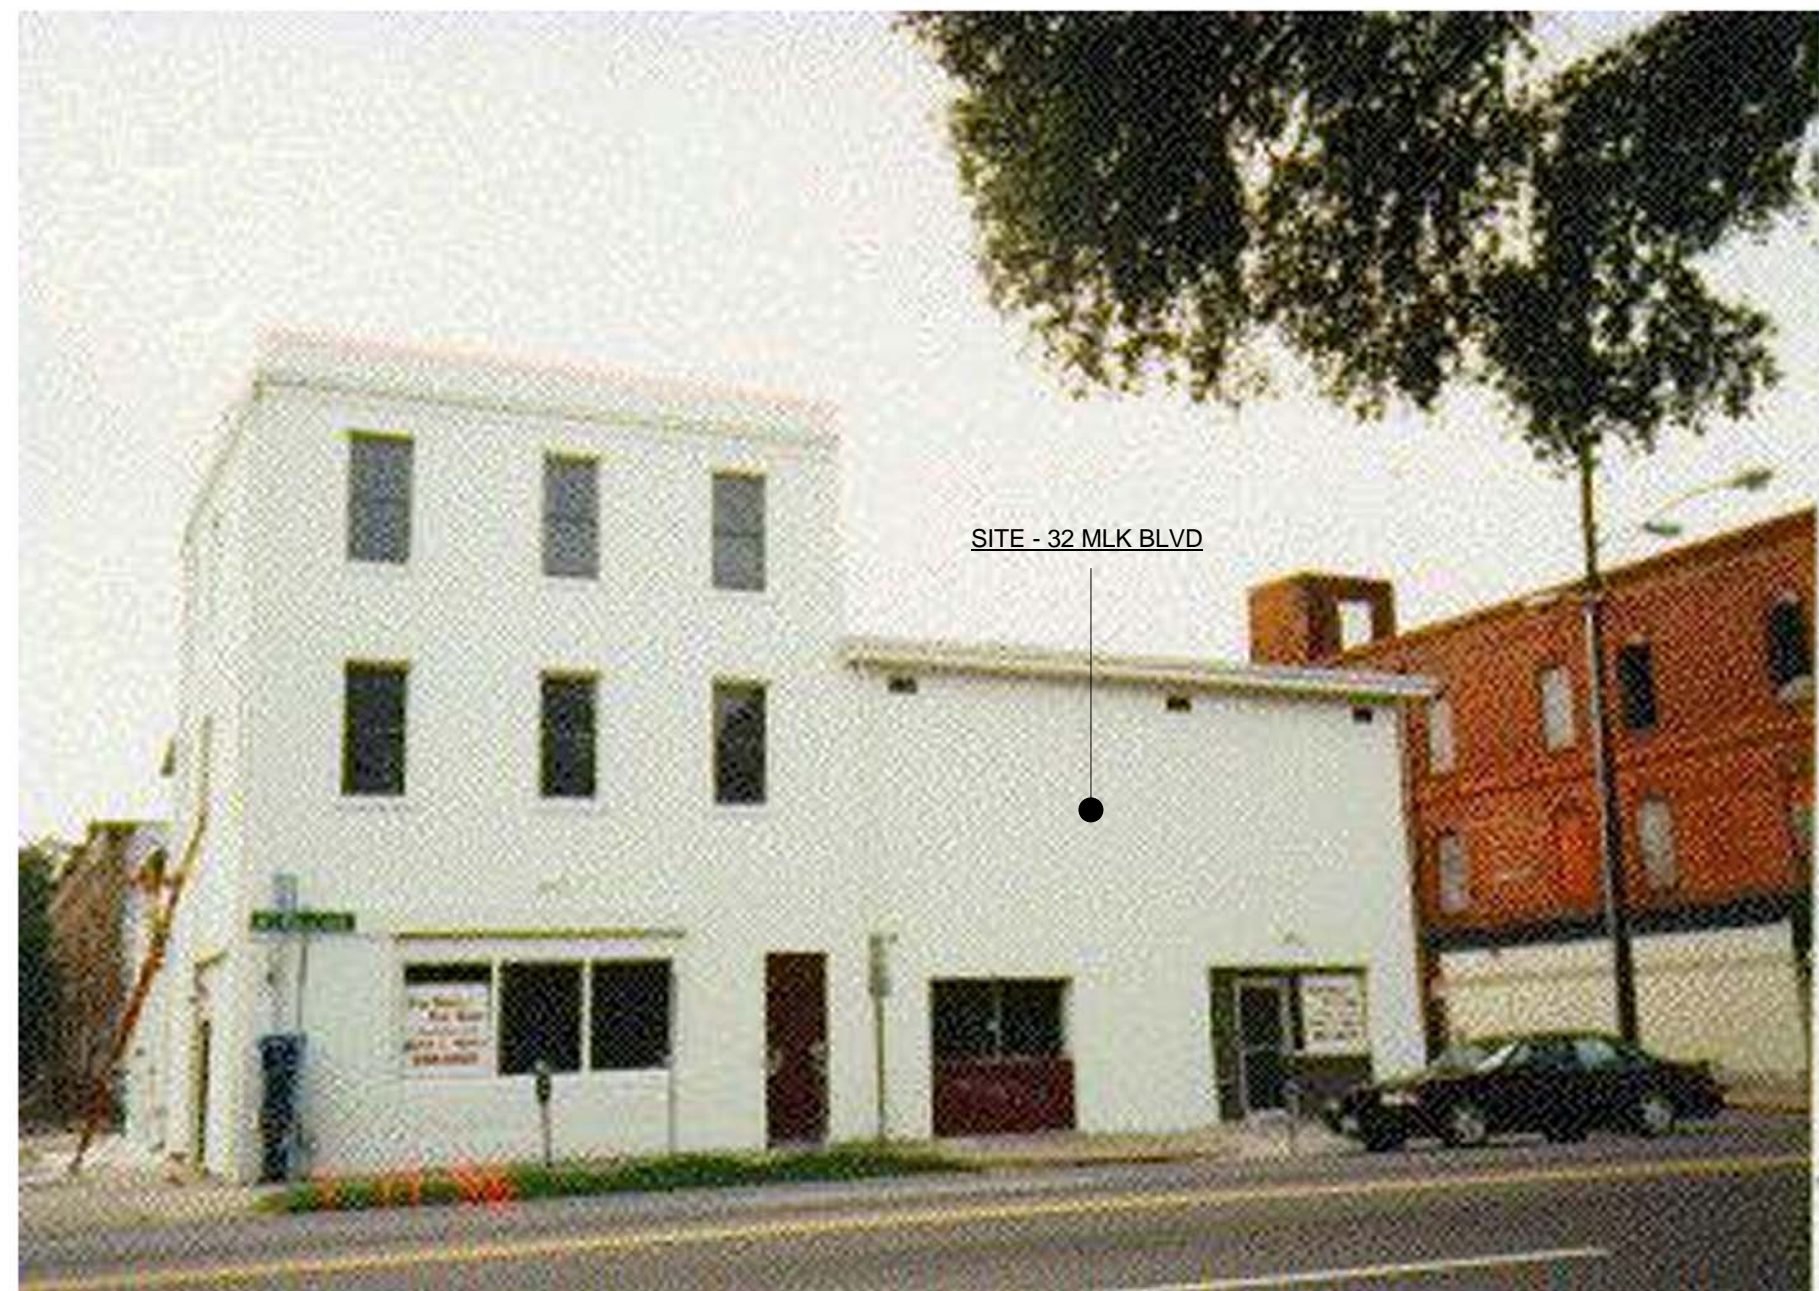
32 MLK BLVD. - APPROXIMATELY 1996
 NO HISTORIC PHOTOGRAPHS OF 32 MLK BLVD. HAVE BEEN DISCOVERED AT THIS TIME. THE OLDEST PHOTOGRAPH LOCATED IS FROM LATE 90'S, APPROXIMATELY 1996. THIS PHOTOGRAPH CONFIRMS THERE WERE STOREFRONT OPENINGS LOCATED ALONG MLK BLVD. GHOSTING OF THESE OPENINGS IS STILL VISIBLE ON THE BUILDING TODAY, INDICATED IN IMAGES J-L OF SHEET A4. ALTHOUGH THIS PHOTOGRAPH CONFIRMS THERE WAS STOREFRONT IN THESE OPENINGS, THIS STOREFRONT SYSTEM OF 1996 WAS NOT HISTORIC. ADDITIONALLY, IT CAN NOT BE DETERMINED IF THE SIZE AND PROPORTION OF THESE OPENINGS ARE ORIGINAL AND IS DIFFICULT TO DETERMINE SINCE THE BUILDING HAS BEEN MODIFIED MULTIPLE TIMES THROUGHOUT HISTORY.

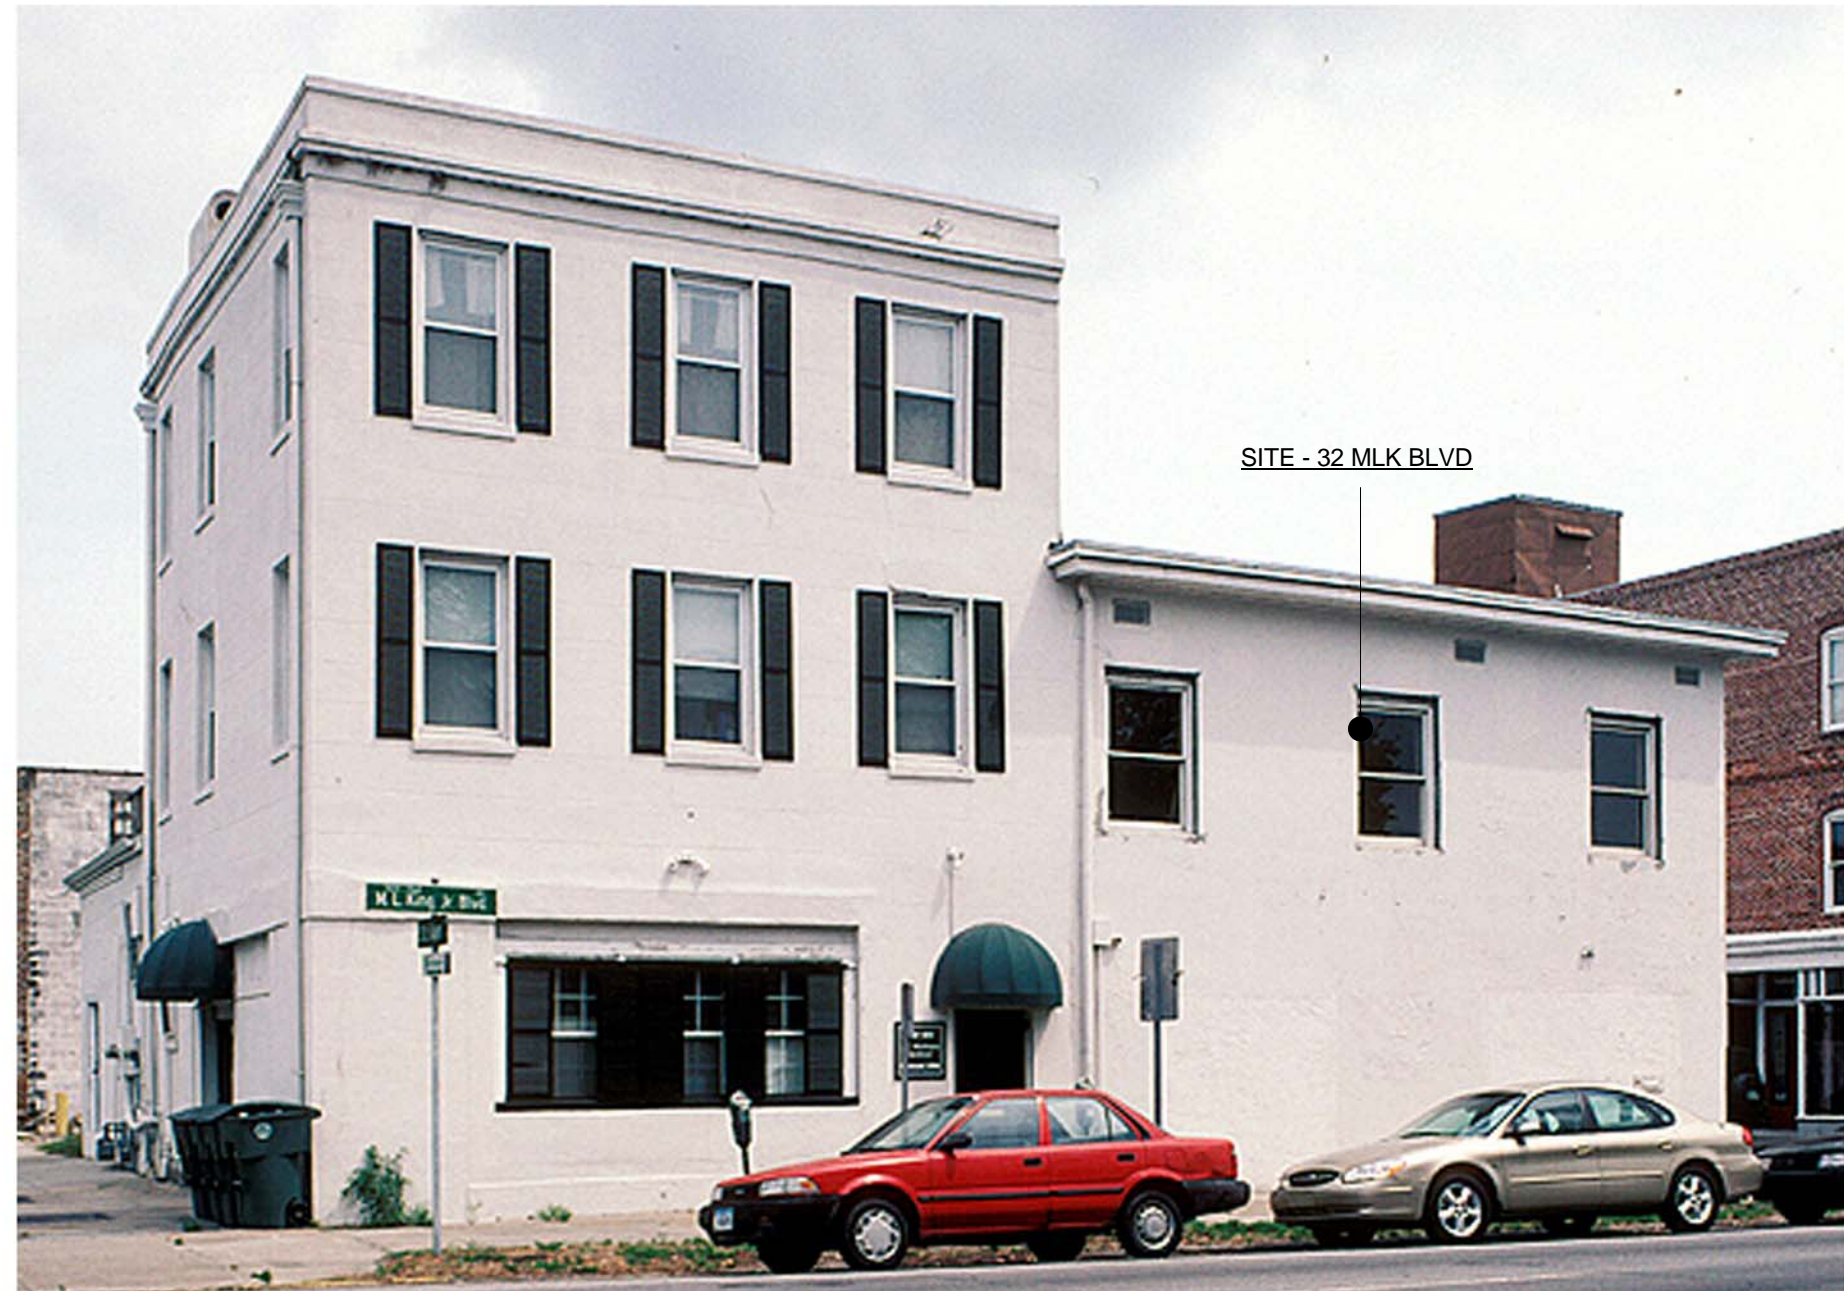
32 MLK BLVD. - 2001
 A LATER PHOTOGRAPH, TAKEN IN 2001 ONE, INDICATES THE MLK BLVD. STOREFRONT WAS INFILLED, WHILE THREE WINDOW OPENINGS WERE ADDED ON THE SECOND FLOOR REVIEWING THE WIDER, TRUNCATED PROPORTION OF THE SECOND FLOOR WINDOWS, IT IS SAFE TO ASSUME, THEY ARE NOT HISTORIC. ADDITIONALLY, FROM THE INTERIOR OF THE BUILDING, THE CENTER BEAM OF THE SECOND FLOOR FALLS AT THE HEADER OF THE CENTER WINDOW WHICH WOULD NOT BE AN APPROPRIATE/HISTORIC METHOD OF CONSTRUCTION. (IMAGE D - SHEET A4). ADDITIONALLY, THIS BEAM AT THE HEADER CONTRIBUTES TO THE BUILDINGS STRUCTURAL DEFICIENCIES, NOTED IN THE STRUCTURAL REPORT, ITEM 3 - PAGE 2 OF 14.

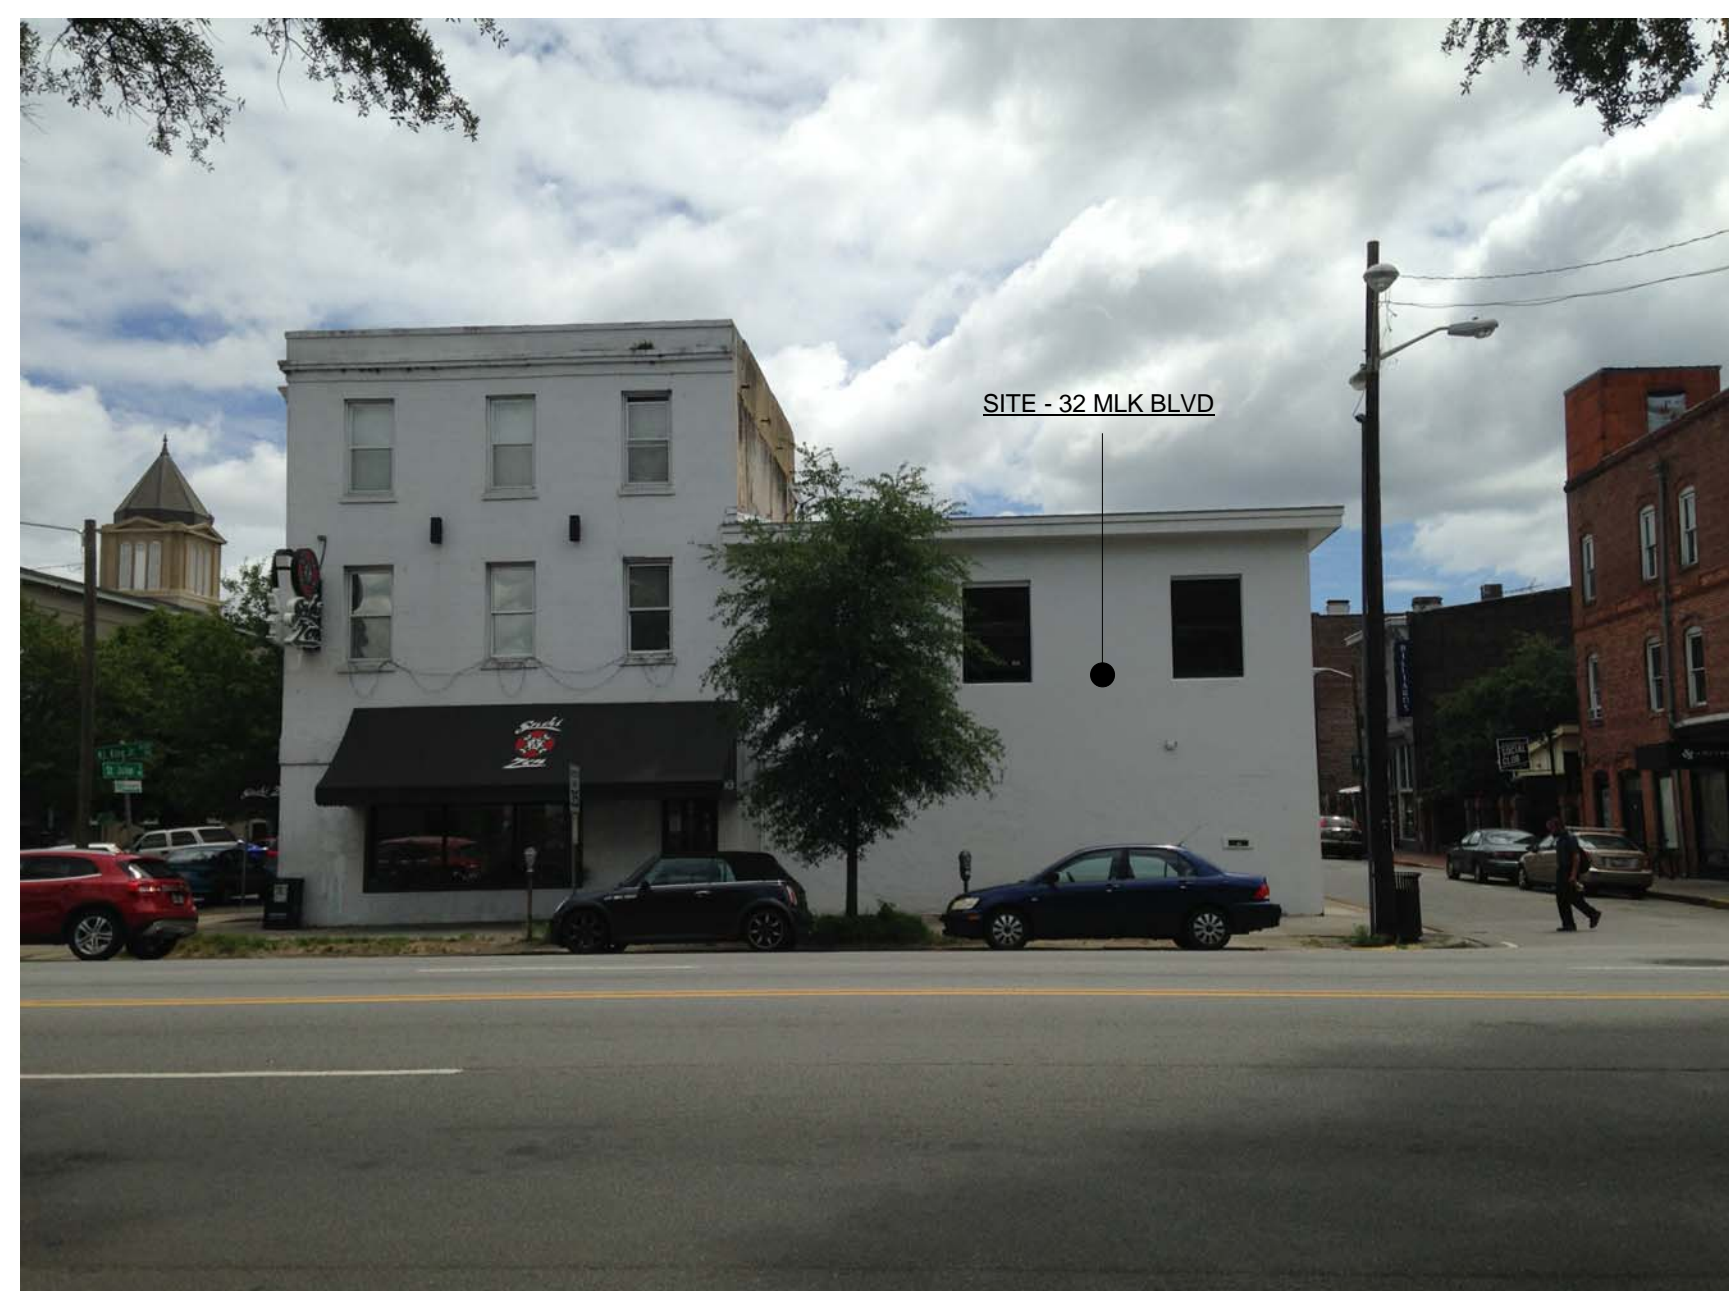
32 MLK BLVD - CURRENT 2015
 TODAY, WHEN REVIEWING THE WEST FACADE OF 32 MLK BLVD, IT APPEARS TO HAVE CHANGED MINIMALLY SINCE THE 2001 PHOTOGRAPH. HOWEVER, REVIEWING THE WEST FACADE FROM THE INTERIOR, SIGNIFICANT MODIFICATIONS ARE VISIBLE, APPROXIMATELY TWO YEARS AGO, THE PREVIOUS OWNER REPAIRED THE ROOF TO THE EXTENT OF COMPLETE ROOF REMOVAL, REPLACING THE HISTORIC ROOF WITH PRE-ENGINEERED ROOF TRUSSES. (IMAGES A-E - SHEET A4)
 IN ADDITION TO COMPLETE REPLACEMENT OF THE ROOF, THE ENTIRE SOUTH WALL WAS RERAMMED FROM THE FIRST FLOOR UP, VISIBLE IN IMAGES B-C, SHEET A4.
 THE MULTIPLE MODIFICATIONS TO THIS BUILDING, SPECIFICALLY THE LOSS OF THE THIRD FLOOR LEFT A BUILDING THAT NOT ONLY LACKS HISTORICAL PROPORTIONS AND SCALE OF SURROUNDING CONTEXT, BUT ALSO HAS MULTIPLE STRUCTURAL DEFICIENCIES. IN ORDER TO STABILIZE AND REVONATE THE BUILDING TO MEET STRUCTURAL CODE REQUIREMENTS, THE COST WOULD EXCEED THE PURCHASE PRICE OF THE PROPERTY BY NEARLY DOUBLE.

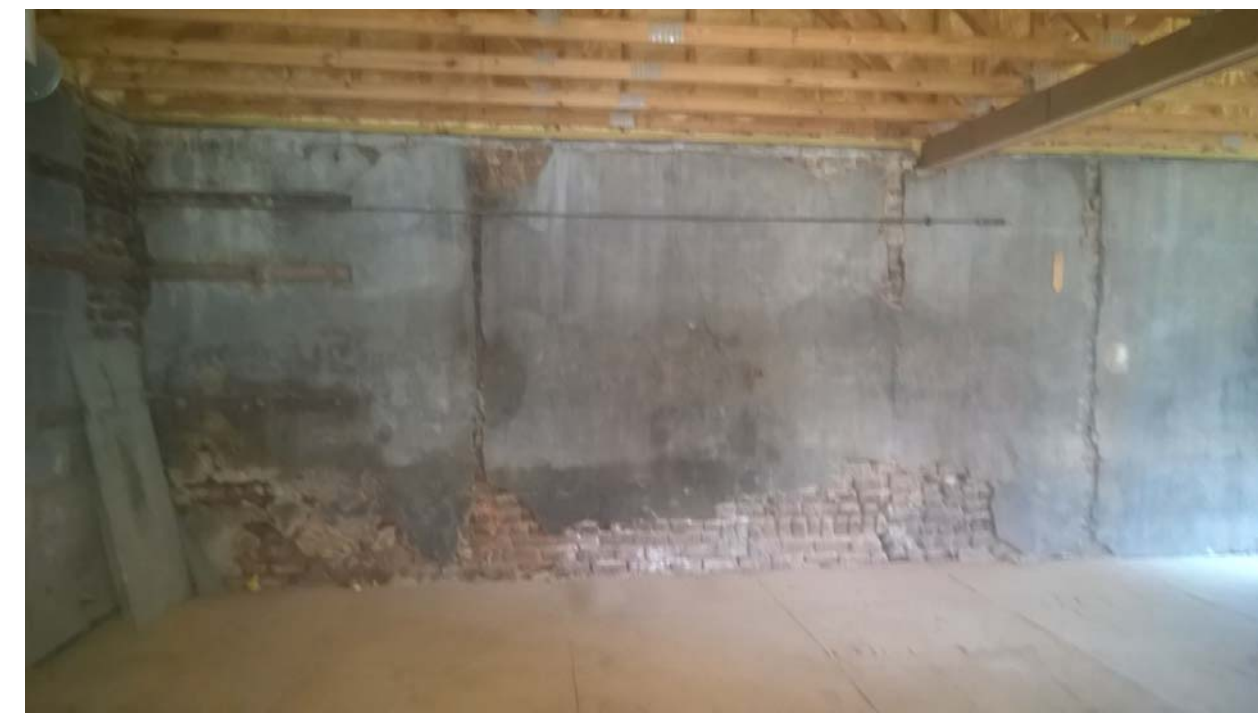
A. SECOND FLOOR, EAST WALL. REFERENCE ITEMS 1, 3 & 7 OF THE STRUCTURAL REPORT, PAGES 1-2 OF 14

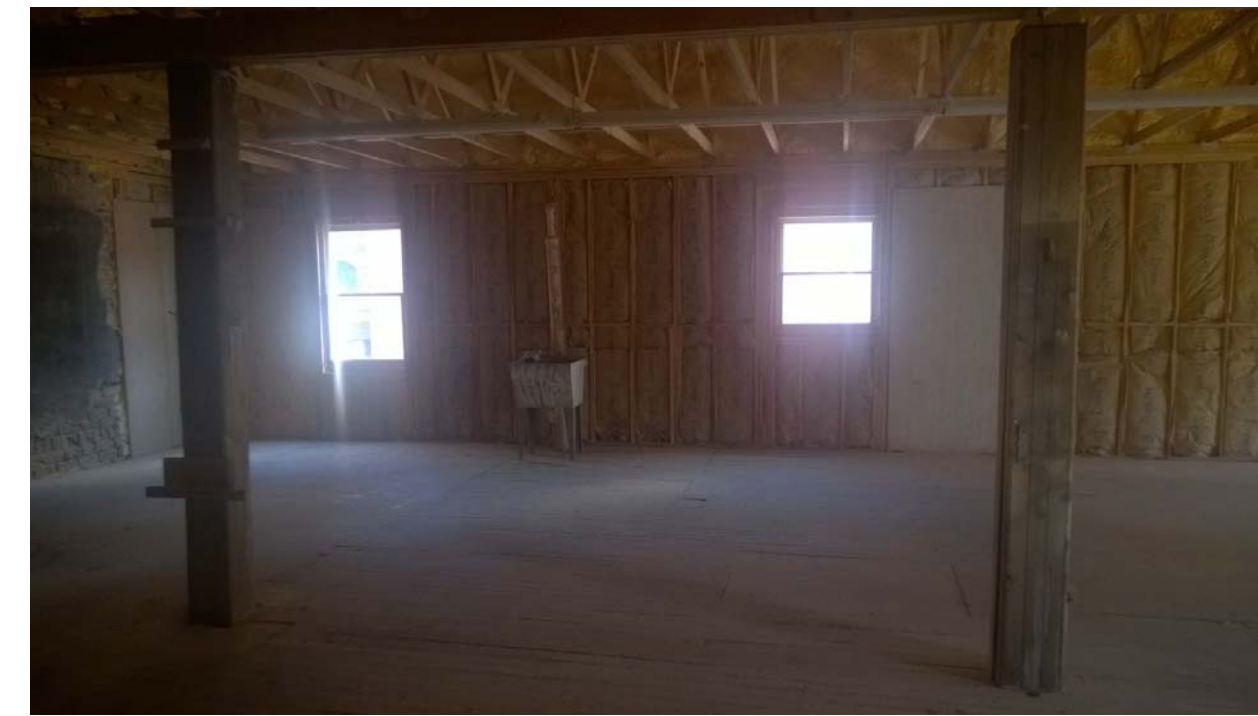
B. SECOND FLOOR, NEW CONSTRUCTION ENTIRE SOUTH WALL & ROOF STRUCTURE. NOTE OPENING PROPORTIONS WITH INCONSISTENT RYTHEM AND CHANGE IN FLOORING MATERIAL INDICATES ASSUMED LINE OF ORIGINAL BUILDING EXTERIOR.

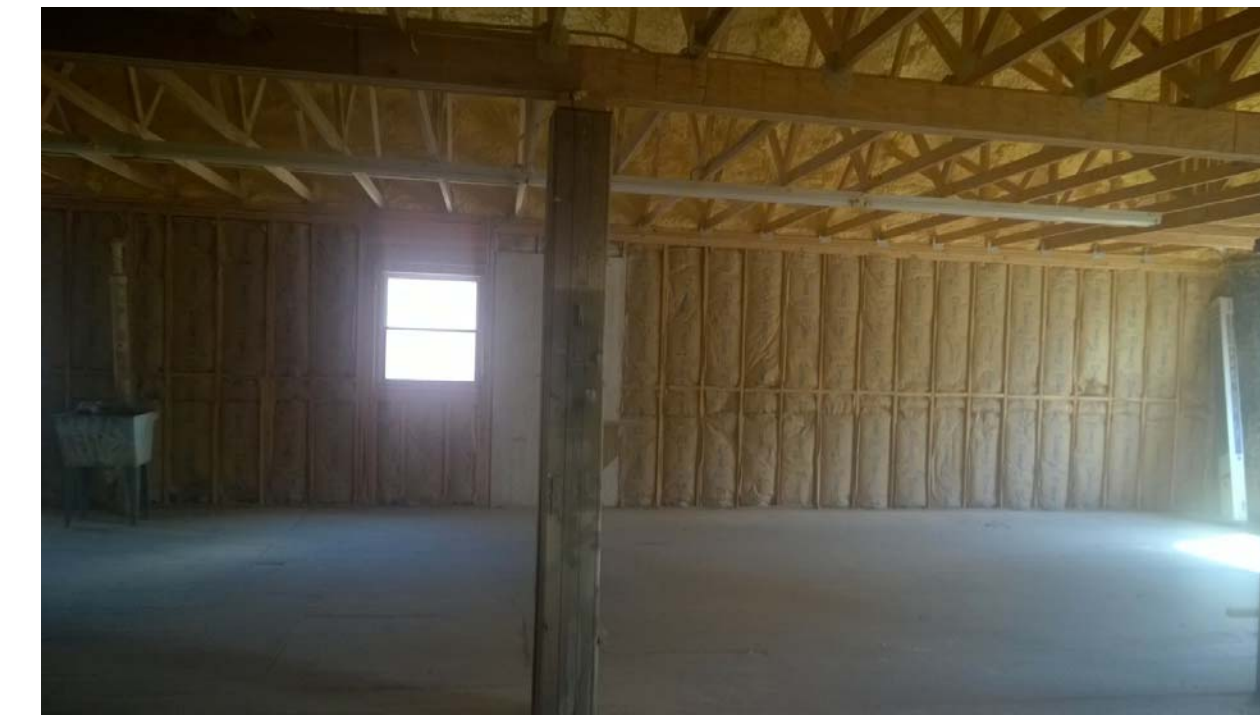
C. SECOND FLOOR, NEW CONSTRUCTION ENTIRE SOUTH WALL & ROOF STRUCTURE

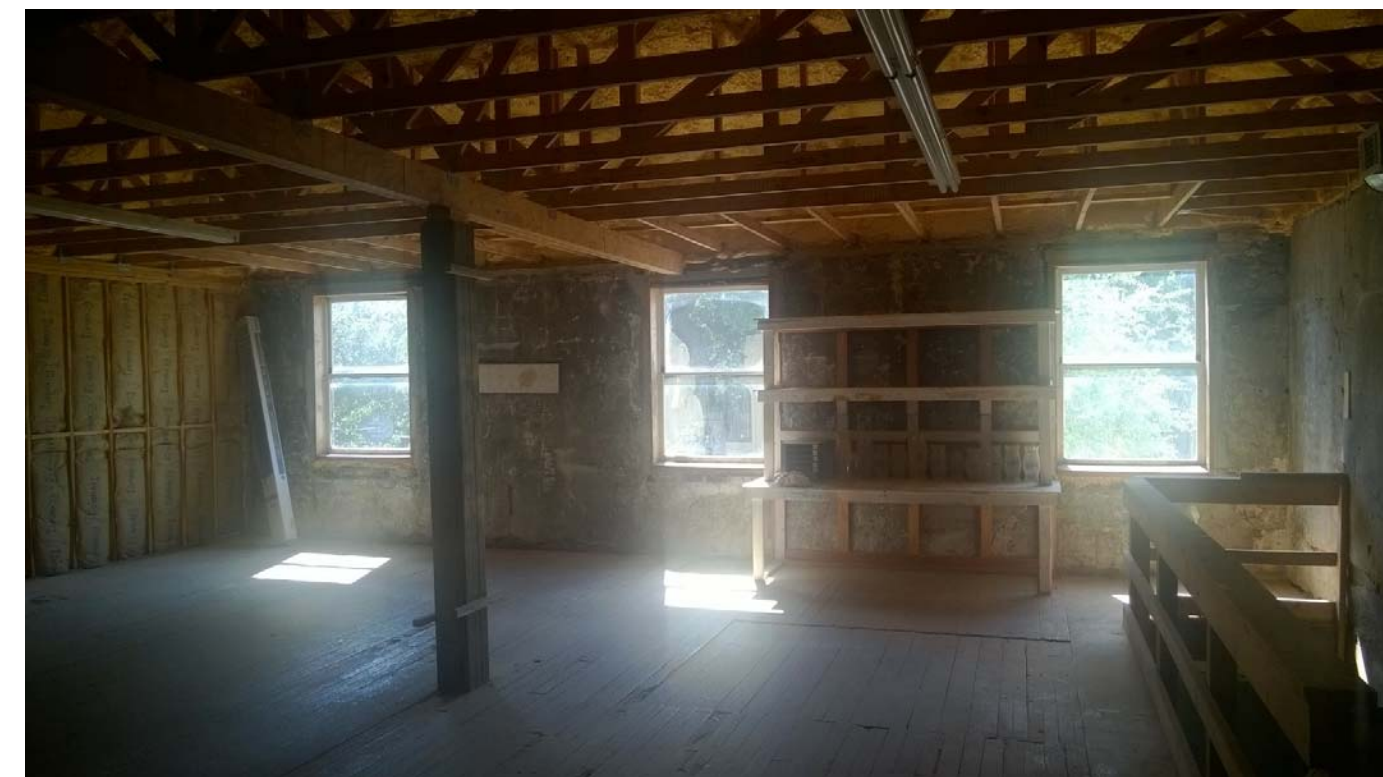
D. SECOND FLOOR, MLK BLVD SIDE, WEST WALL. NOTE BEAM AT WINDOW HEADER INDICATES NON-HISTORIC WINDOW OPENINGS. REFERENCE STRUCTURAL REPORT ITEM 3, PAGE 2 OF 14.

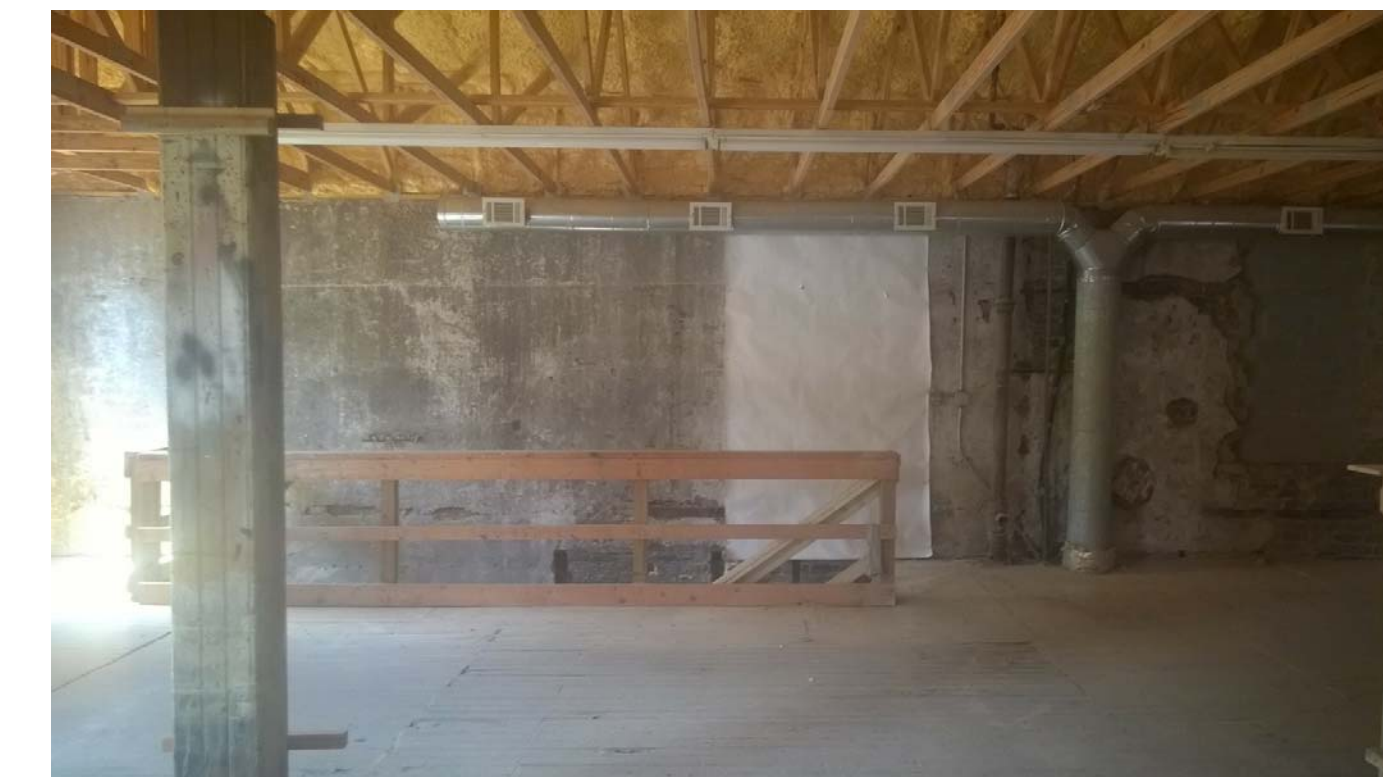
E. SECOND FLOOR, NORTH WALL (ADJACENT TO 30 MLK); NOTE NOTCHES IN MASORNY INDICATE PREVIOUS FLOOR SYSTEM EXISTED; NON-HISTORIC STAIR.

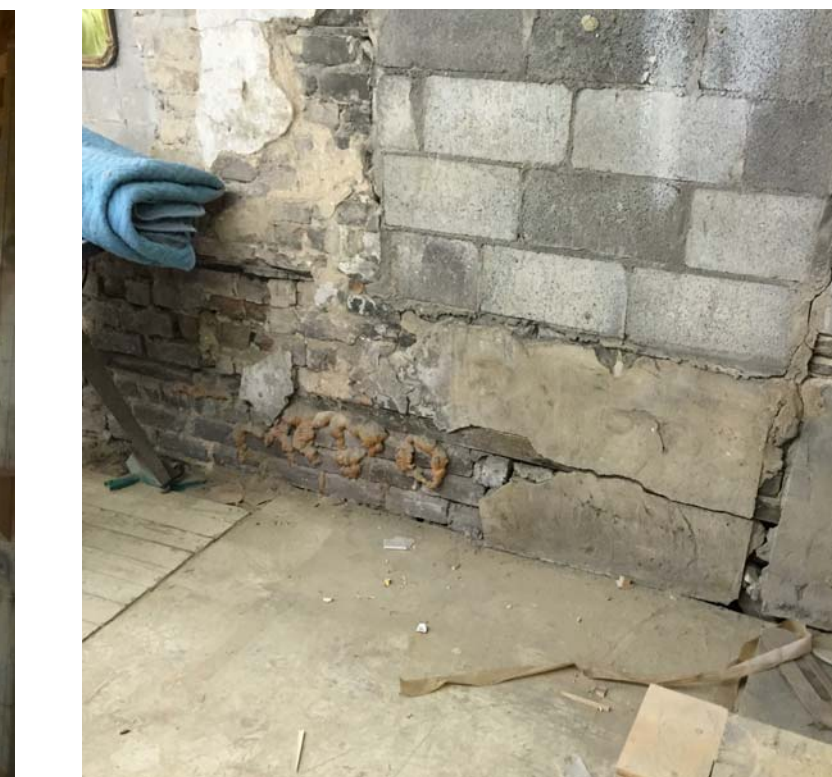
F. SECOND FLOOR, NORTH WALL (ADJACENT TO 30 MLK), REFERENCE STRUCTURAL REPORT ITEM 5, PAGE 2 OF 14. NOTE: CHANGE IN FLOOR INDICATES ASSUMED LINE OF ORIGINAL EXTERIOR

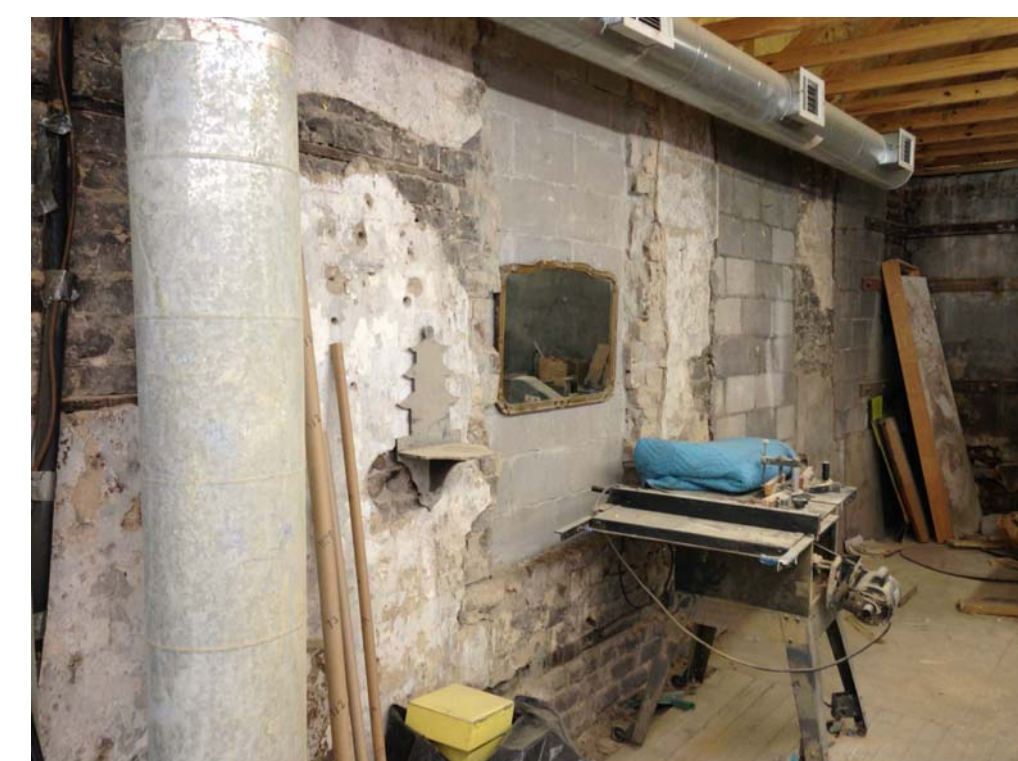
G. SECOND FLOOR, NORTH WALL (ADJACENT TO 30 MLK), REFERENCE STRUCTURAL REPORT ITEM 5, PAGE 2 OF 14.

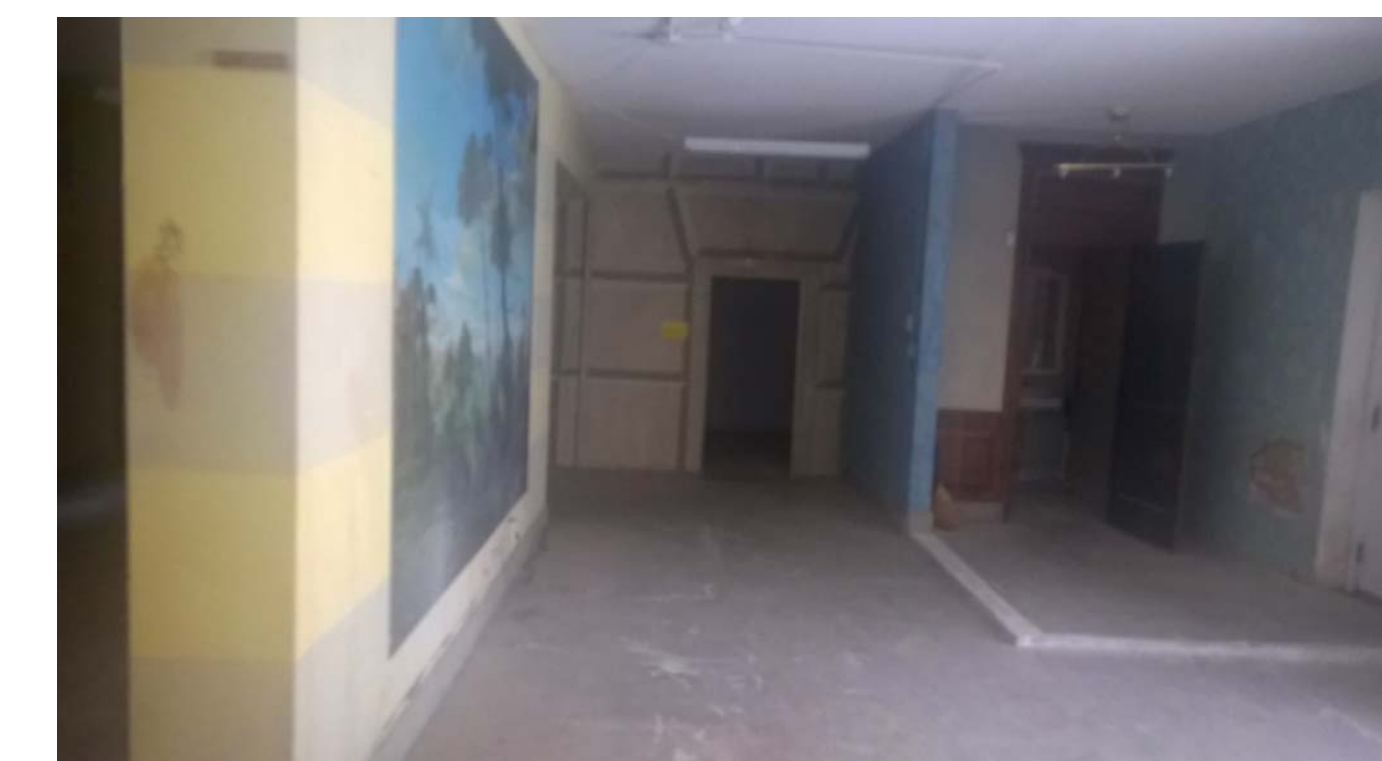
H. FIRST FLOOR, VIEW EAST TOWARDS CONCEALED MASONRY WALL, ASSUMED TO BE HISTORIC BUILDING EXTERIOR WALL

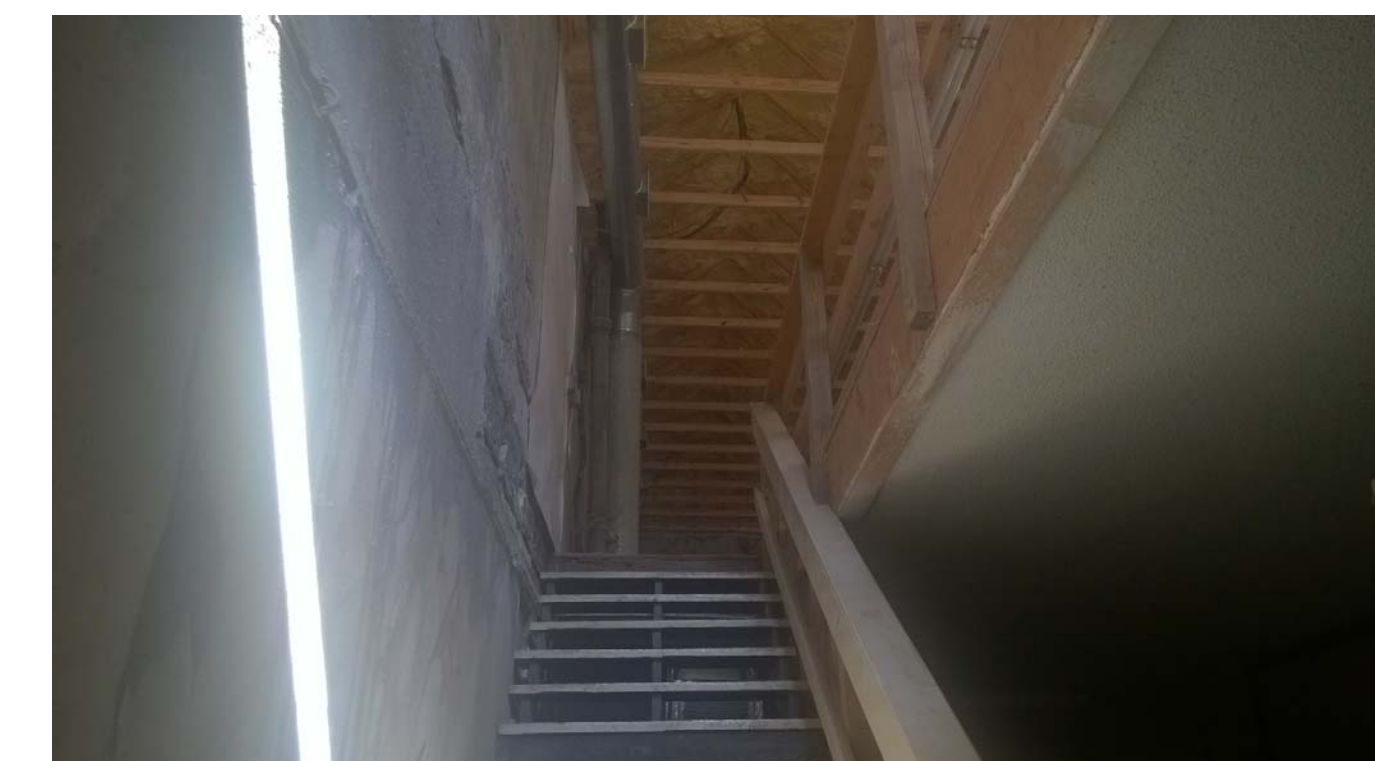
I. VIEW UP NON-HISTORIC STAIR. NOTE PRE-ENGINEERED WOOD TRUSSES

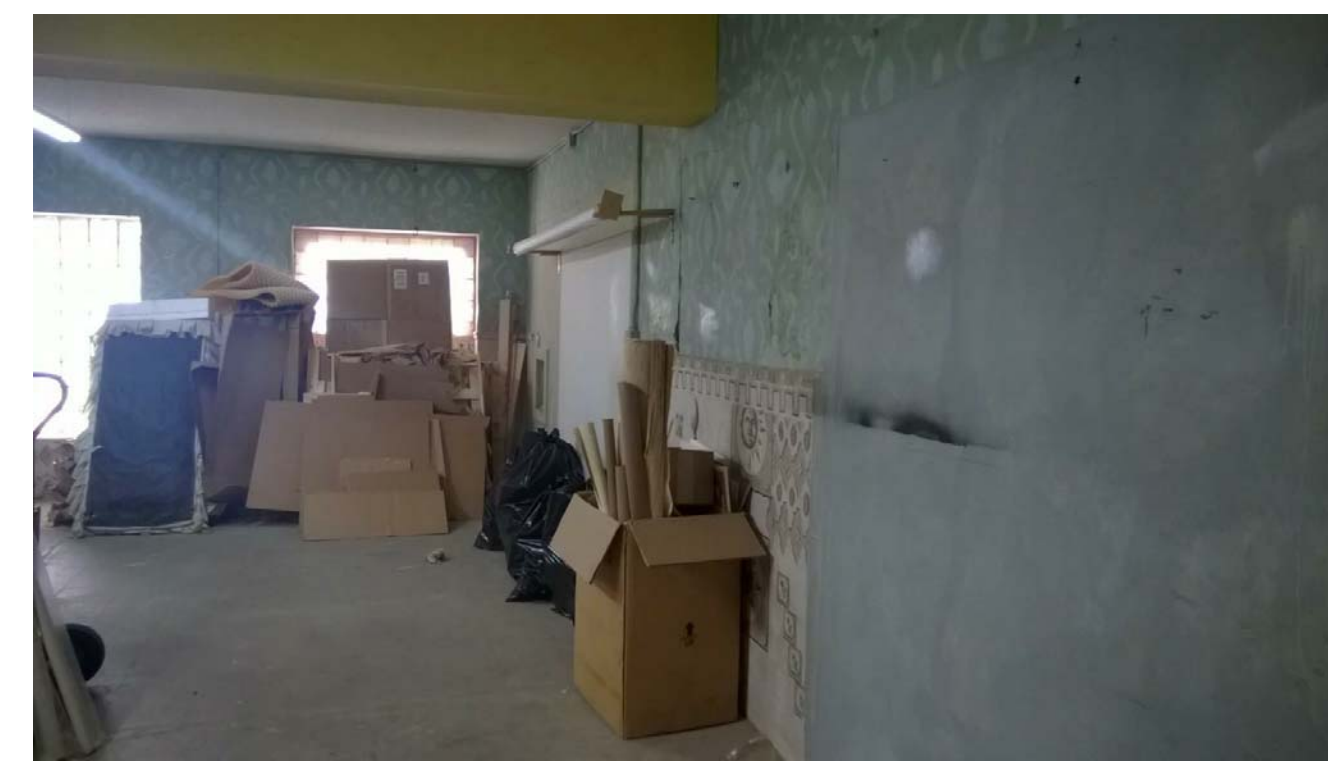
J. FIRST FLOOR, VIEW SOUTHWEST, INFILLED OPENINGS VISIBLE ALONG MLK JR. BLVD

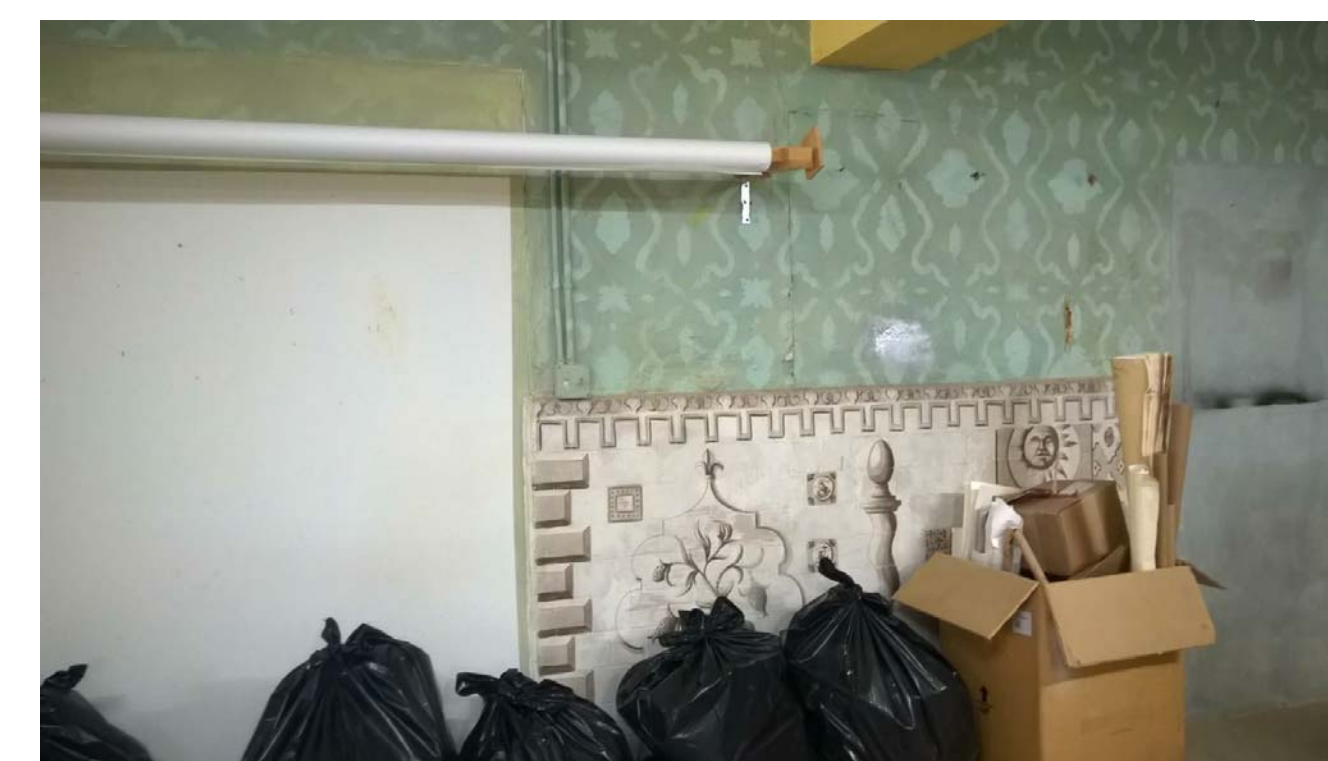
K. FIRST FLOOR, VIEW SOUTHWEST, INFILLED OPENINGS VISIBLE ALONG MLK JR. BLVD

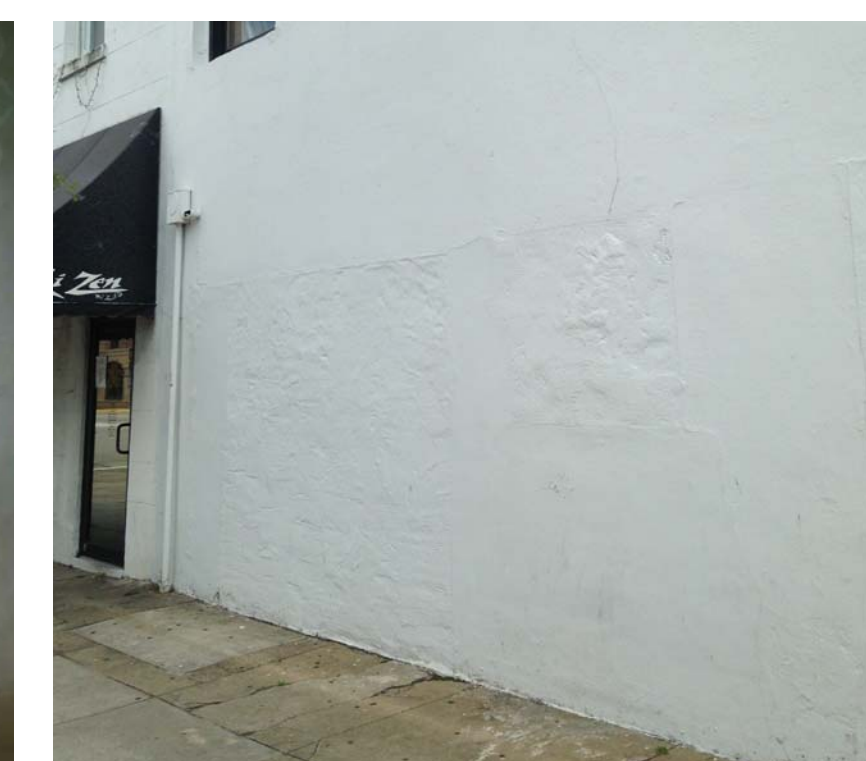
L. FIRST FLOOR, INFILLED OPENINGS VISIBLE ALONG MLK JR. BLVD EXTERIOR
