211 West Henry Street

Siding Repairs & Exterior Painting (Left & Right Side Only)

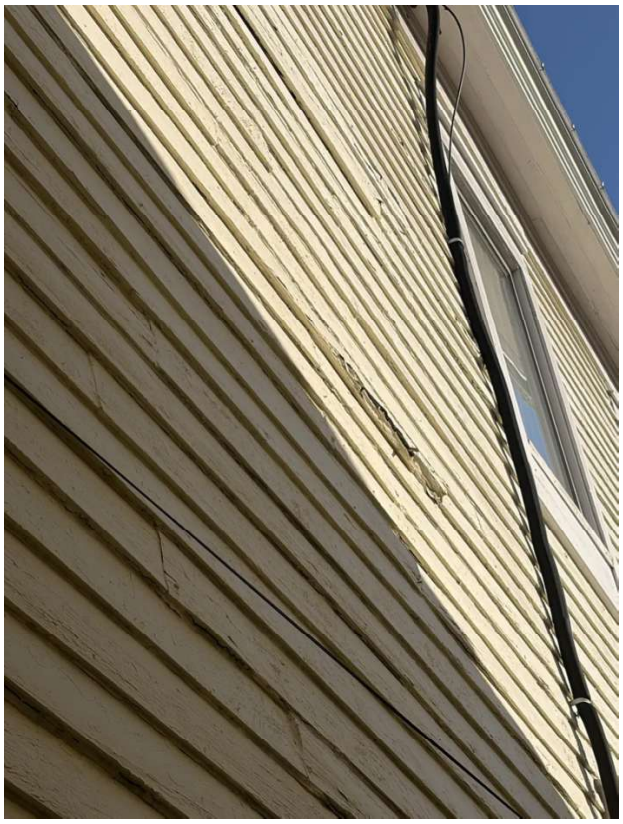
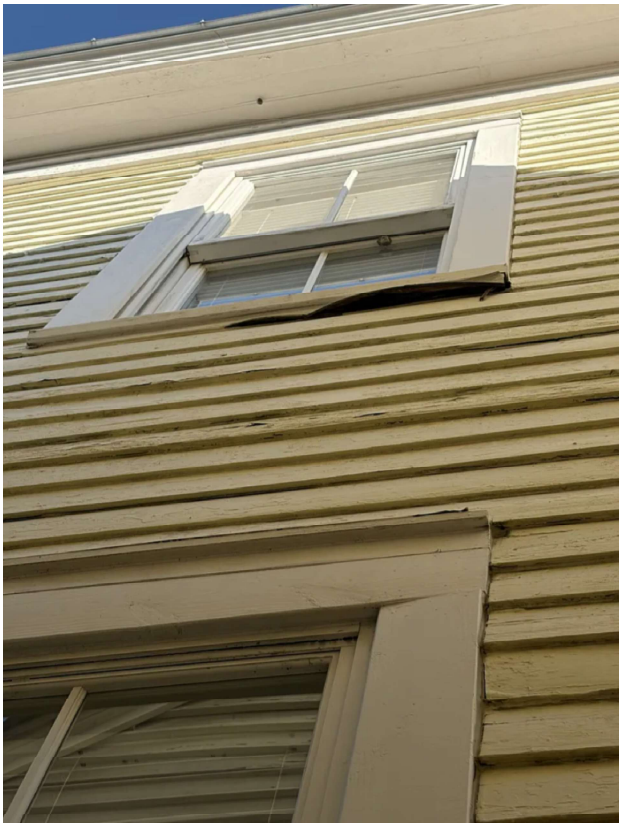
Remove and replace the rotten pieces of siding on the left and right side of the house with NEW #119 1x6x16 Pine Lap Siding (approximately 700 linear ft).

Remove and replace the rotten 1x6 vertical trim board on (6) of the windows and repair (2) rotten windows sills.
