*The Berrien House Restoration*

322-324 EAST BROUGHTON STREET  
SAVANNAH, GEORGIA 31401

Savannah HDRB Supplement  
Continued Application  
September 19, 2013

## UPDATED NOTES FOR BERRIEN RESTORATION

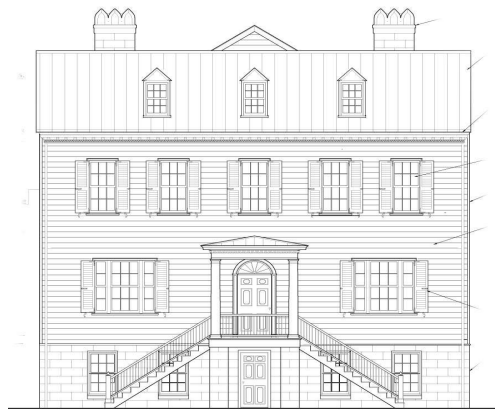
View of front elevation with portico scars. The evidence clearly gives a height & width based on the east side of the scars that are believed to be original to our period of significance.
