#### 12.30.25 SCOPE OF WORK

# DRONE-ASSISTED UNDERWRITING REPORT

**808 Barnard St  
Savannah, GA 31401**

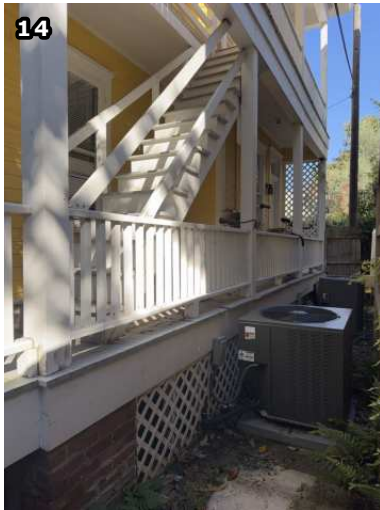
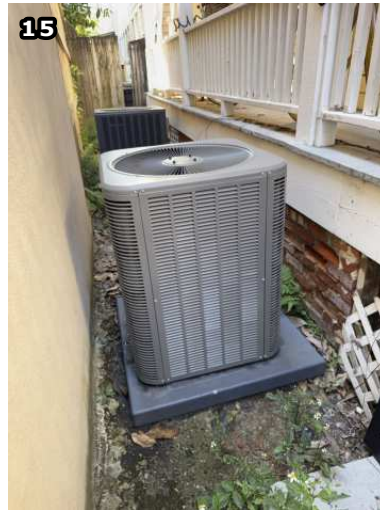
- Rear Elevation: HVAC units were noted in Good condition.

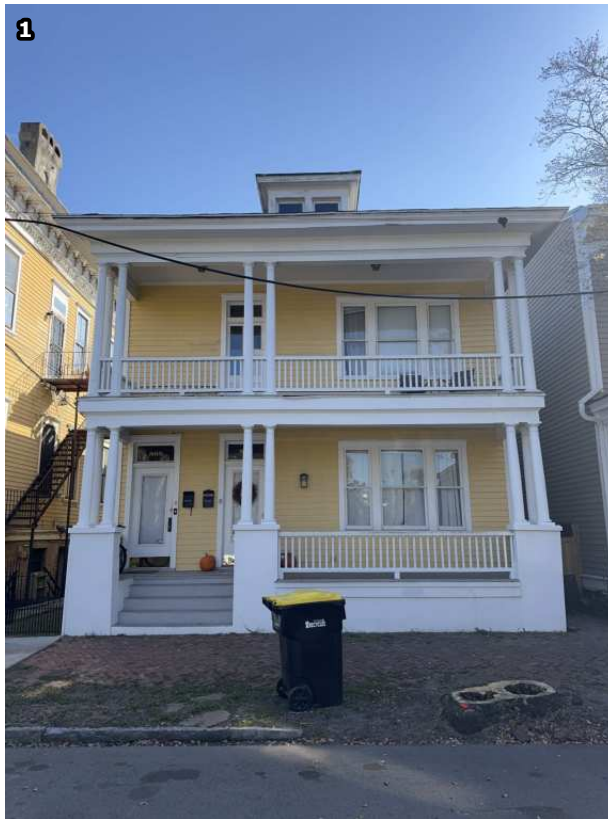
**Front Elevation. Overview.**

Peeling paint was noted on the fascia, window frame.

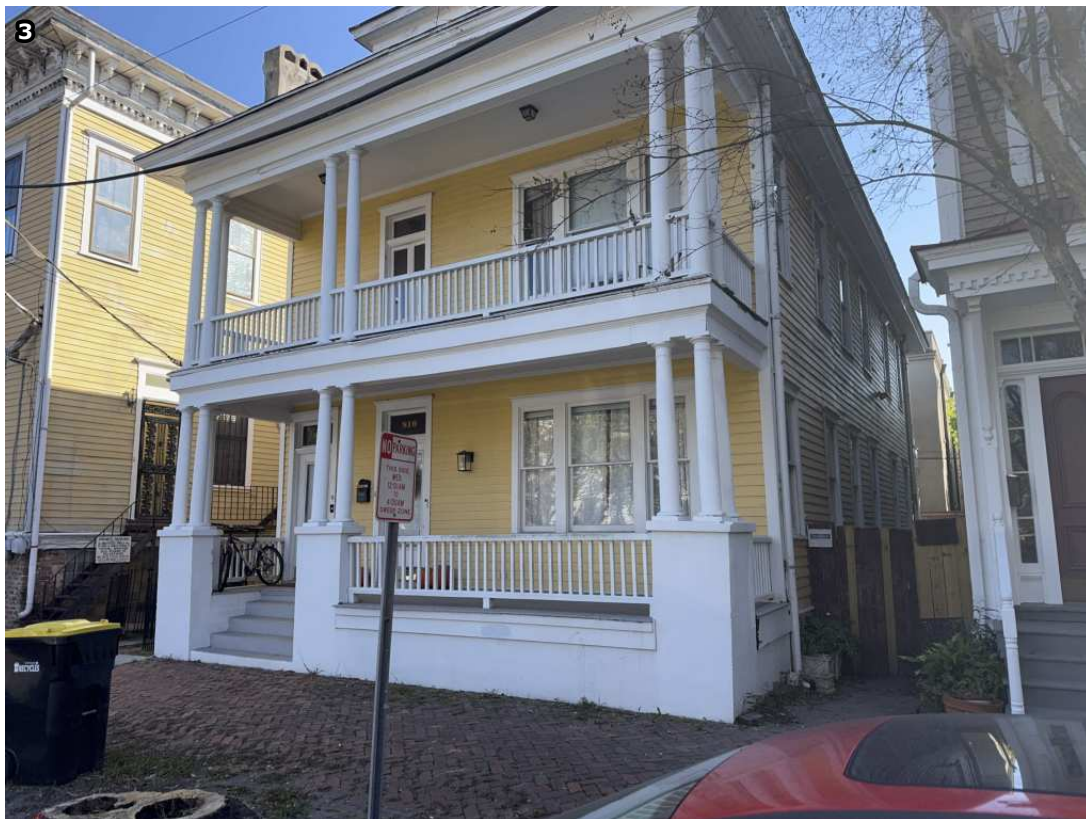
**Right Elevation. Overview.**

Damage was noted to the siding, deck. Peeling paint was noted on the siding, downspouts, window frame. Crack(s) on the siding was noted.

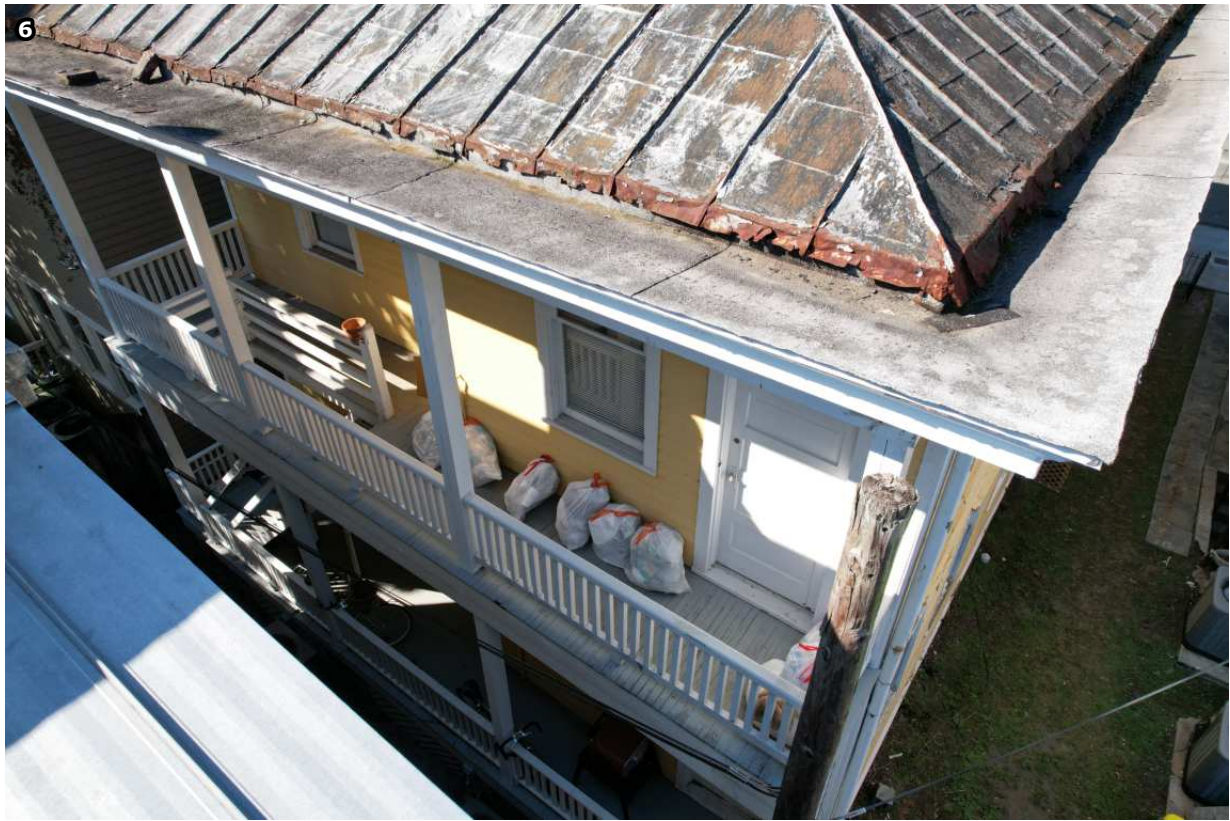
**Rear Elevation. Overview.**

Damage was noted to the deck, door.

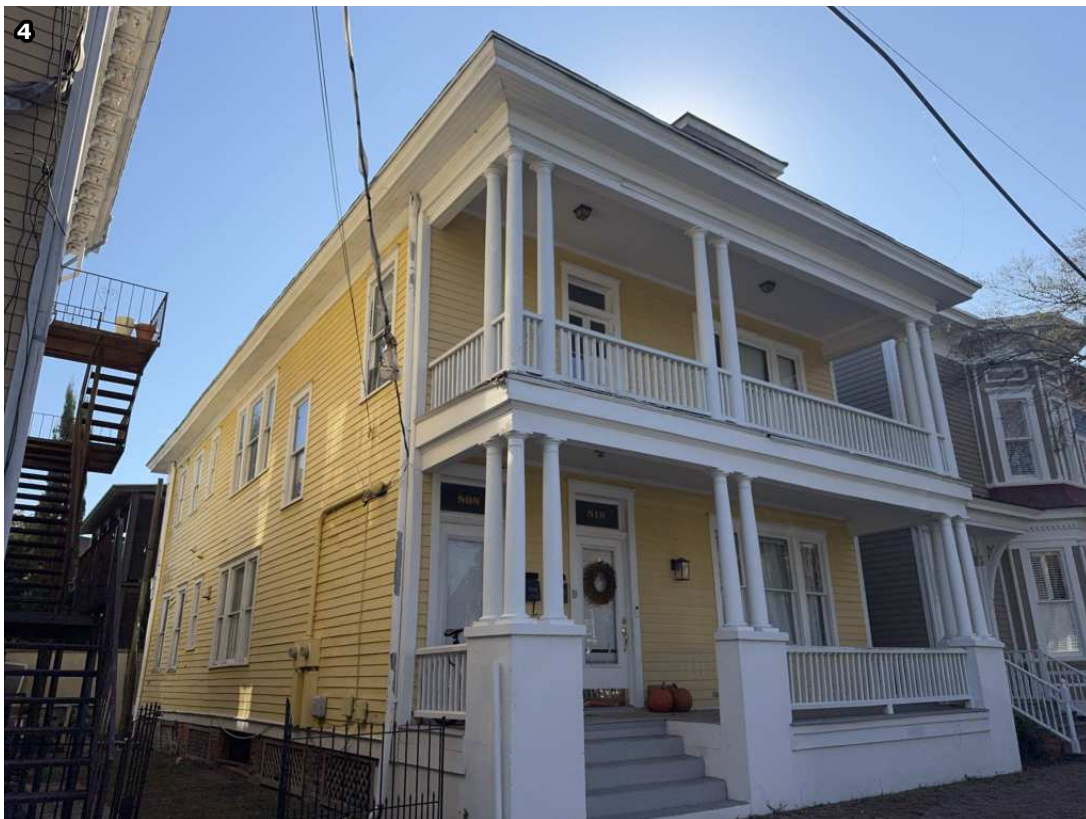
**Left Elevation. Overview.**

Damage was noted to the siding. Peeling paint was noted on the siding, downspouts, window frame. Loose, missing, or damaged gutters and/or downspouts was noted. Crack(s) on the siding was noted.

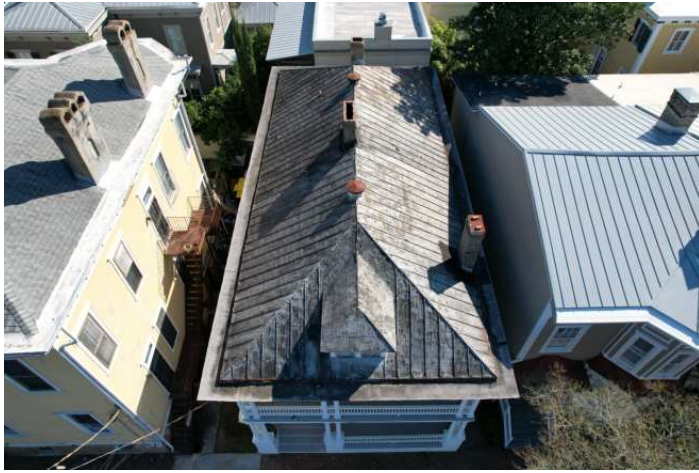
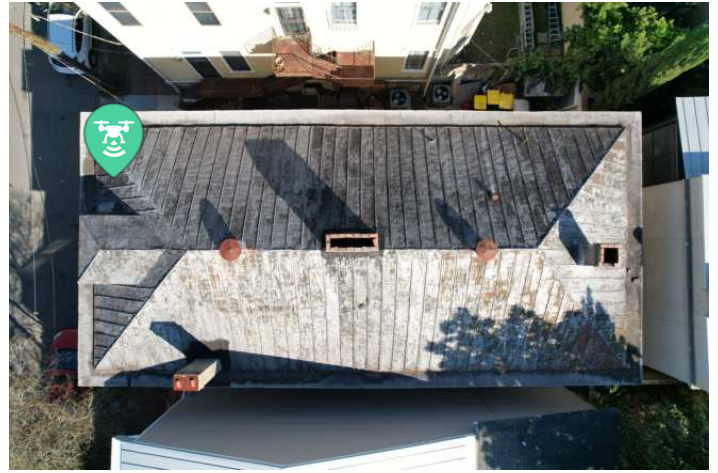
**Front Slope. Peeling paint was noted on the roof. Algae/Moss was noted on roof. Loose, damaged, or missing metal roof were noted. Rust on the roof was noted.**

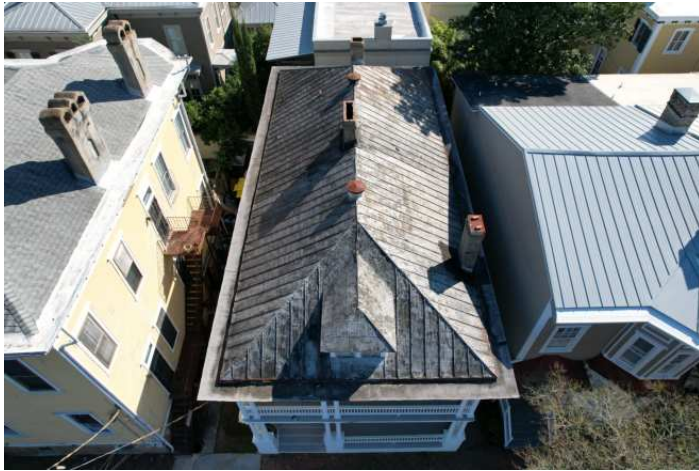
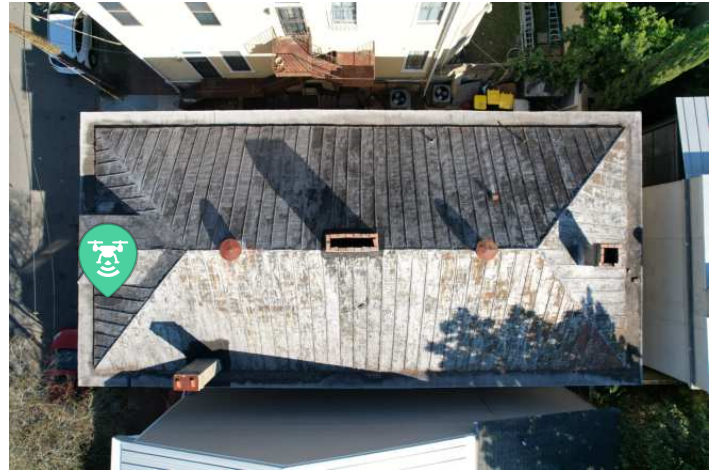
**Front Slope. Algae/Moss was noted on roof. Peeling paint was noted on the roof. Loose, damaged, or missing metal roof were noted. Rust on the roof was noted.**

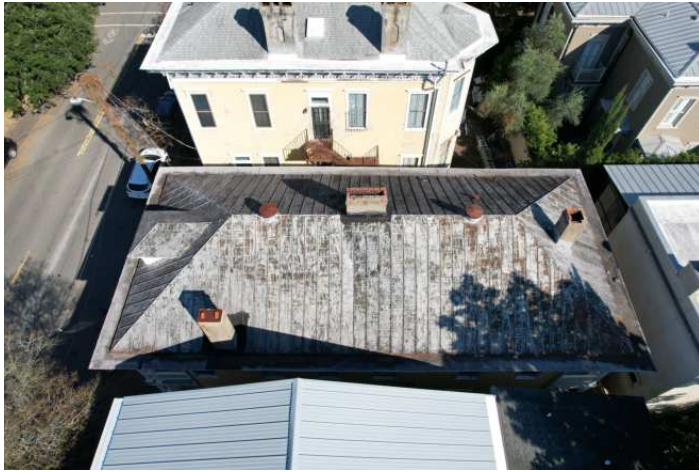
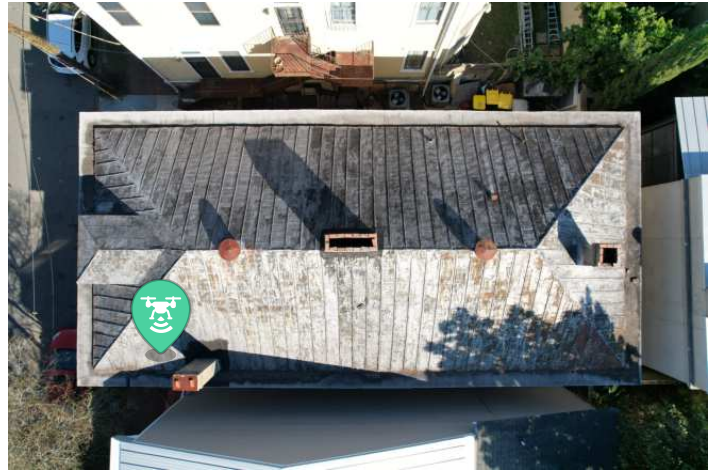
**Right Slope. Peeling paint was noted on the roof. Algae/Moss was noted on roof. Rust on the roof was noted.**

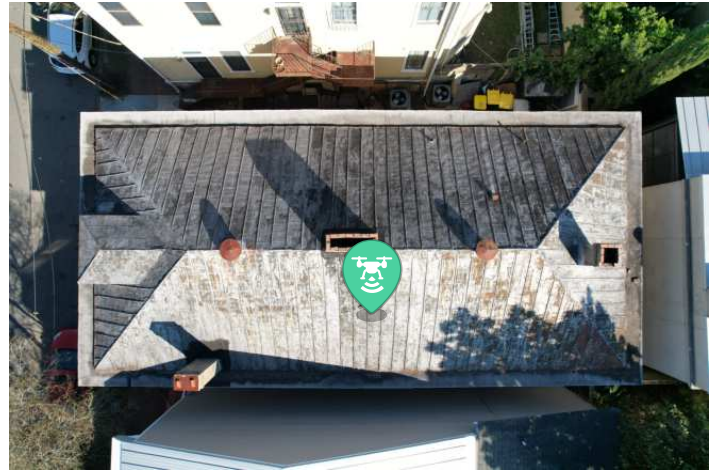
**Right Slope. Algae/Moss was noted on roof. Peeling paint was noted on the roof. Rust on the roof was noted.**

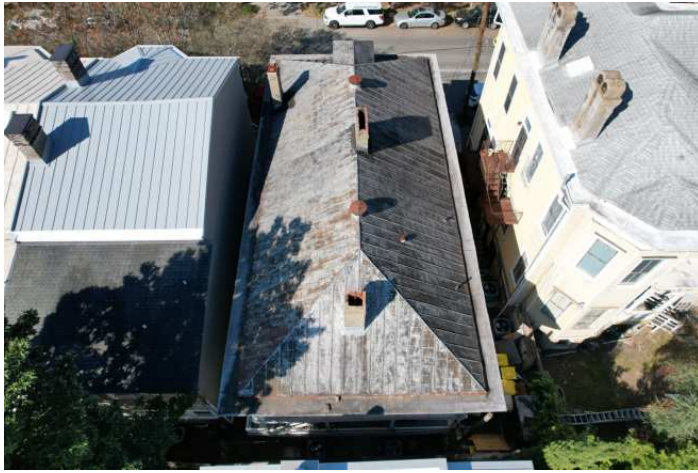
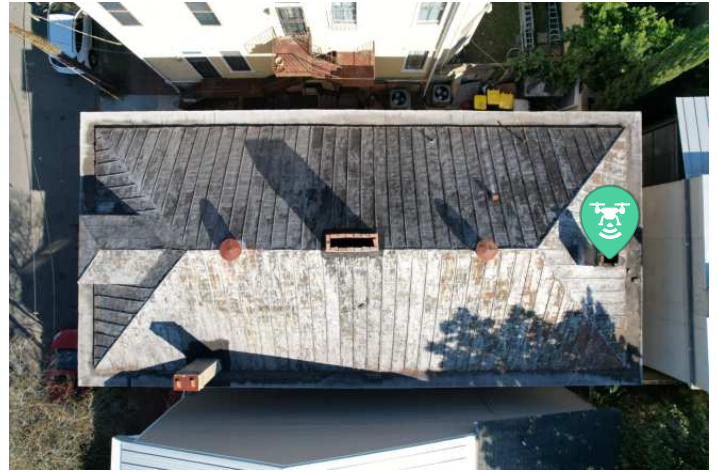
**Rear Slope. Algae/Moss was noted on roof. Peeling paint was noted on the roof. Rust on the roof was noted.**

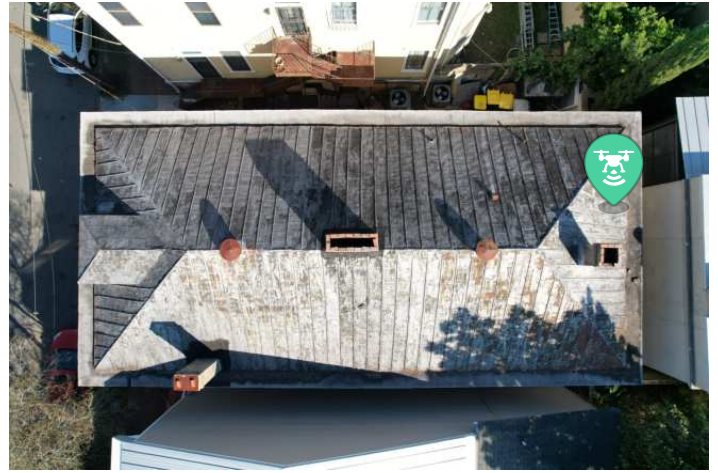
**Rear Slope. Algae/Moss was noted on roof. Peeling paint was noted on the roof. Loose, damaged, or missing metal roof were noted. Rust on the roof was noted.**

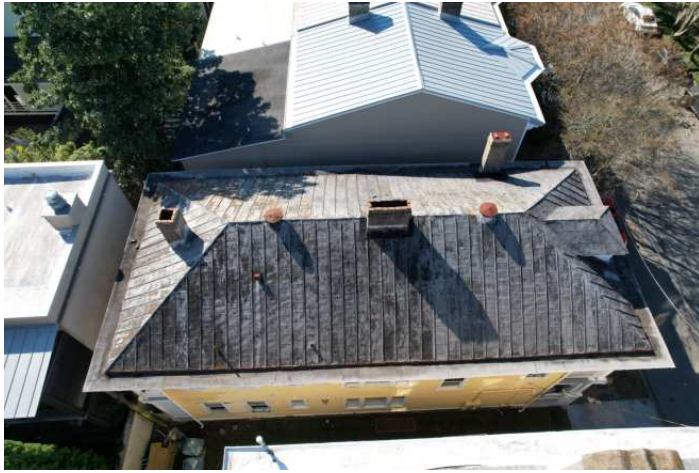
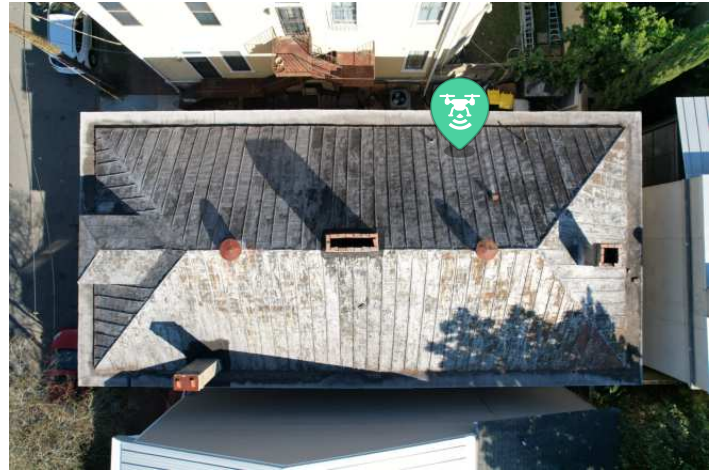
**Left Slope. Peeling paint was noted on the roof. Algae/Moss was noted on roof. Rust on the roof was noted.**

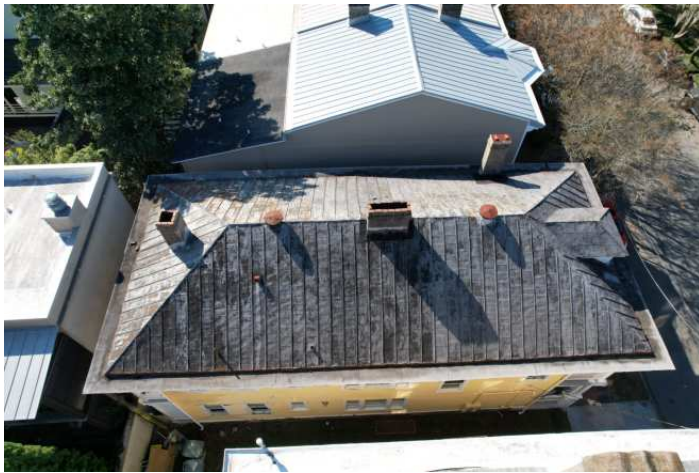
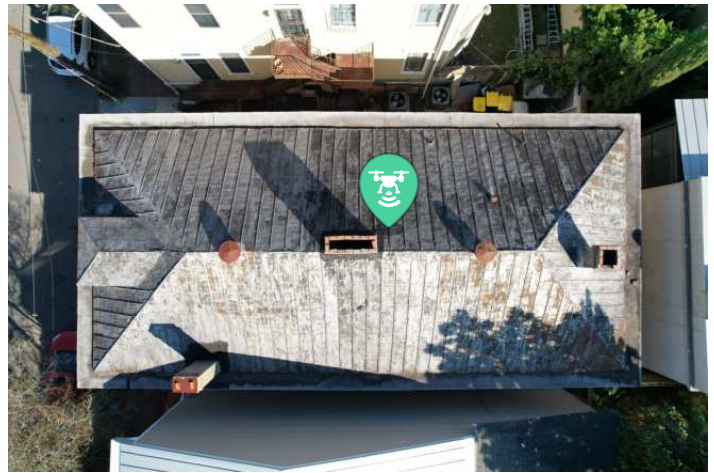
**Left Slope. Algae/Moss was noted on roof. Peeling paint was noted on the roof. Rust on the roof was noted.**

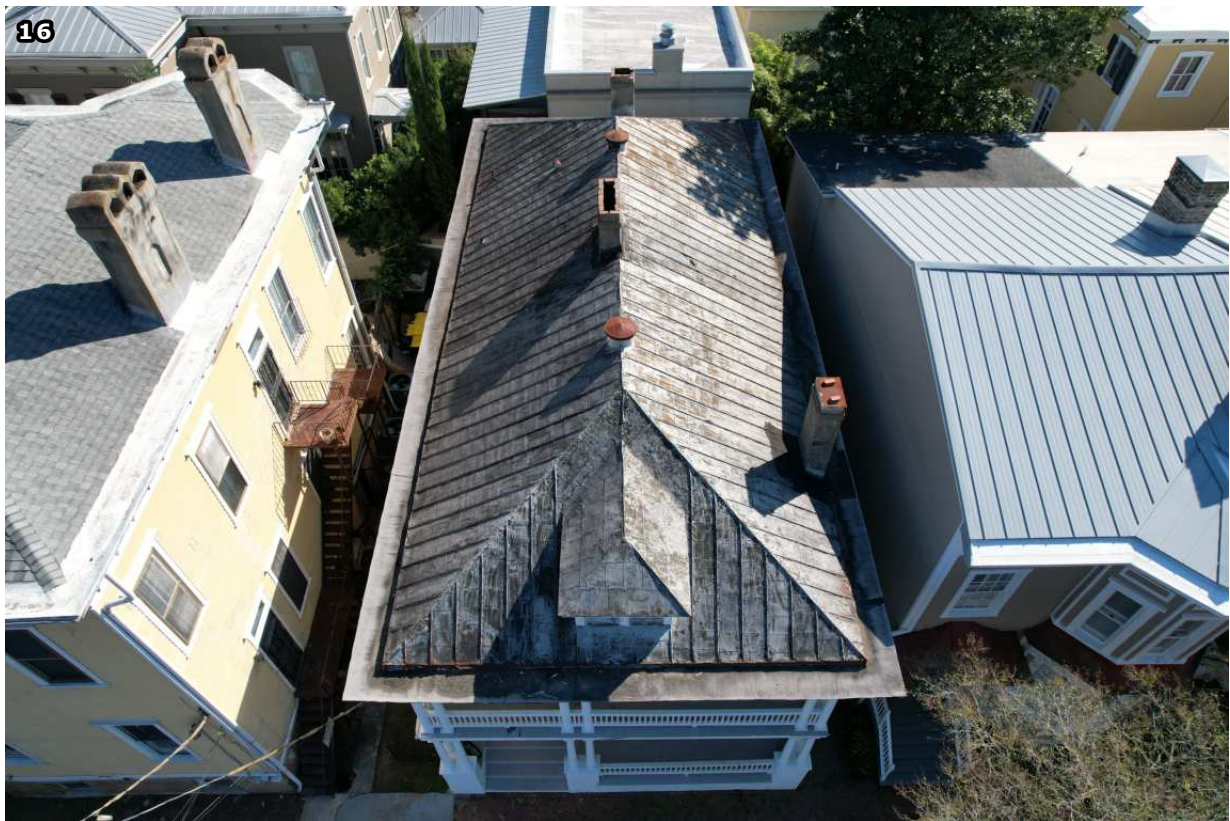
**Front Slope. Overview.**

Peeling paint was noted on the roof.  
Algae/Moss was noted on roof.  
Loose, damaged, or missing metal roof were noted.  
Rust on the roof was noted.

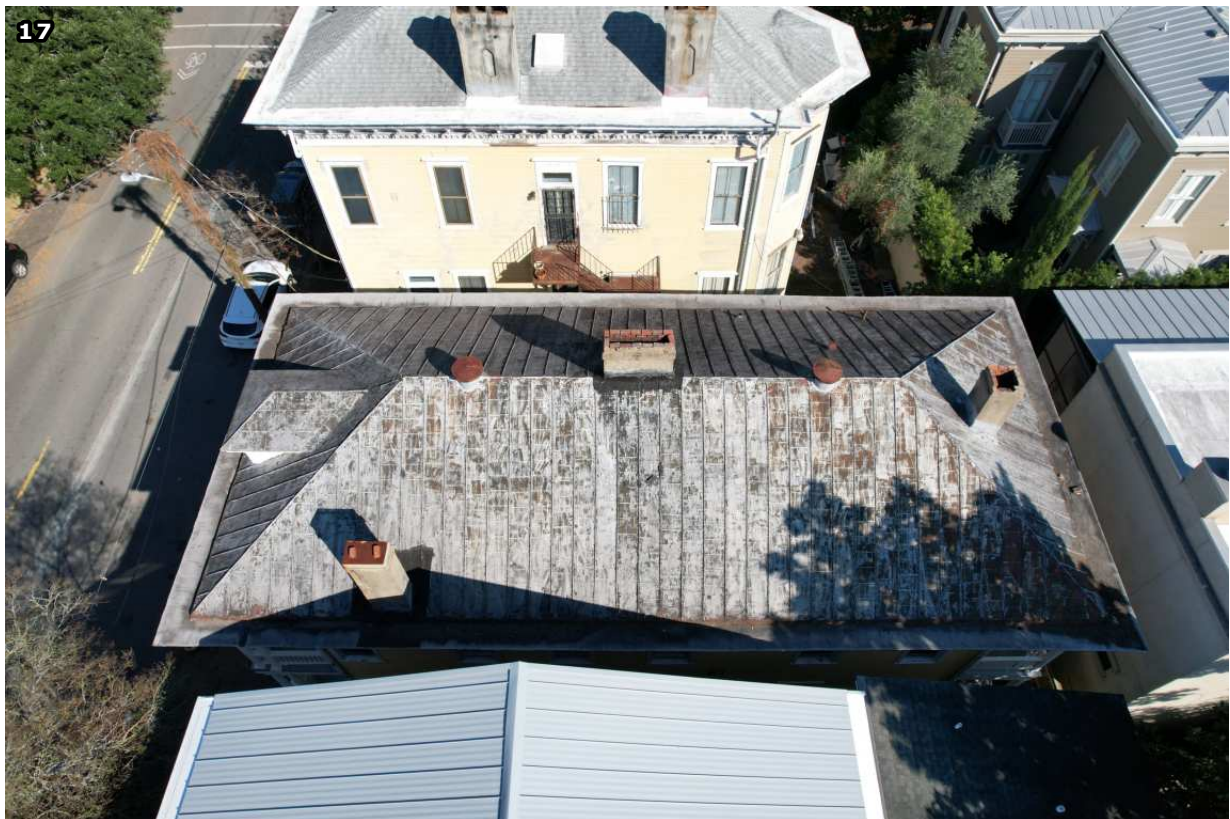
**Right Slope. Overview.**

Peeling paint was noted on the roof.  
Algae/Moss was noted on roof.  
Rust on the roof was noted.

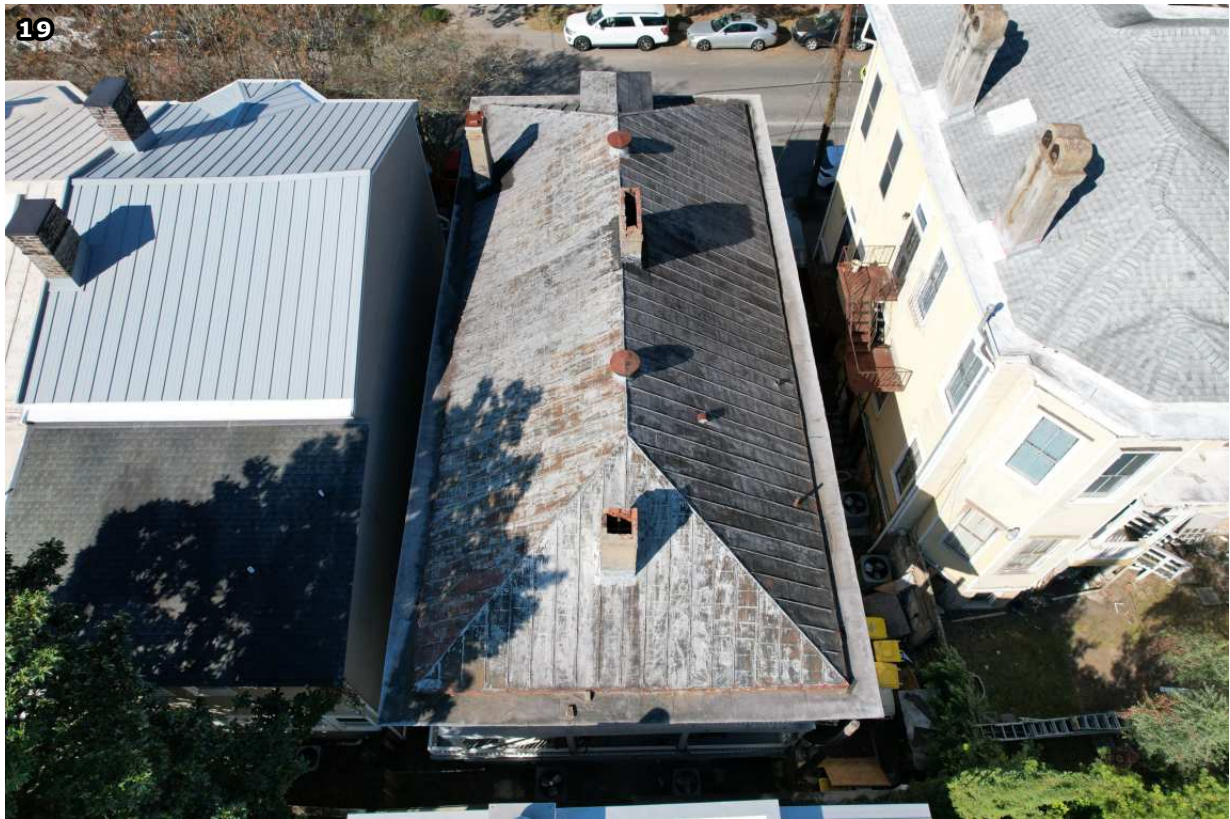
**Rear Slope. Overview.**

Algae/Moss was noted on roof.  
Loose, damaged, or missing metal roof were noted.  
Peeling paint was noted on the roof.  
Rust on the roof was noted.

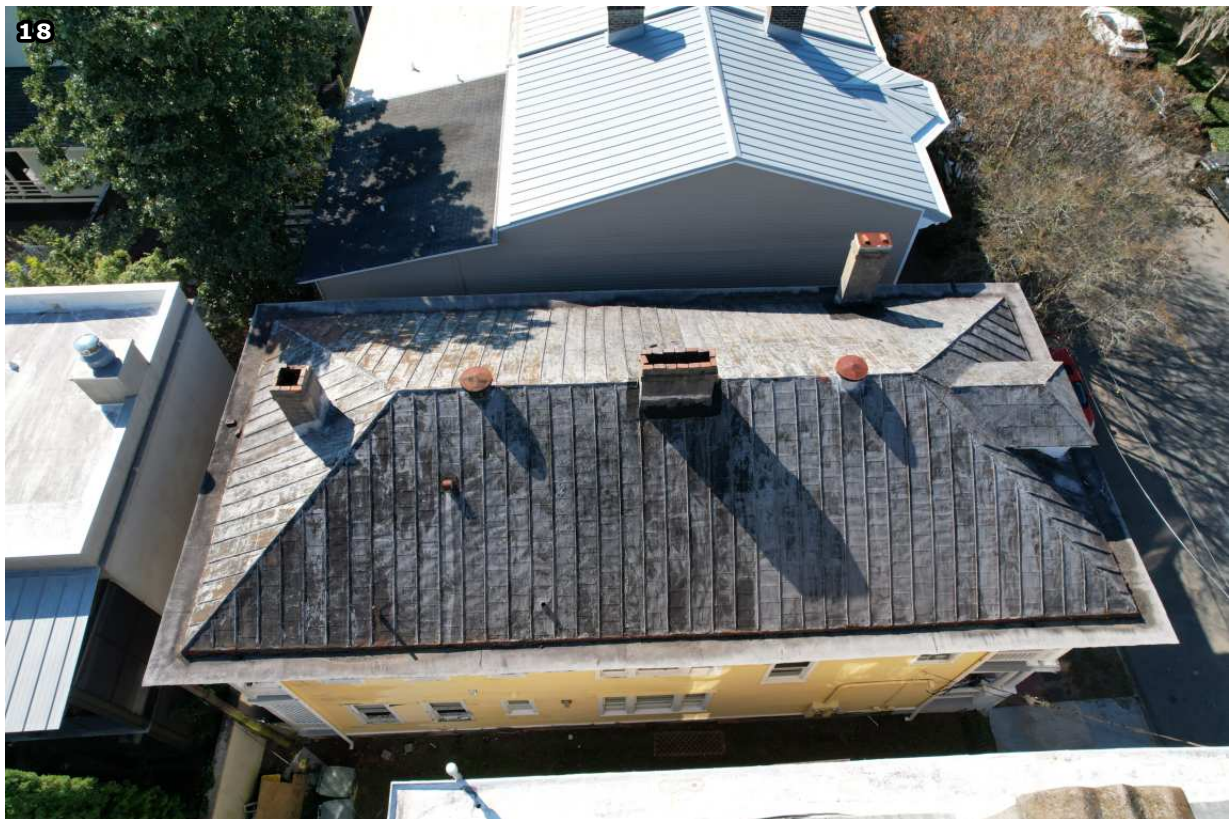
**Left Slope. Overview.**

Algae/Moss was noted on roof.  
Peeling paint was noted on the roof.  
Rust on the roof was noted.

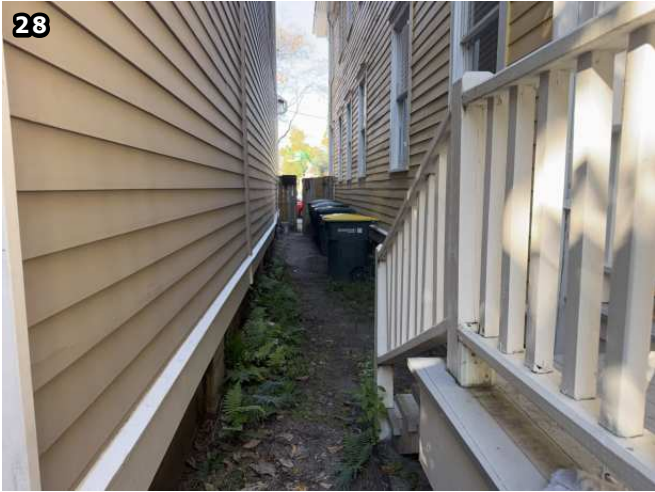
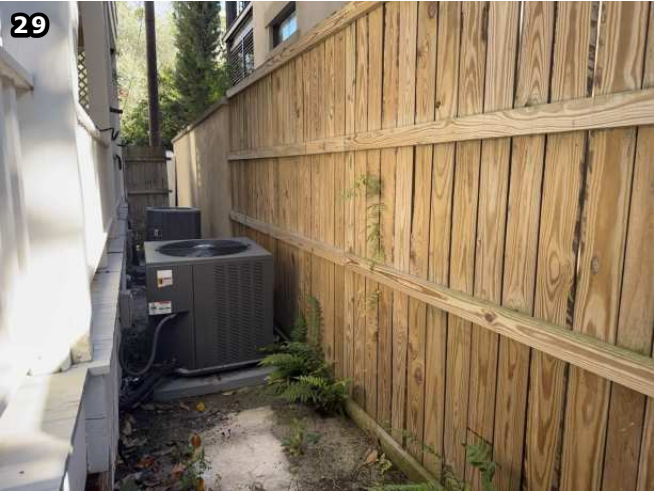
- The fence is noted to be in Good condition.
