Re: 301 Alice Street Demolition

LIMITED CONDITION ASSESSMENT REPORT FOR:

301 Alice St
Savannah, GA

Harley Krinsky | January 2, 2023

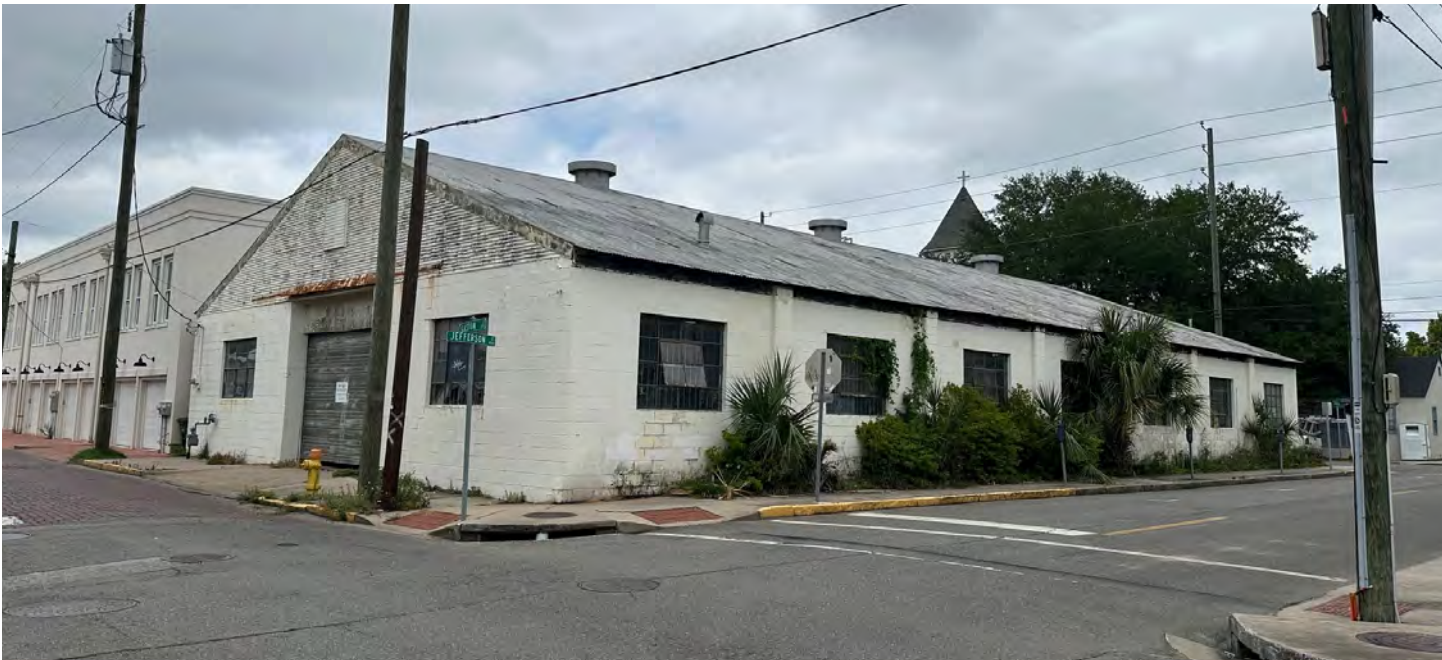
View looking north west.

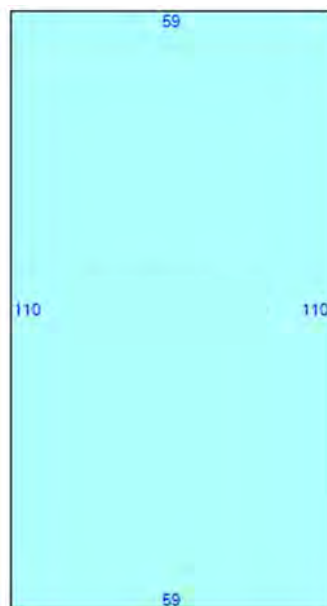
Figure 1: Building Layout

The building is a single-story commercial structure used as a warehouse and has a footprint of 59 feet by 110 feet. The walls of the building are of 8-inch concrete masonry units (CMU) and the roof structure is of metal trusses. It is anticipated that the foundation of the walls are shallow, isolated concrete foundations. The ground slab is a concrete slab on grade and isolated from the building walls or foundation.
