S A V A N N A H   H I S T O R I C   D I S T R I C T  
B O A R D   O F   R E V I E W

**REQUEST FOR CERTIFICATE OF APPROPRIATENESS**

**MPC File No.:** 26-002967-COA

**Address:** 114 West Bay Street

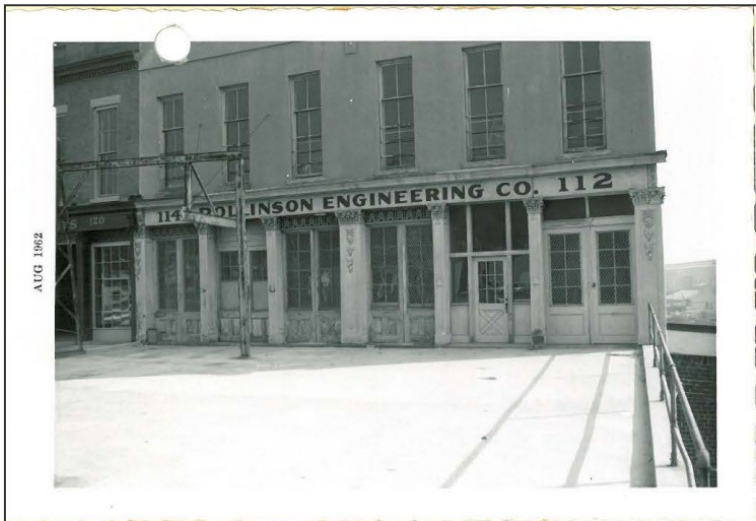
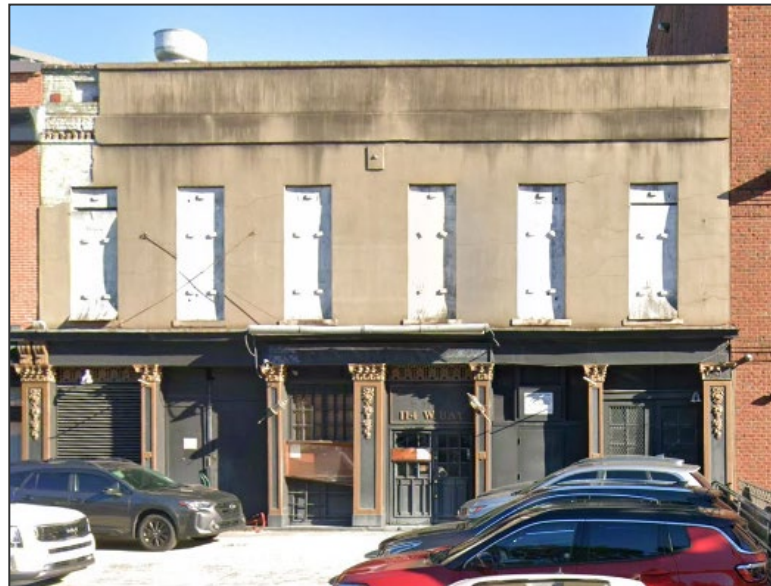
The image below left shows the 1962 Ward Notebook image and the image to the right is present day. The upper-level windows have been covered and the storefront doors and windows have changed, though the columns and decorative work remain intact. The applicant intends to preserve these.

The original windows and storefront no longer exist. The window openings are boarded, and the storefront is a later replacement. The window openings on the River Street side are also boarded. The current enclosed second-story balcony is not historic and thus its removal and replacement will not be detrimental to the historic character of the building.

The windows are missing and boarded up, but older photographs show what the window configuration was, which the new ones will match. As for the stucco, there are areas that require replacement. The stucco will be an appropriate 20<sup>th</sup> century mixture of Portland Cement and lime to match the existing. For the doors on the ground level of the River Street side, the original configuration is unknown, and the doors there currently are not the original. What is proposed for the replacement is fitted to the arched doorways and a similar style to what is there now.
