# Materials Attachments – Full Board Review

Property: 623 W. 36th Street, Savannah, Georgia  
Project: Rear Deck and Stairway Repair and Replacement  
Review Type: Full Board Review

### **1) Written Description / Scope of Work**

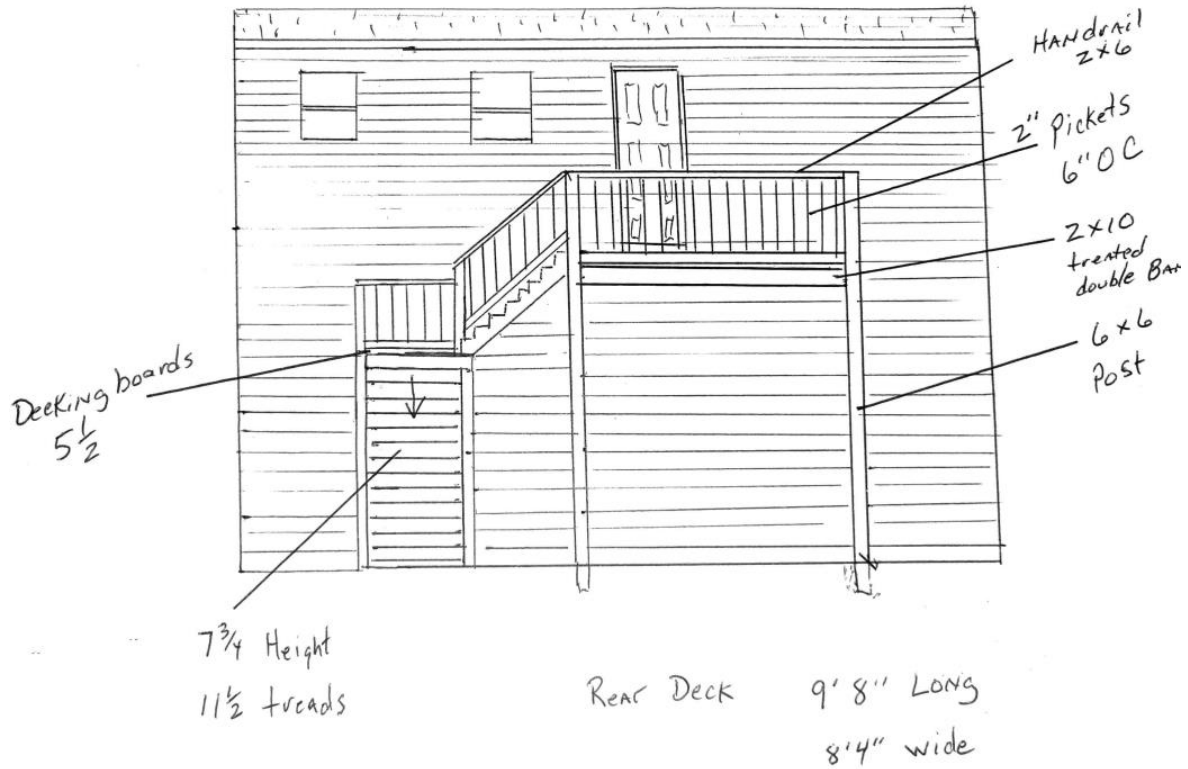
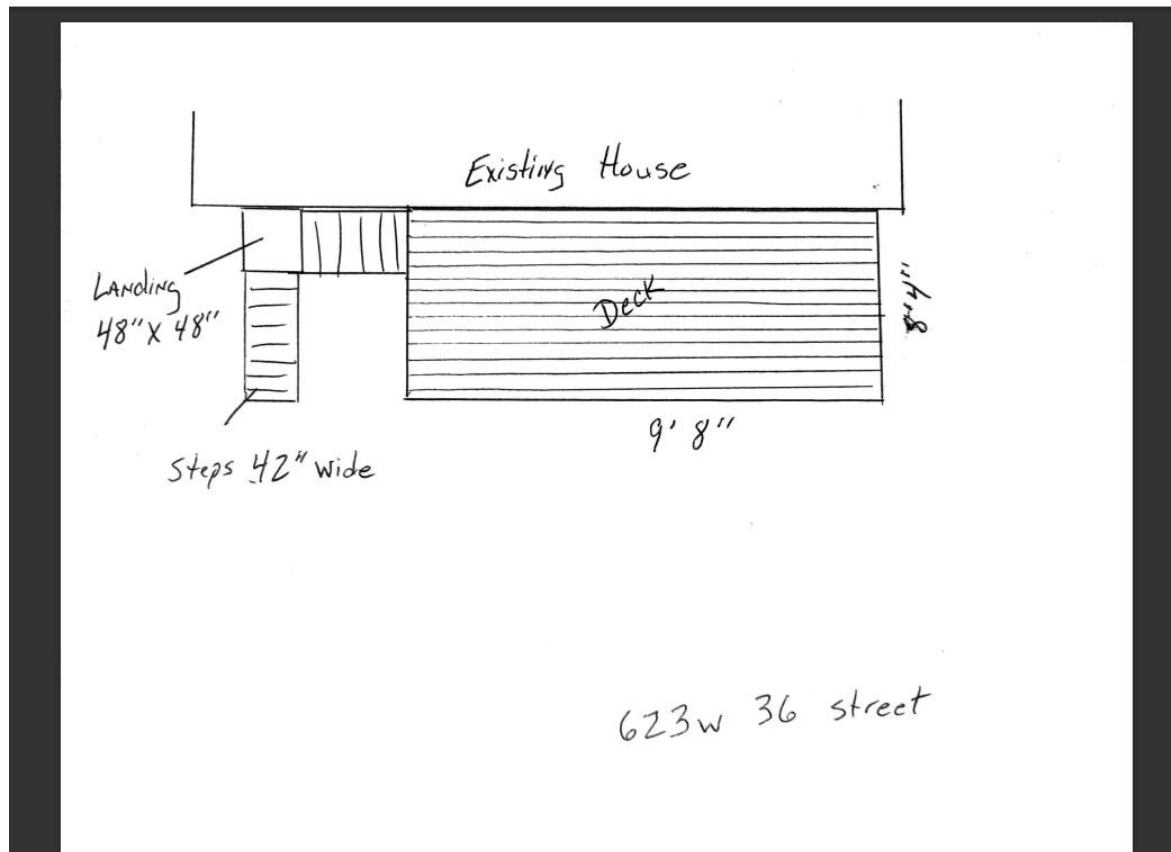
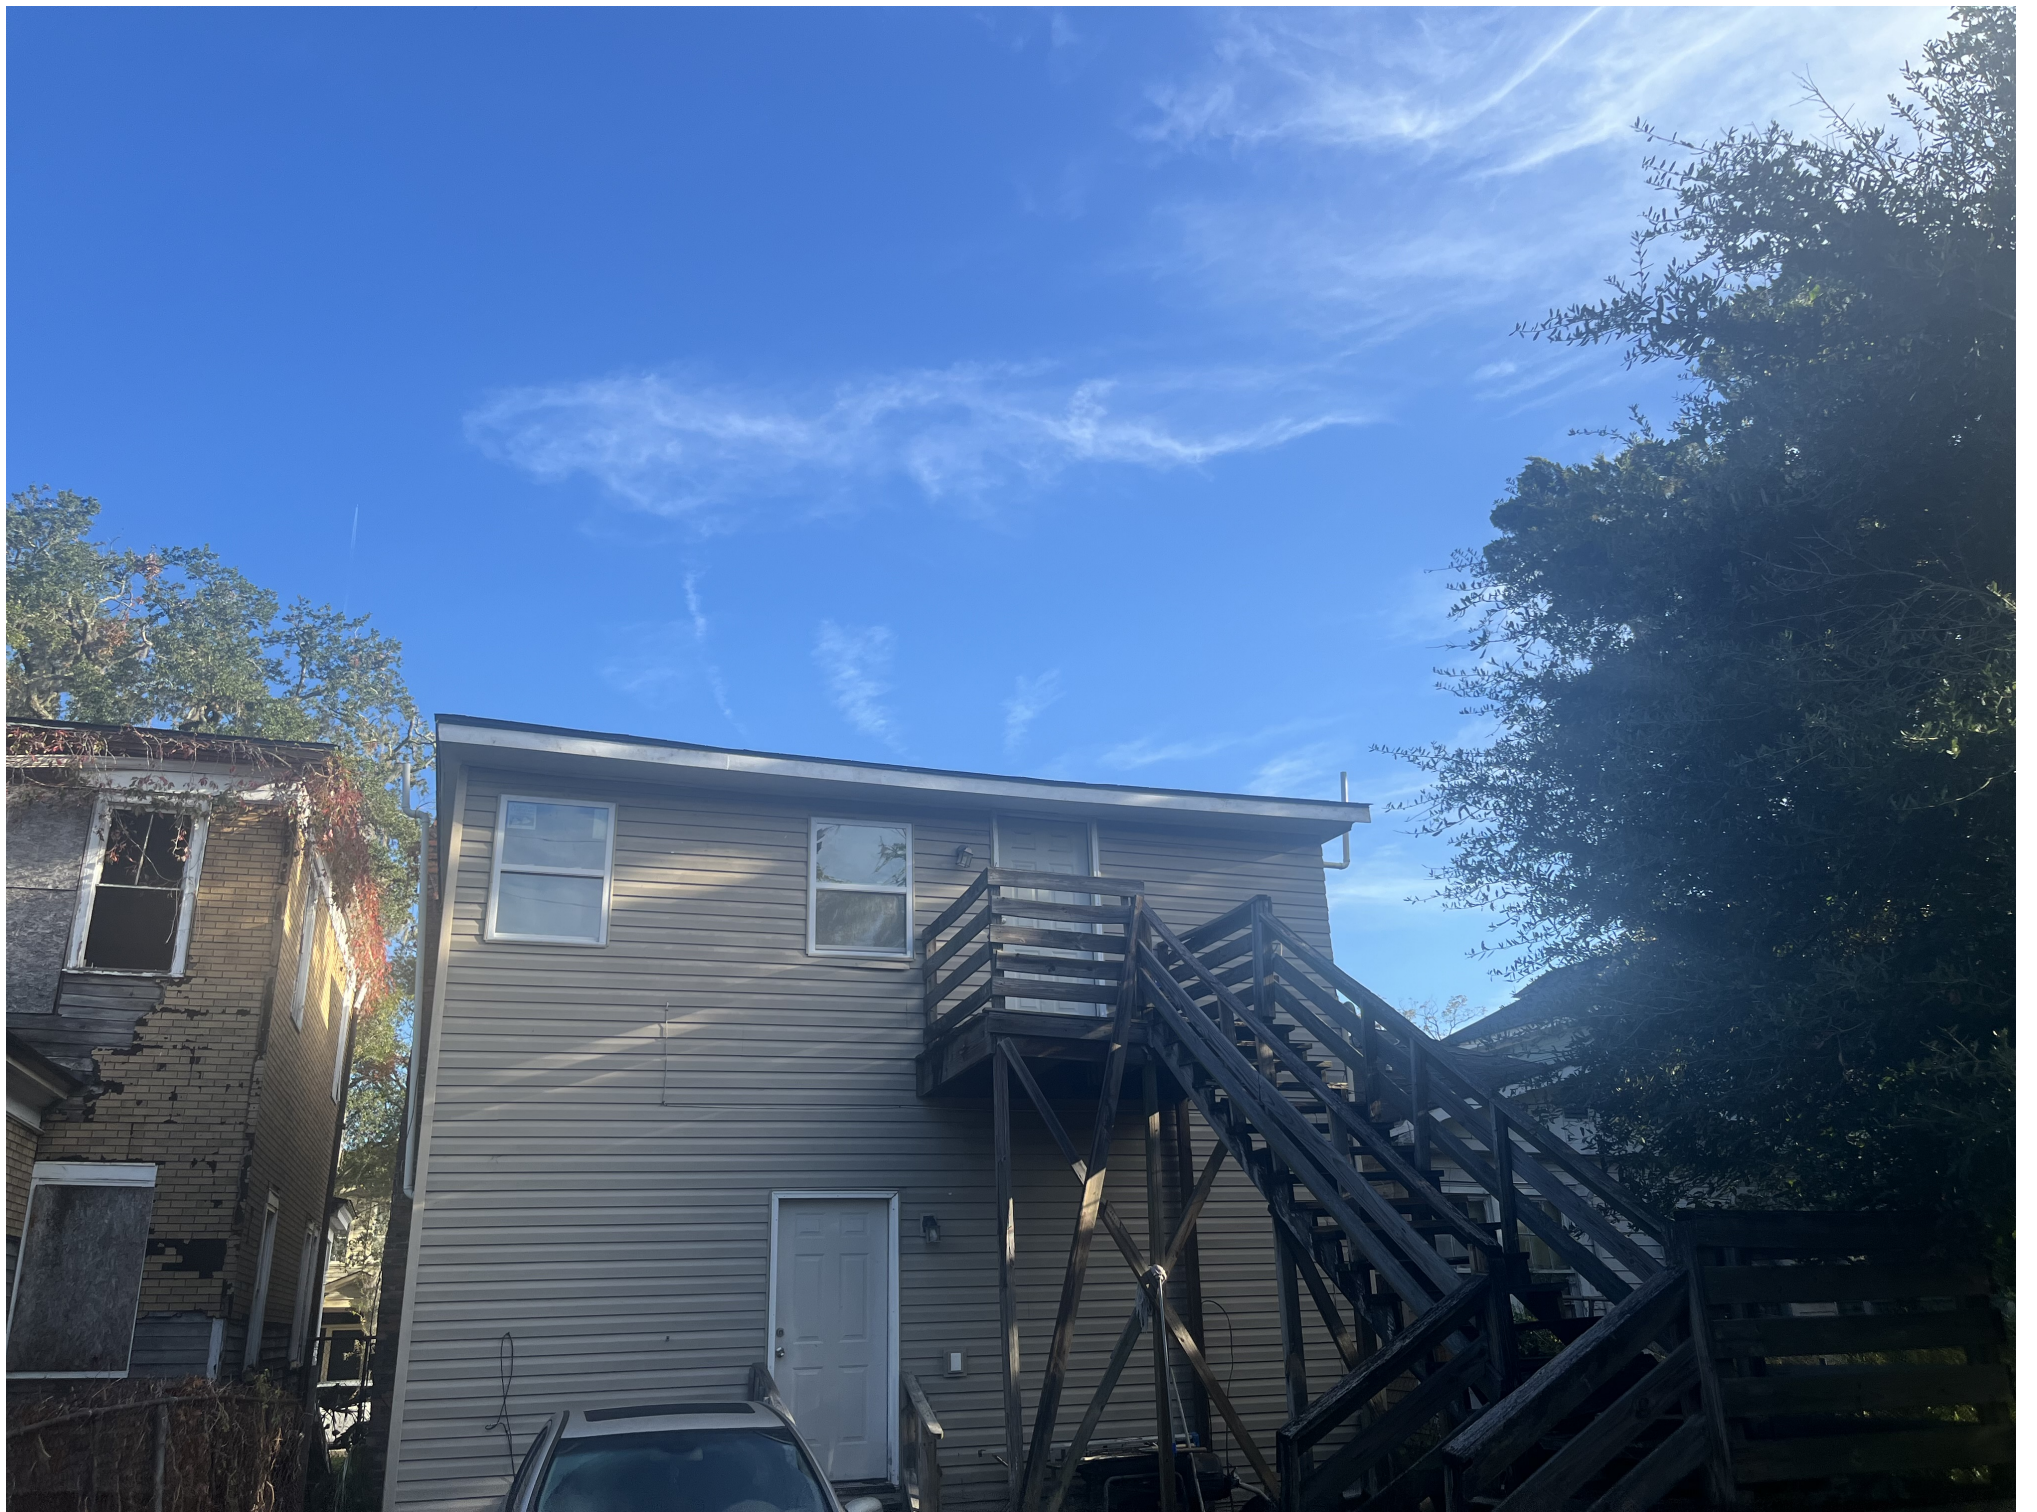
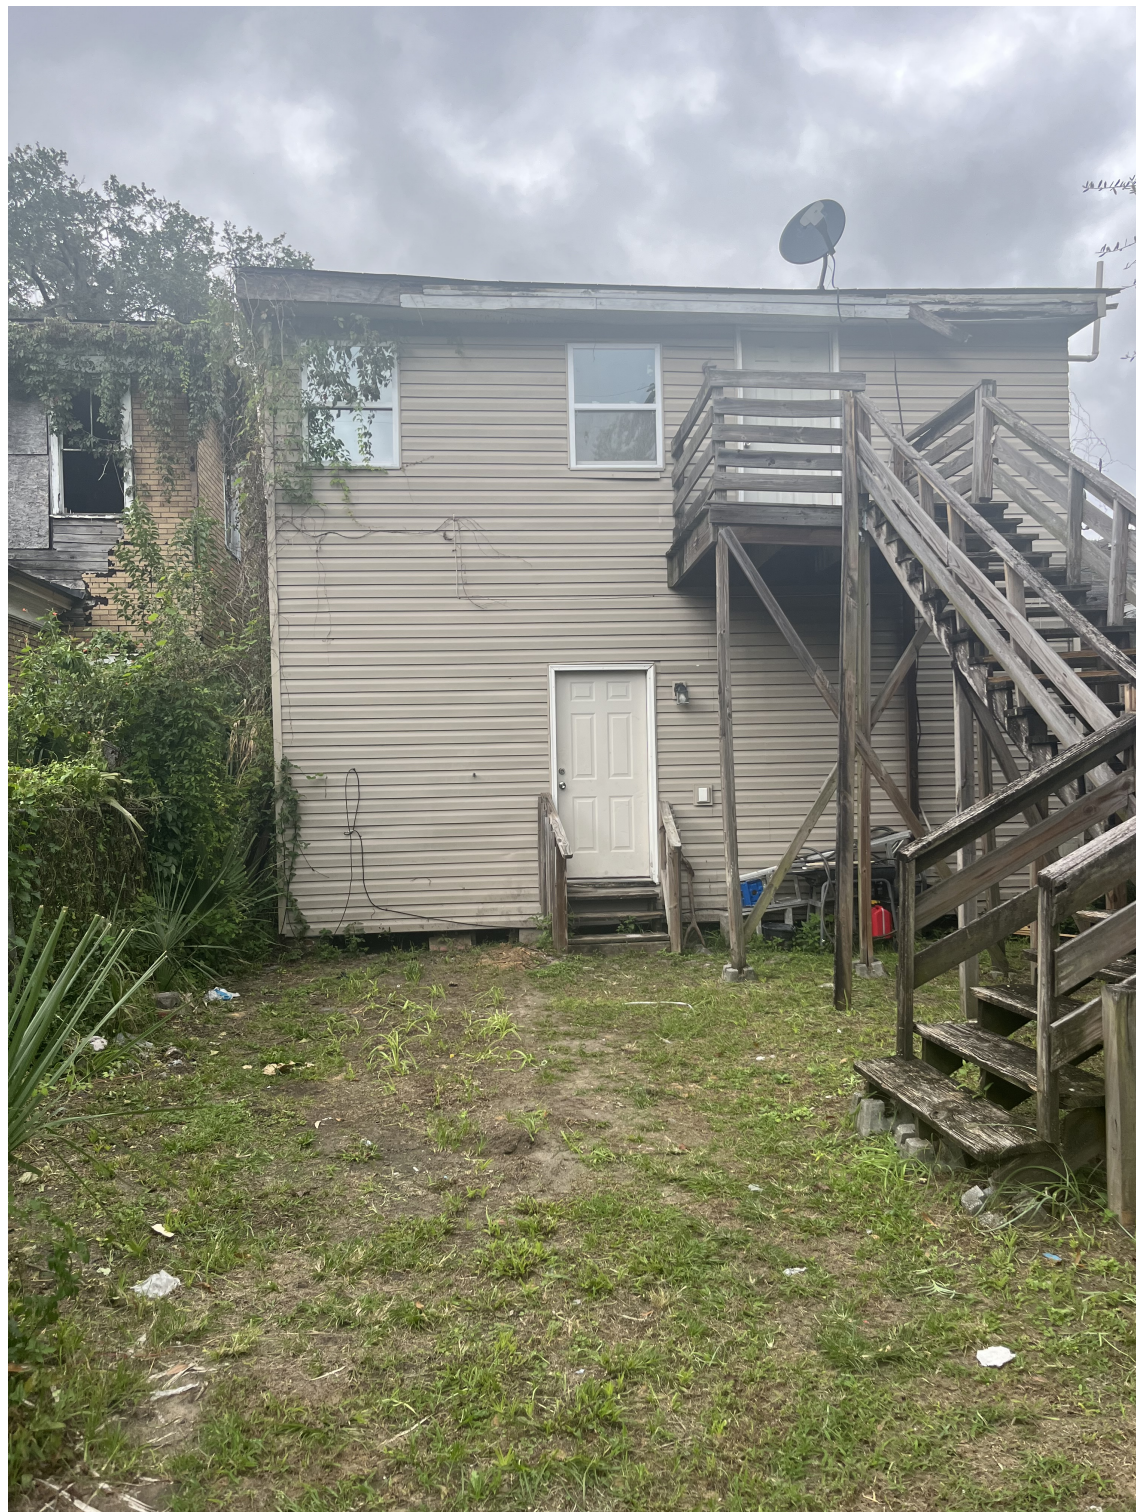
623 W. 36<sup>th</sup> Street

The existing rear stairway and landing serving the residence at 623 W. 36th Street have deteriorated due to prolonged exposure to moisture and age. Several structural components—including stair stringers, treads, decking boards, and lower support framing—are affected by wood rot, compromising the structural integrity and safety of the stairway.

The existing rear wooden deck and stairway are structurally compromised due to **rotted wood components**, including decking boards, stair treads, stringers, and lower support framing. The deterioration presents a safety concern and makes repair of individual components infeasible.

- Existing house and rear deck location
- Deck dimensions: approximately **9'8" long x 8'4" wide**
- Stair width: **42 inches**
- Landing size: **48" x 48"**
- Stair rise and tread configuration consistent with existing construction

The proposed work consists of **like-for-like replacement** of the existing rear deck, landing, and stairway in the **same location, footprint, dimensions, and configuration** as the existing structure. No expansion, height increase, or change in design is proposed. The work is limited to the **rear elevation of the residence**, with no impact to character-defining features of the primary historic structure.

- Pressure-treated **6x6 wood posts** for structural support
- Pressure-treated **2x10 lumber** for beams and stair stringers
- Pressure-treated **2x6 lumber** for handrails, framing, and guardrails
- **5/4 pressure-treated decking boards** to match existing decking
- Pressure-treated stair treads sized to existing dimensions
- Vertical wood pickets (approx. **2" width, spaced ~6" on center**)
- Galvanized or exterior-rated fasteners and connectors
