# CITY OF SAVANNAH

### REQUEST FOR CERTIFICATE OF APPROPRIATENESS

**MPC File No.:** 26-002125-COA

**Address:** 106 West 31<sup>st</sup> Street

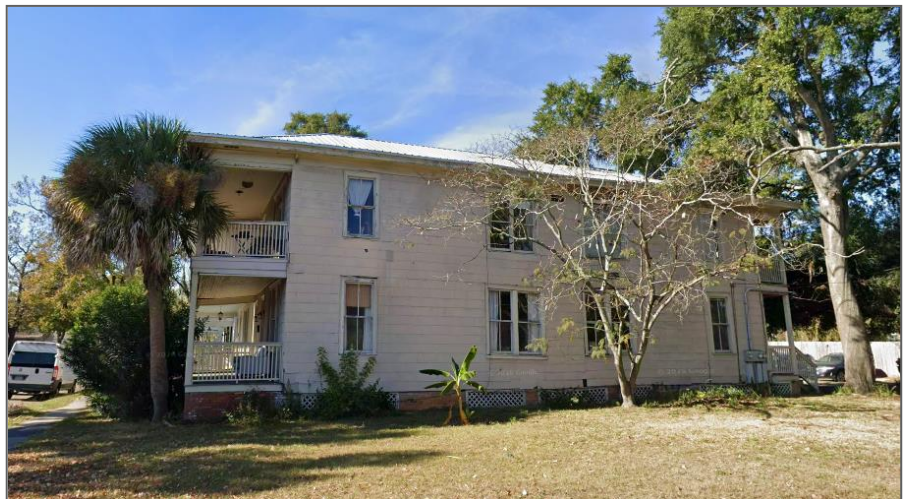
106 West 31<sup>st</sup> Street was built in 1913 and is a contributing resource within the Thomas Square-Streetcar National Register Historic District and the local Streetcar Historic District. It is next to a vacant lot which makes it highly visible from the corner of Whitaker and West 31<sup>st</sup> Streets. At some point, the house was covered in asbestos shingles. There are portions of this that have fallen off, exposing at least some of the original clapboard siding beneath.

There are various areas on the building where the asbestos shingles have either fallen off or have deteriorated. Due to the hazardous nature of asbestos, it would not be possible or advisable to install replacement asbestos, hence the request for a replacement that is close with fiber cement. This is typically a prohibited material but in this unusual circumstance it may be the most sensible option to spot treat areas where the shingles must be replaced.

Fiber cement is a prohibited material on historic buildings. However, staff finds it may be something that could be supported in lieu of seeking out asbestos shingles, but also requests information on whether there is a product made of wood that would serve the same purpose and have the same look that once painted, will blend in with the existing shingles.

- 1. Provide clear photographs of each window proposed for repair and provide more details about the repair work per window.**
- 2. Explore options for wood instead of fiber cement for the replacement of missing and damaged asbestos shingles. If there is no option, a sample of the fiber cement must be provided to present at the next meeting, for analysis and determination of next steps.**
